PROPERTY INSPECTION REPORT

Concerning: 273 Cedar Lake Dr, Abilene, TX 79606
(Address or Other Identification of Inspected Property)

By: David Renner, Lic #20502 / NAWT #12181ITC 01/05/2018
(Name and License Number of Inspector) (Date)

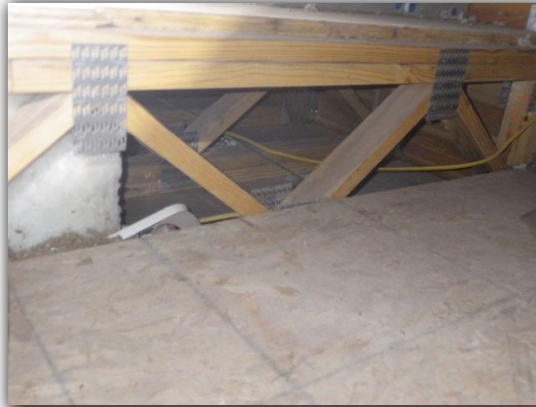
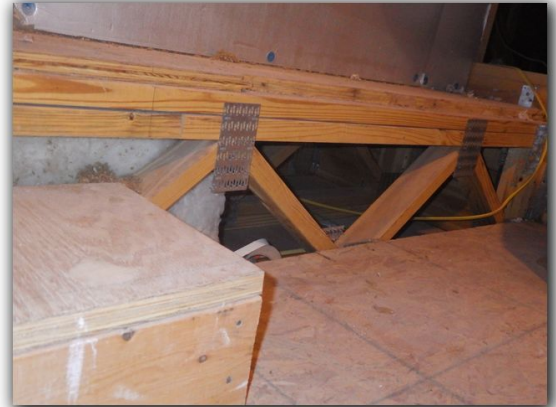
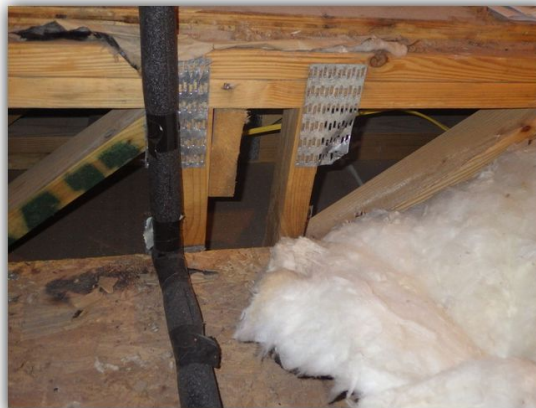
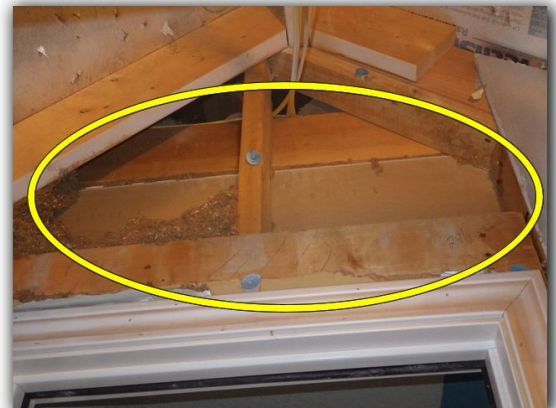
- The sidewall insulation was observed to be missing at a few locations in the attic area. This condition should be further evaluated and corrected as necessary.

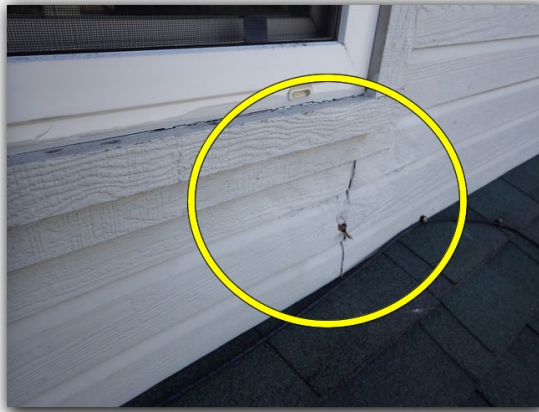
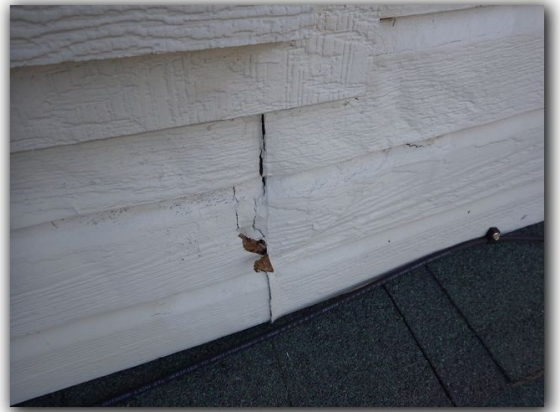
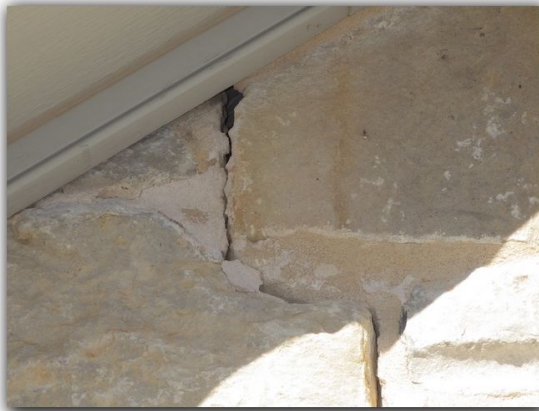
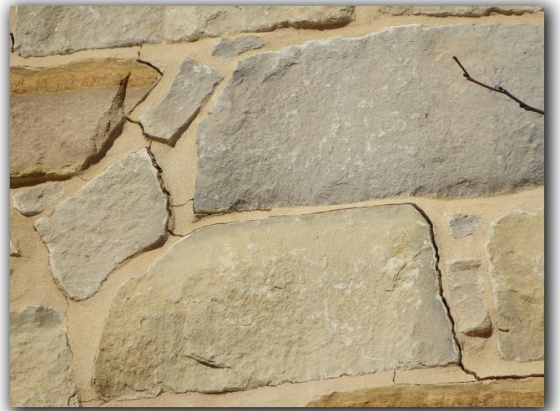
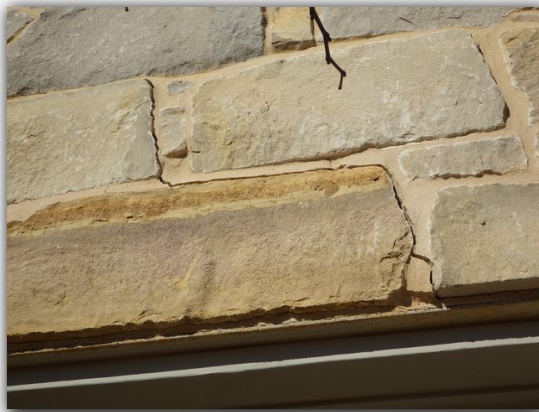
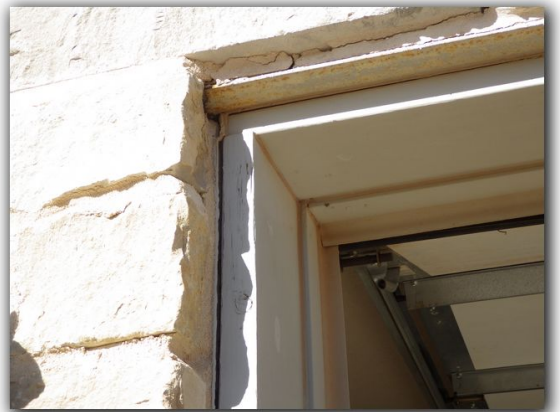
- The wood veneer has some deterioration and/or damage on the north side of the structure.
- The steel lintels over the exterior doors and windows should be painted.
- Caulking improvements are recommended for the area between the exterior veneer and the exterior door frames, window frames and garage door trim boards.
- Mortar improvements are recommended for the exterior masonry veneer on the south side of the structure. Cracks were observed in the stone veneer around and above the garage door.
- The sidewall veneer is in contact with the roofing material. Under current building standards, there should be at least 2-inch of clearance between the roofing material and the sidewall veneer.

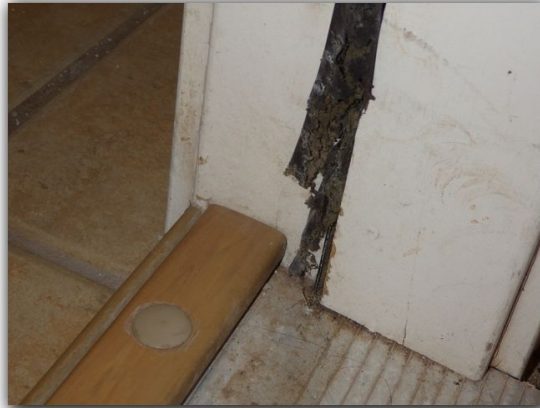
- Weather-stripping improvements are recommended for the garage entry door.

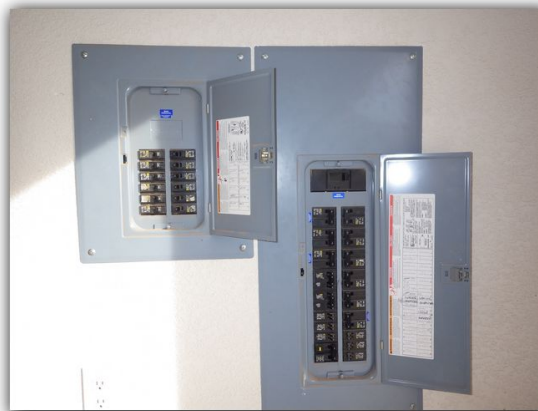
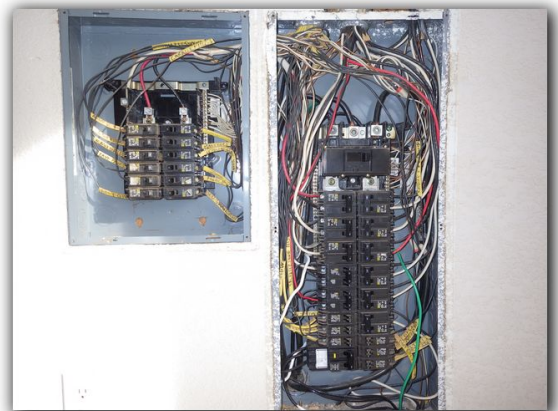
- One or more of the neutral wires are incorrectly connected under a single screw on the grounding/neutral bus bar. Under current installation standards, the ground and neutral wires should be under separate screws with no more than one neutral wire per screw.
- The wires entering the electrical cabinet are not properly secured or protected from the sharp edges of the cabinet.
- The electrical service wiring appears to be loose and/or overheating.

The electrical system should be checked by a Qualified Licensed Electrician. The observations made to support the rendering of this opinion are listed but not limited to the following:

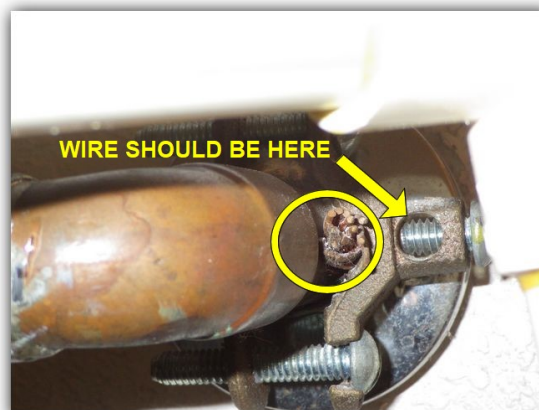
- The ground wire was not properly connected to the cold water pipe at the water heater. This condition needs to be corrected to properly ground the electrical system.

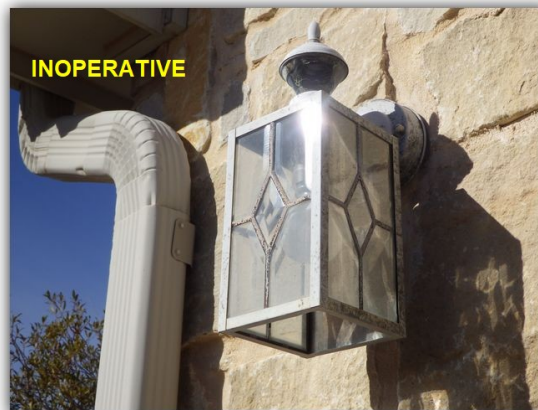
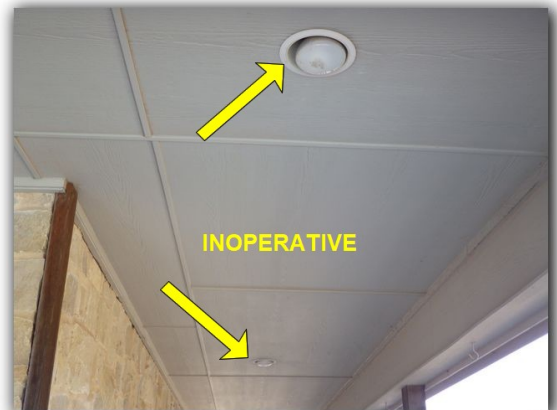
- **Note:** Some of the receptacles in the home were inaccessible and could not be reached for inspection due to personal effects, heavy storage, furniture or conditions outside the control of the inspector.
- Not all of the garage receptacles appear to be connected to a ground fault circuit interrupter (GFCI) device. Under current electrical standards, all of the garage receptacles should have GFCI protection. The new National Electrical (NEC) Code no longer has an exception for "non-appliance dedicated".
- One of the ground fault circuit interrupter (GFCI) devices does not appear to be functioning properly at the time of this inspection. The device in question is located at the garage.
- All exterior receptacles should have weather tight (bubble) covers. The receptacle weather cover plate is damaged and/or missing on the south exterior wall.

- One or more of the light fixtures appear to be inoperative in the back porch, front porch, south exterior wall. This may be due to a bad bulb or some other unknown condition. This condition should be further evaluated and corrected as necessary.
- An improper light fixture was observed to be in use over the master bathroom bathtub and downstairs hall bathroom bathtub. Under current building standards, luminaries listed for use directly above tub & shower locations should be used. This condition should be corrected for reasons of safety.
- The ceiling fan is not balanced properly and wobbles when operated in the rear corner bedroom, front corner bedroom.

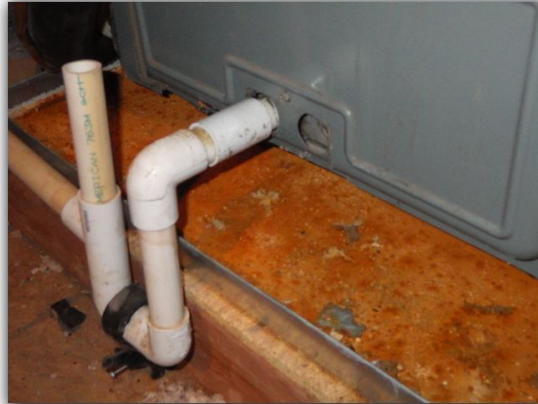
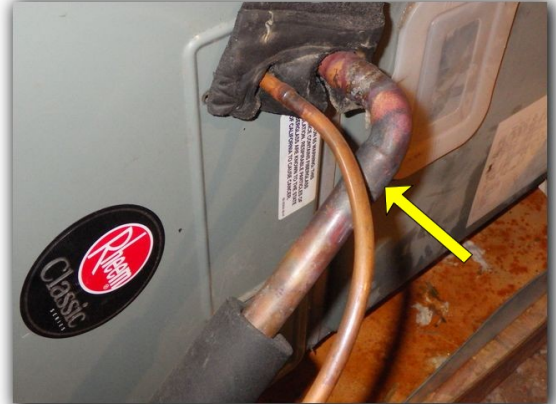
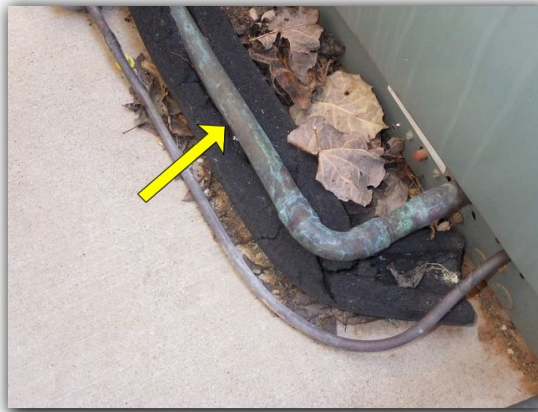
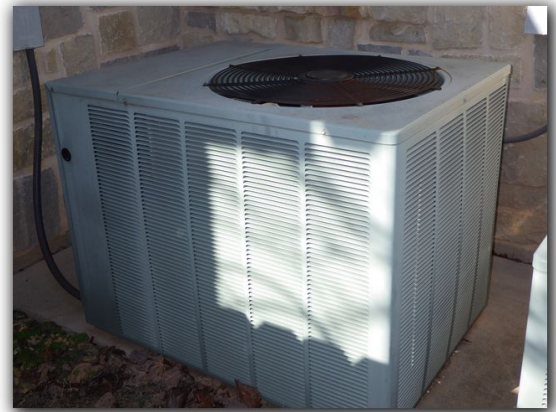
- Damaged, deteriorated and/or missing insulation on the refrigerant lines in the attic area and at the outside condenser should be repaired or replaced as necessary.
- **Note:** The auxiliary/secondary drain pan under the coil housing has some water staining and/or a rust build-up. This would indicate that the pan has held water in the past and should be closely monitored.

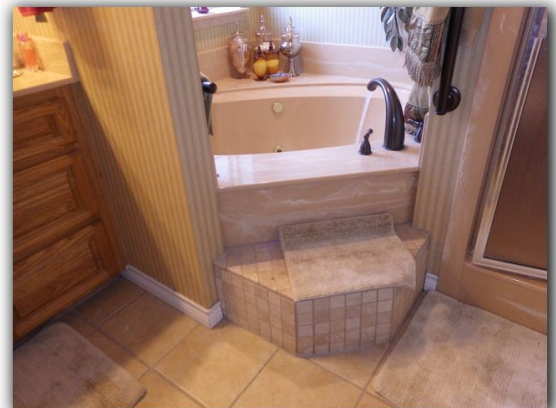
- I was unable to locate a ground fault circuit interrupter (GFCI) receptacle or breaker for the hydro-massage therapy equipment. The homeowner should be consulted on the location of this GFCI device. If there is no GFCI device installed on the hydro-massage therapy equipment circuit, a GFCI receptacle or breaker should be installed for reasons of safety.
- The access to the hydro-massage therapy equipment motor is not readily accessible and inspection of the equipment lines and motor could not be performed. This does not meet current installation standards.

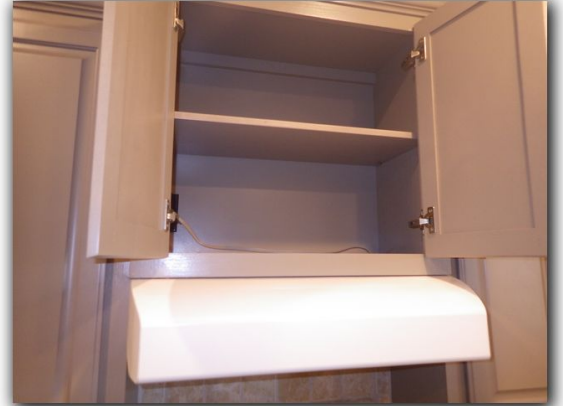
- The range exhaust appears to terminate into the wall. Vented range exhaust should terminate to the exterior of the structure.

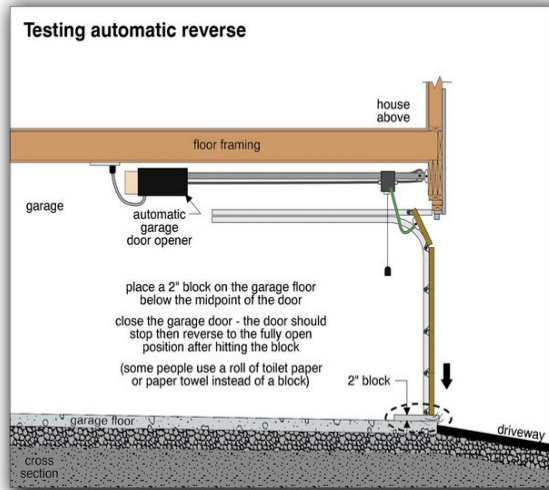
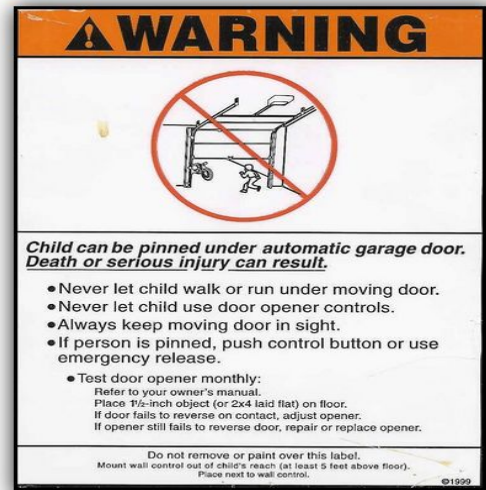
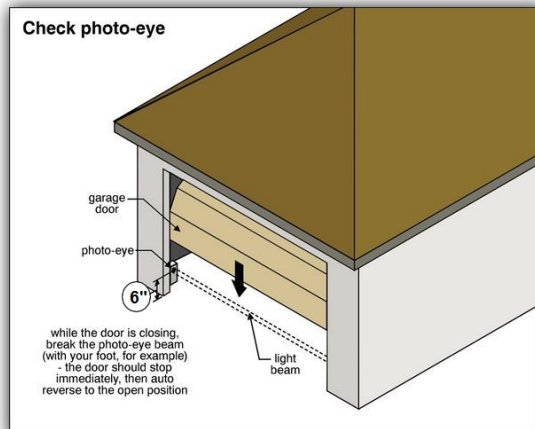
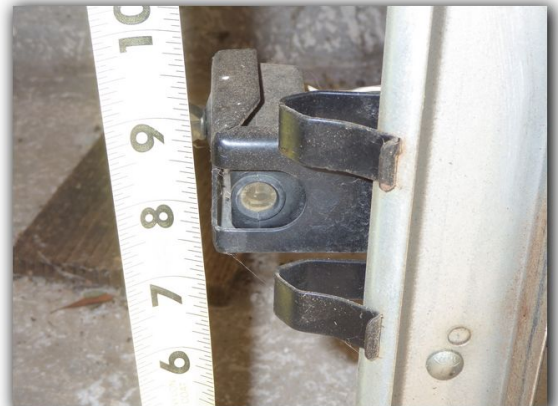
- When an automatic garage door opener is in use, the manual lock should be disabled or removed.
- The garage door reverse sensors are not properly installed. The garage door reverse sensors should be installed within 6-inches of the garage floor.
- The garage door opener ***DID NOT*** automatically reverse under reasonable resistance when closing. Improvement may be as simple as adjusting the sensitivity control on the opener.
- The opener light is inoperative.

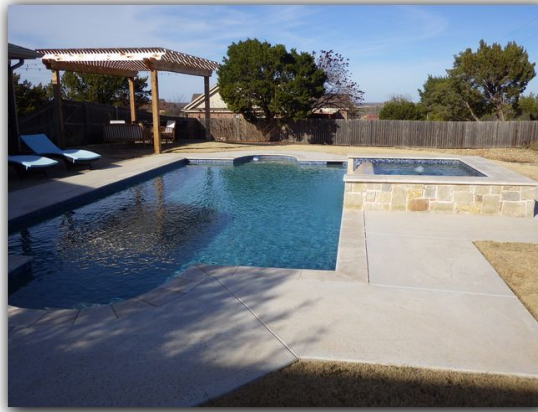
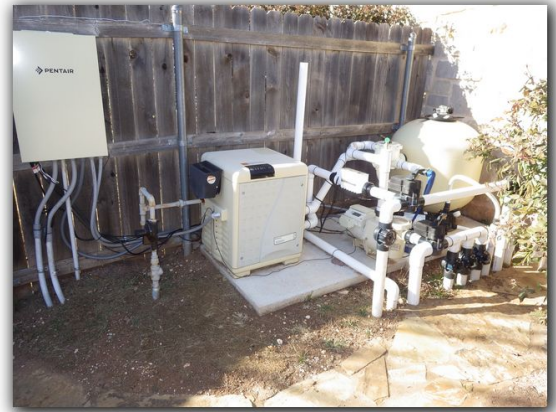
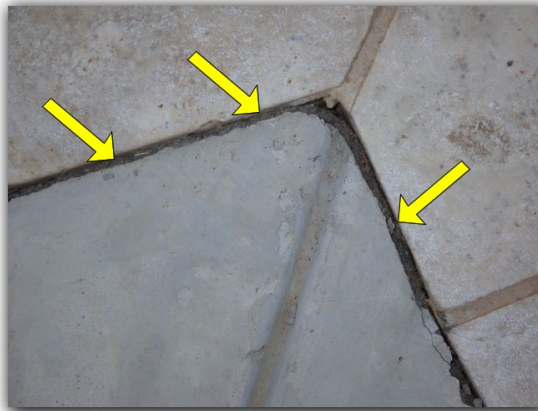
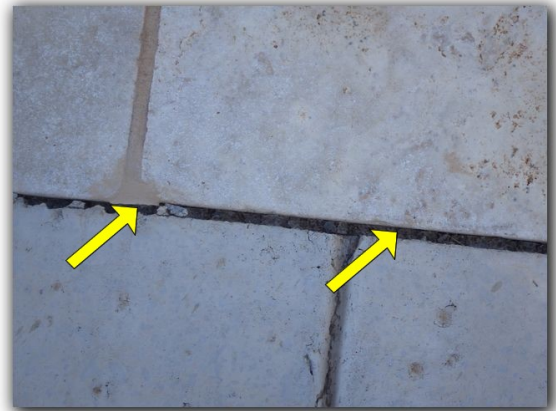
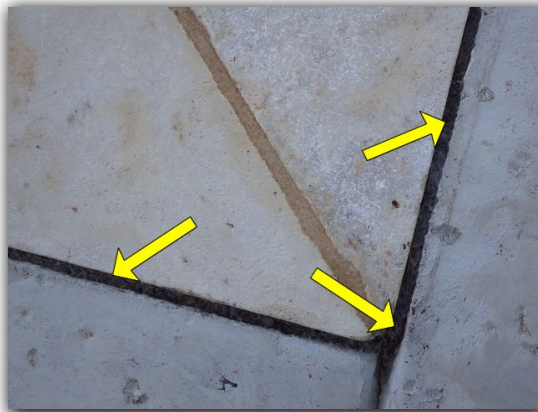
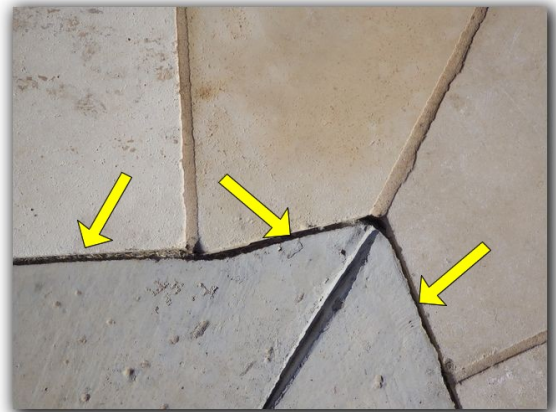
- Missing and/or failing mastic (Deck-O-Seal) was observed between the deck and coping. The mastic requires improvement at this time.
