## PROPERTY INSPECTION REPORT

**Concerning:** 2864 S 7th St, Abilene, TX 79605  
(Address or Other Identification of Inspected Property)

**By:** David Renner, Lic #20502 / NAWT #12181ITC 02/02/2018  
(Name and License Number of Inspector) (Date)

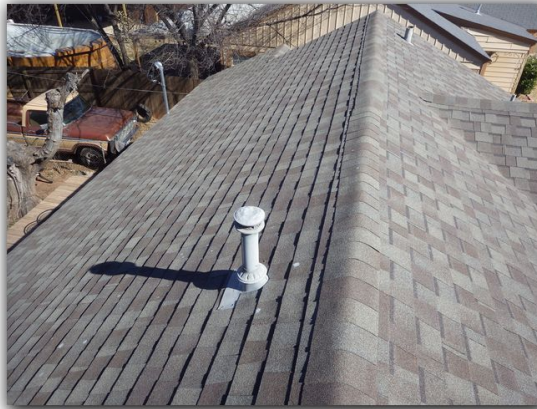
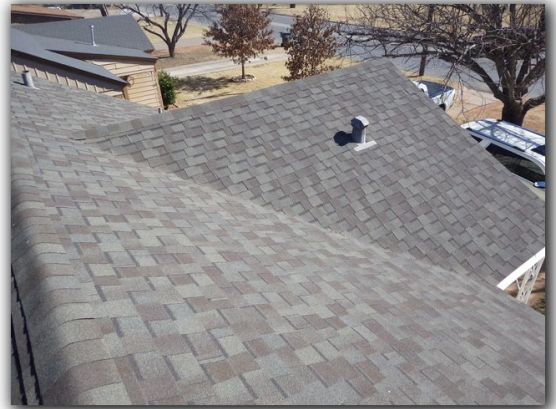
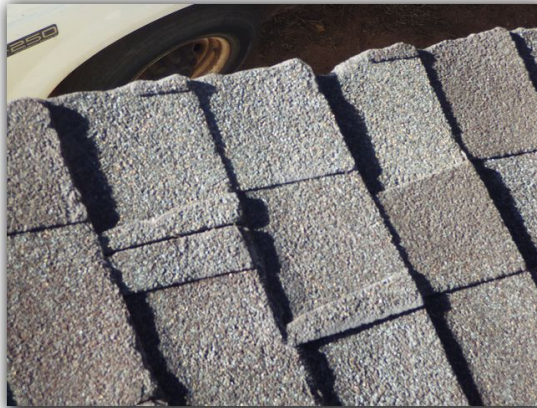
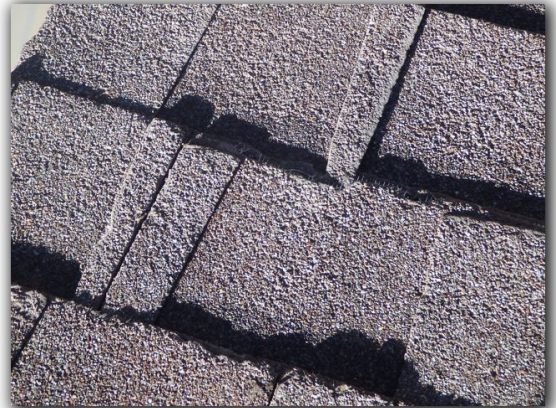
- Minor damaged shingles were observed on the north-west corner of the roof structure.

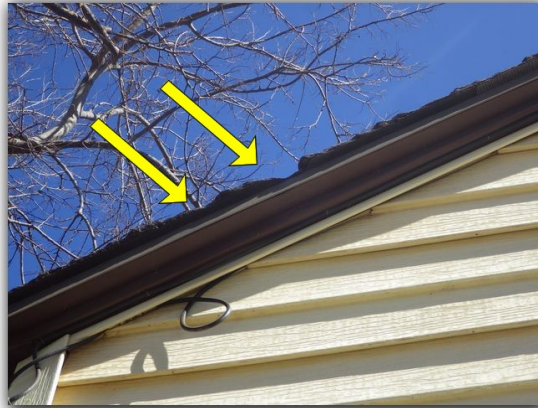
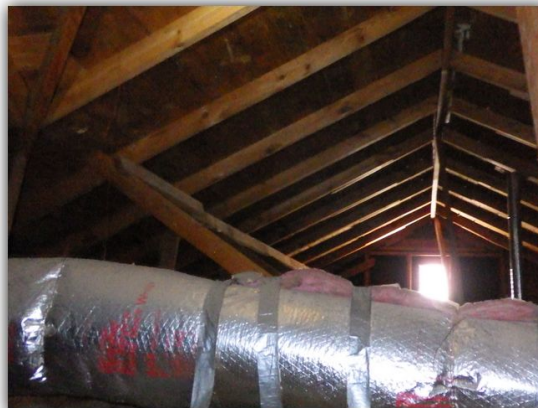
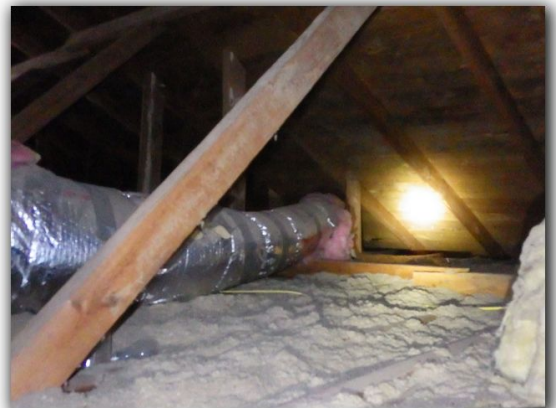
- One or more of the roof structure rafters were observed to be pulling away from the top ridge board. Recommend monitoring and repairs if needed.

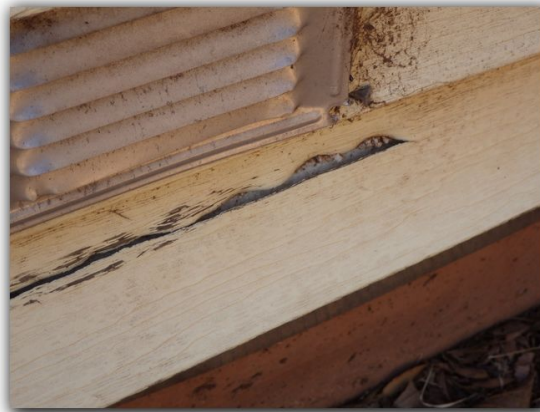
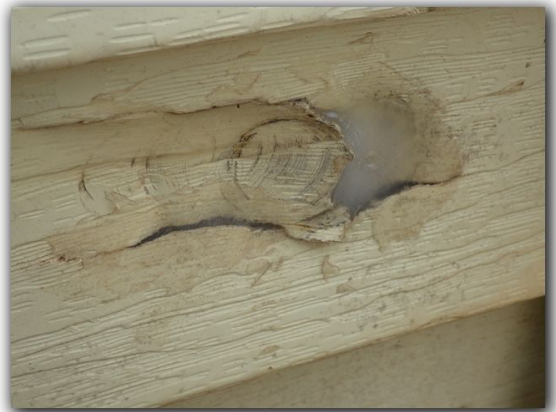
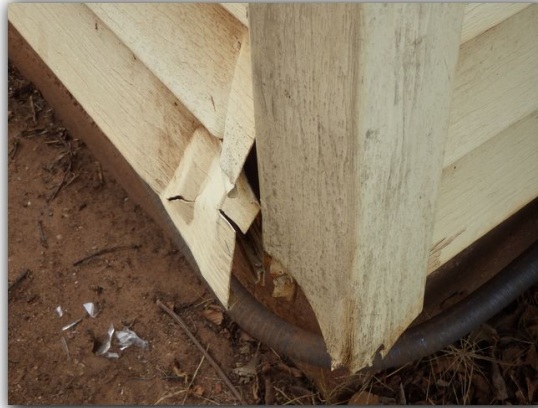
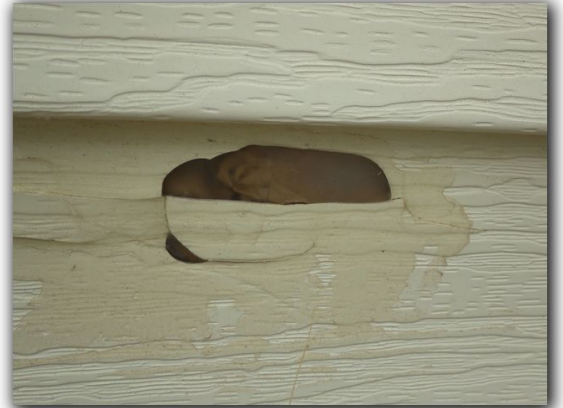
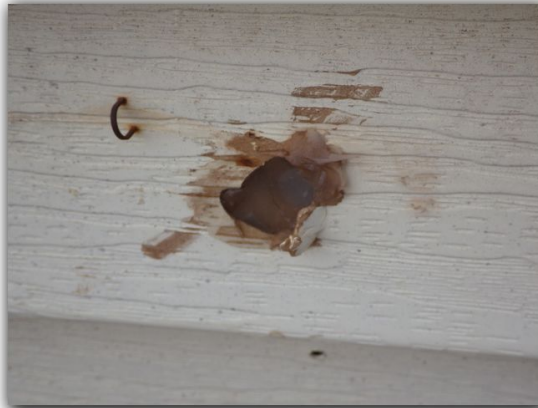
- The vinyl siding was observed to be damaged on the north, east, west and south sides of the structure. These areas have been sealed with caulking where needed.

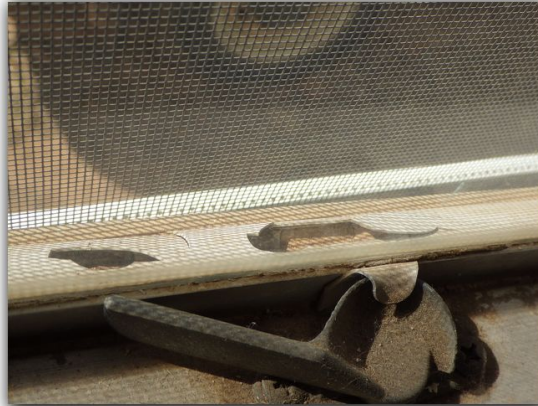
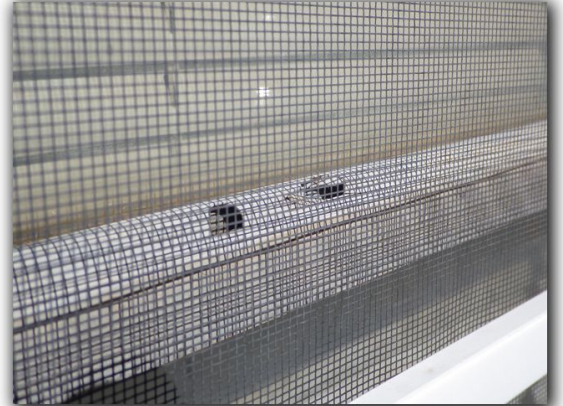
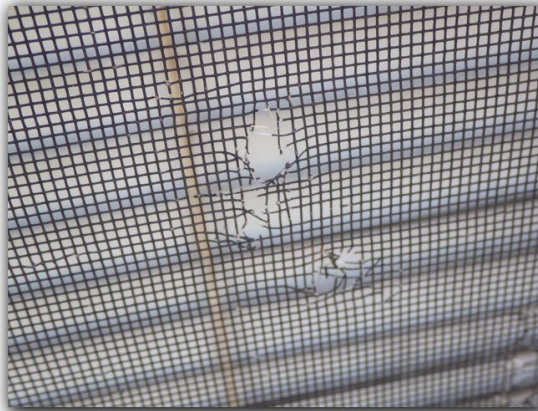
- One or more of the window screens were observed to be damaged.

- The window glass plastic sealing strip damaged and/or missing at one or more of the windows and improvements are recommended.

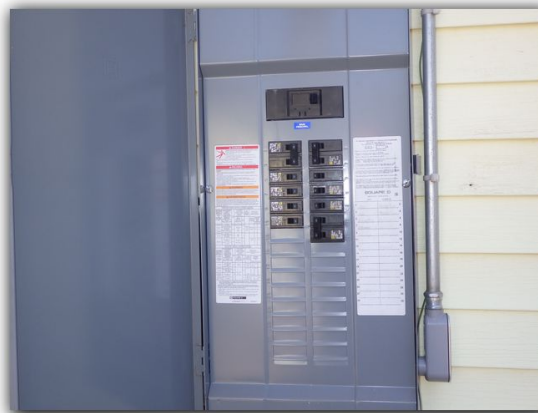
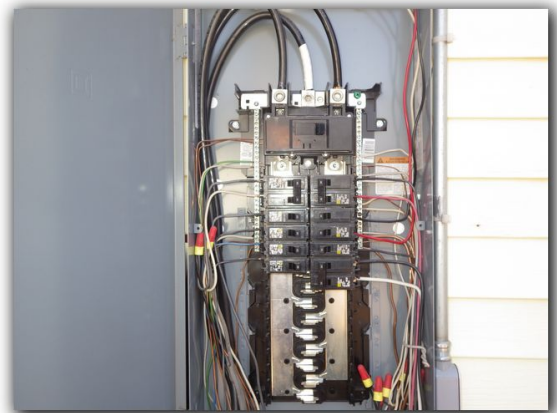
- Wires exposed to the outside elements (i.e. outside weather conditions) should be protected by conduit. There are exposed wires located on the north side of the structure.
- All exposed romex type wiring in the laundry and garage area should be properly enclosed in conduit.

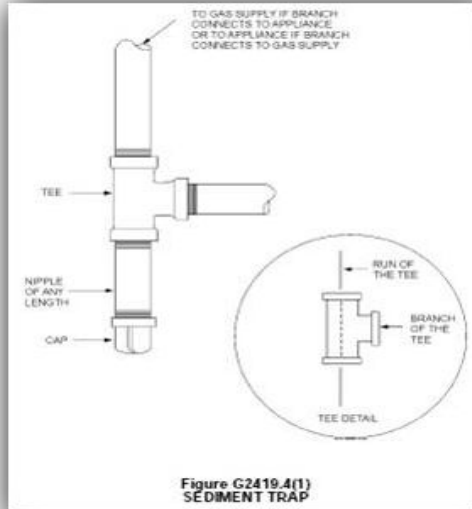
Figure G2419.4(1)  
SEDIMENT TRAP

Samples of correct sediment trap installation.

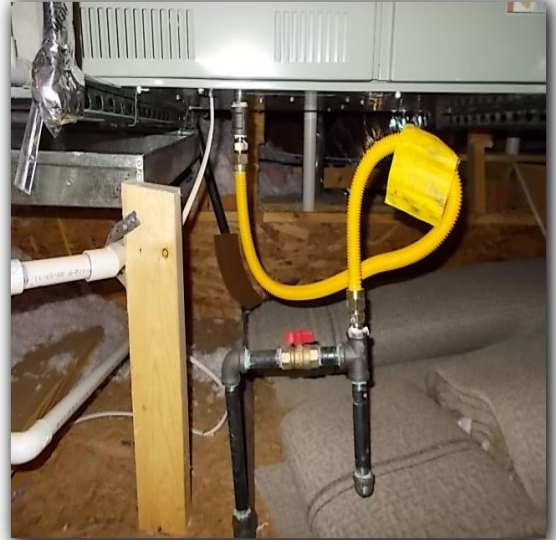
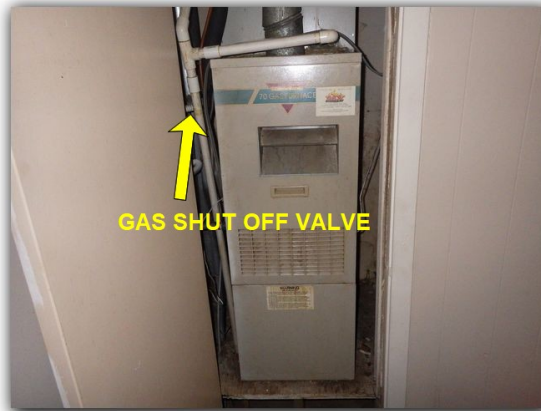
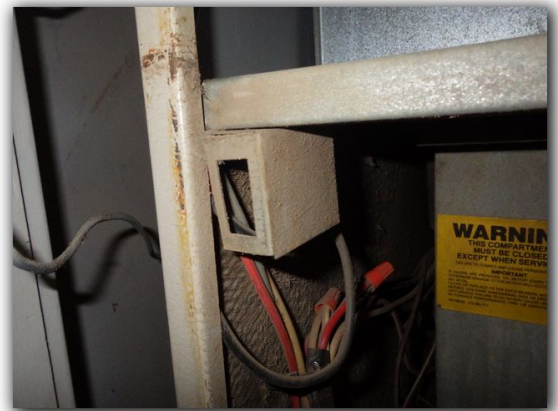
- The gas shutoff valve is in a poor location and is hard to reach.
- The blower door blower switch is removed.
- The heater gas supply line is not equipped with a sediment trap just before the gas appliance connector. This condition does not meet current installation requirements and should be corrected.
- The dirty air filter should be replaced.

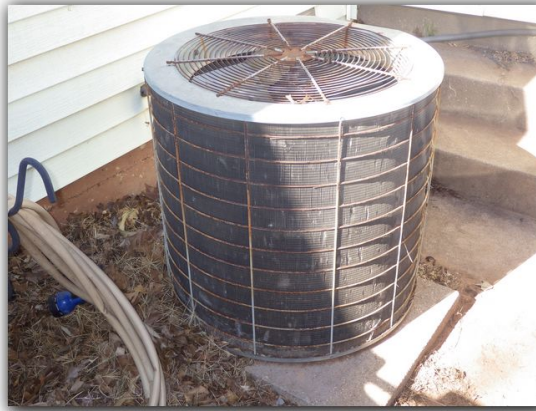
- The fins of the outdoor portion of the air conditioning system were observed to be damaged. This condition can reduce the efficiency of the system.

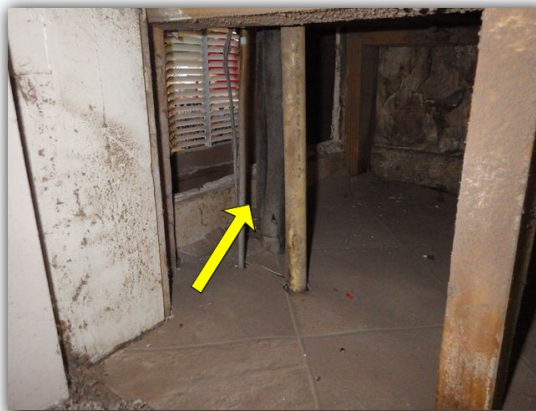
- There was a gas line observed in the air return chase. Under current building standards, this is no longer an accepted practice.

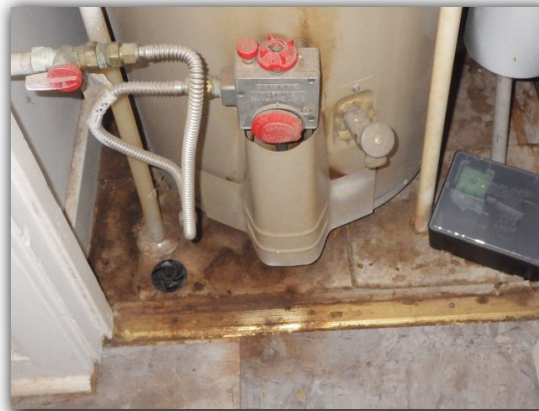
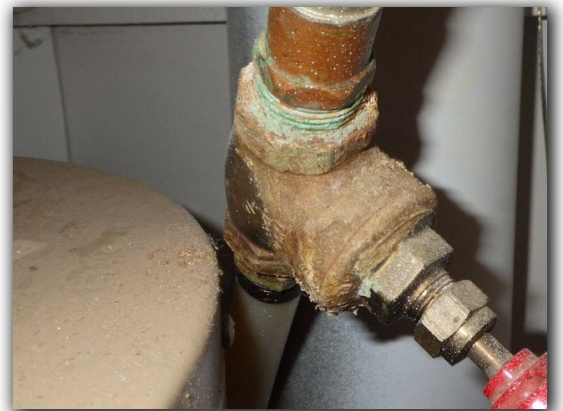
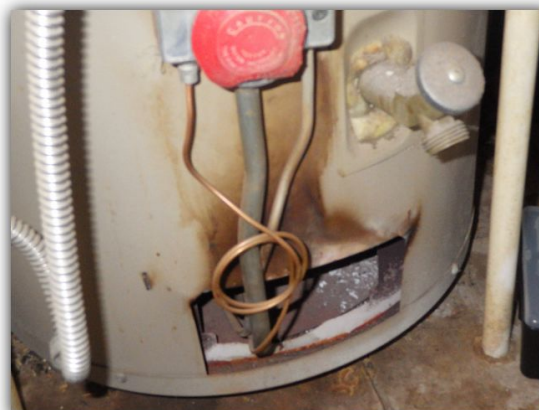
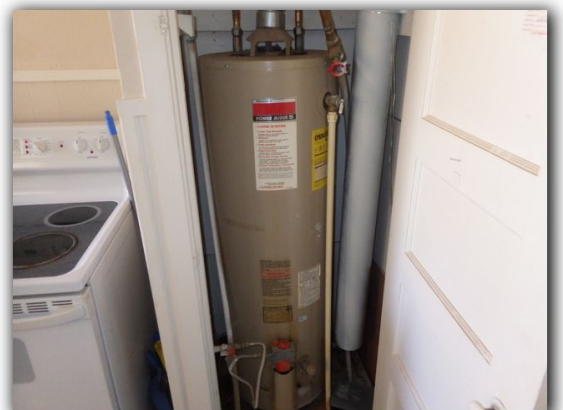
- There is no pan installed under the water heater. It is suggested that the correct sized pan and associated drain pipe system be installed per current installation requirements; at least the next time the water heater is replaced.

- **Note:** I was unable to locate the exterior termination point for the temperature and pressure relief (TPR) valve discharge pipe.
- The water heater burner is dirty. The burner should be cleaned and adjusted.

- There is visible evidence of flame rollout at and around the burner chamber (ignited gas spilling out at the front of the burner chamber at start up). The cause and remedy should be further evaluated and corrected as necessary.

- Some corrosion was observed on the water supply shutoff valve.
- Some corrosion was observed at the water supply connections at the top of the water heater.

- The water heater gas supply line is not equipped with a sediment trap just before the gas appliance connector. This condition does not meet current installation requirements and should be corrected.
