February 6, 2018

PROPERTY INSPECTION REPORT

Concerning: 209 Stardust Trail, Tuscola, TX 79562
(Address or Other Identification of Inspected Property)

By: David Renner, Lic #20502 / NAWT #12181ITC 02/06/2018
(Name and License Number of Inspector) (Date)

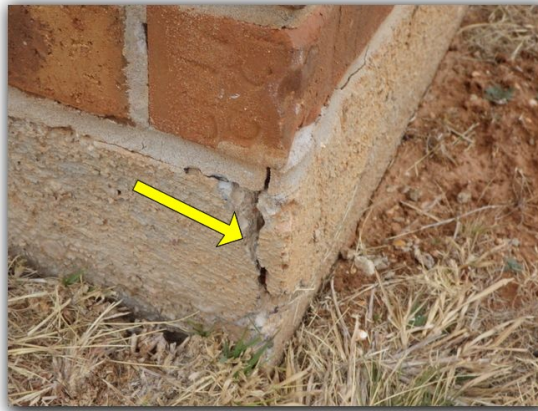
- One or more of the foundation perimeter beam corners were observed to be sheared off (corner pop). This is a common condition in slab on grade foundations. This condition does not adversely affect the performance of the foundation. However, in some cases, some cosmetic improvements may be necessary.

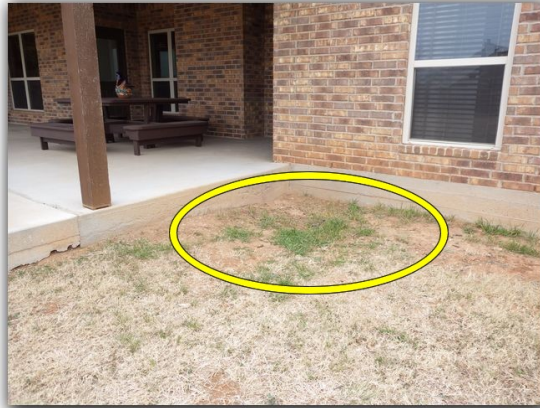
- Fill dirt is needed on the east side of the structure. The low spots in the finished grade (ground) adjacent to the foundation perimeter wall need to be filled in to help prevent water from standing and/or ponding next to the foundation area.

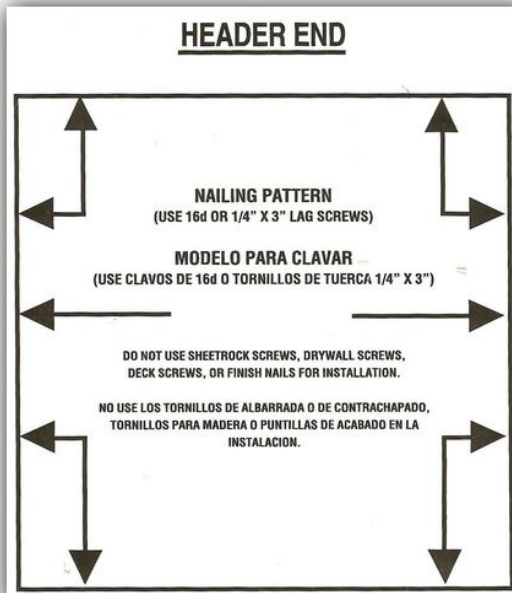
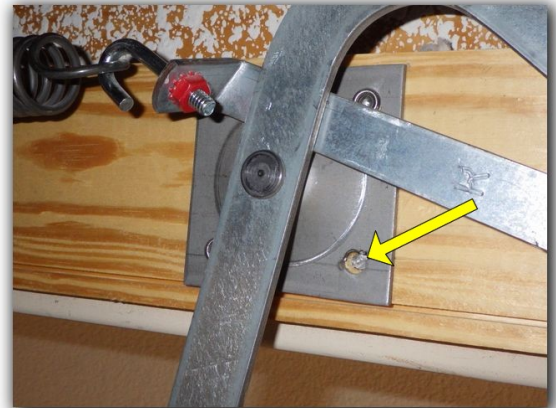
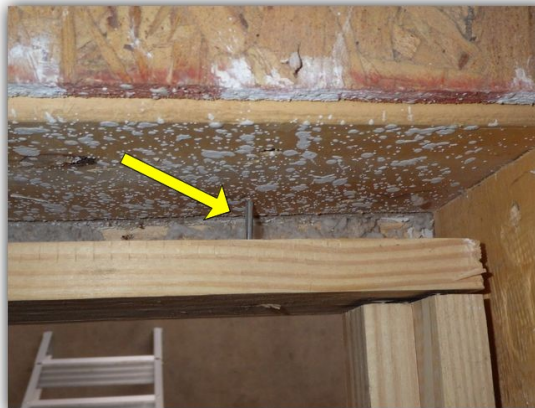
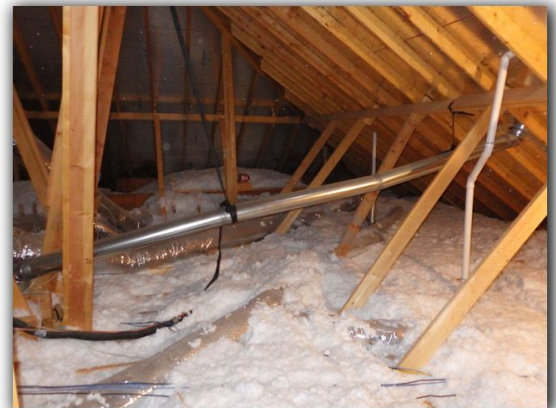
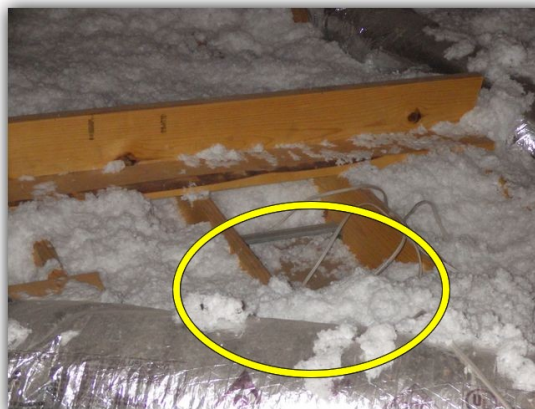
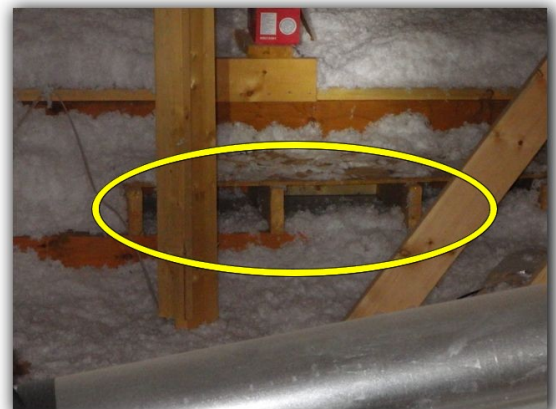
- The attic floor insulation needs to be redistributed in one or more locations.

- The attic ladder was observed to be installed with improper fasteners. The attic ladder should be secured in place with 16d nails or 3-inch lag bolts. This condition should be further evaluated and corrected as necessary.
- Additional blocking is recommended between the attic ladder assembly and the framing members.

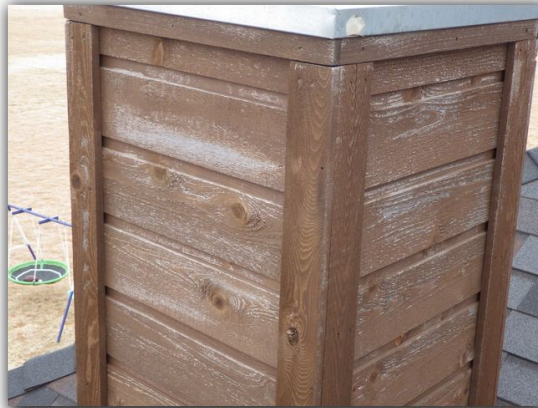
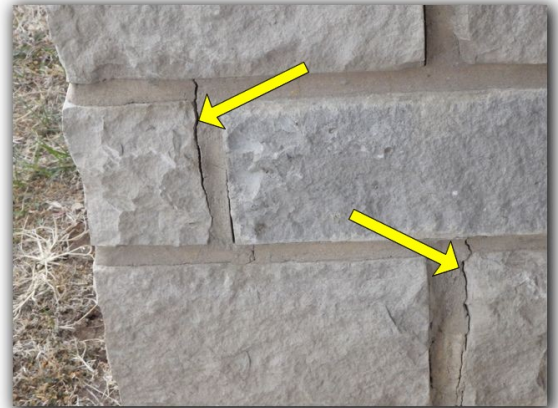
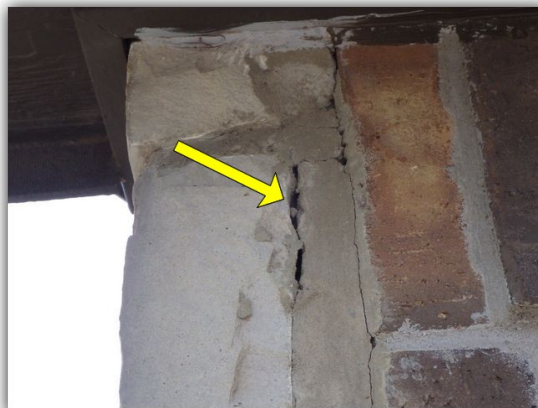
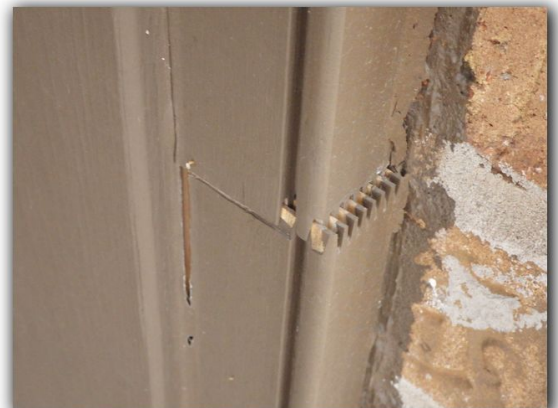
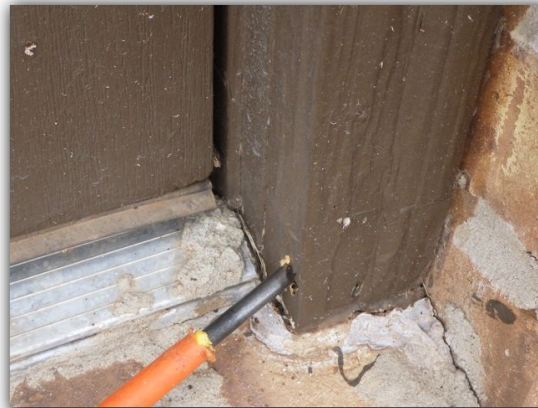
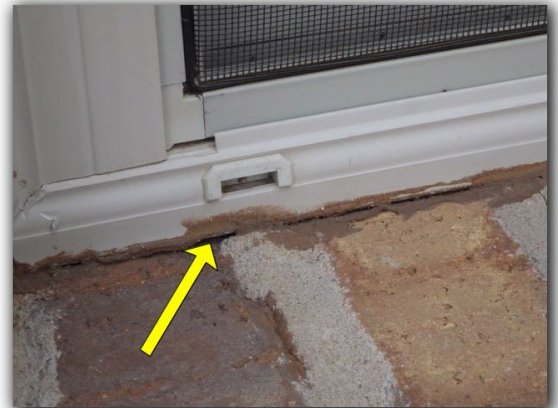
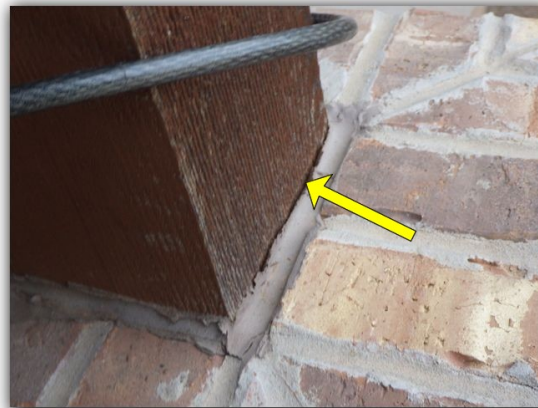
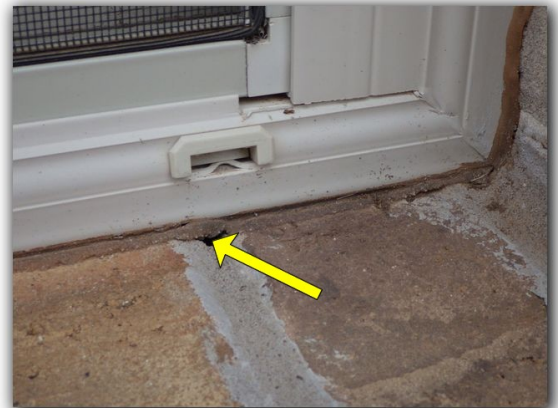
- It is recommended the chimney chase wood veneer and/or veneer trim get a fresh coat of paint/stain.
- Mortar improvements are recommended for the exterior masonry veneer on the south and west sides of the structure.
- Minor caulking improvements are recommended for the area between the exterior veneer and the window frames.
- The wood trim finger joints are pulling loose at a few locations around the garage. Recommend re-securing as needed.
- The south (laundry) exterior door, has some minor damage at the bottom. Recommend caulking and paint improvements.

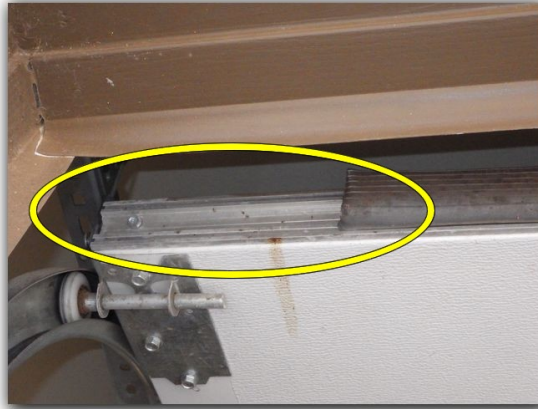
- The lower door trim is damaged.

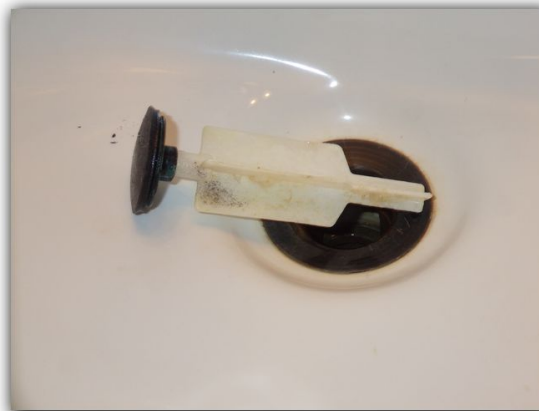
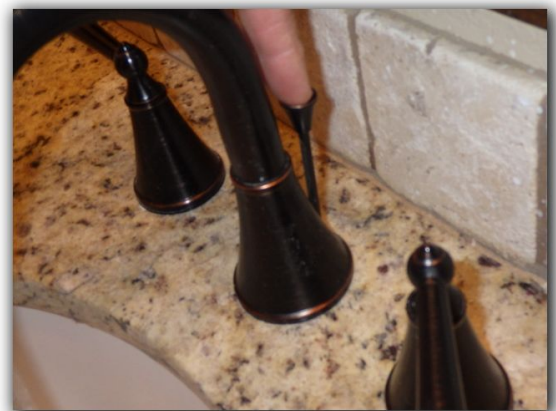
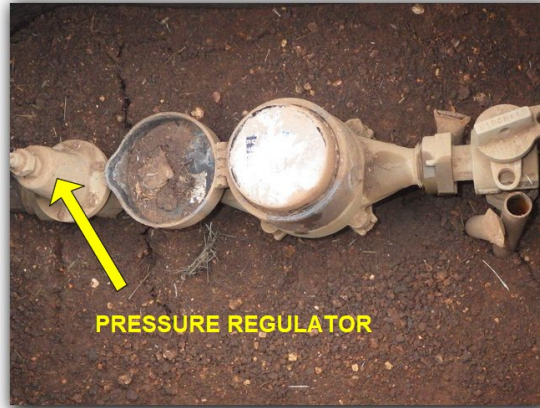
- There is no expansion device installed on the water supply system. Under current plumbing standards an expansion device is required when there is a pressure regulator in place. This condition is a common building practice in the local area.

- The stopper does not appear to be functioning properly.

- The stopper is damaged.

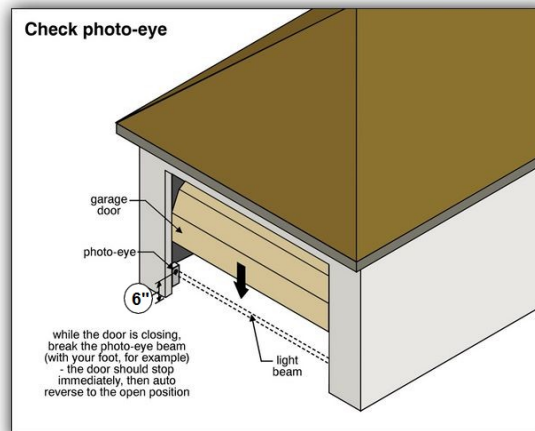
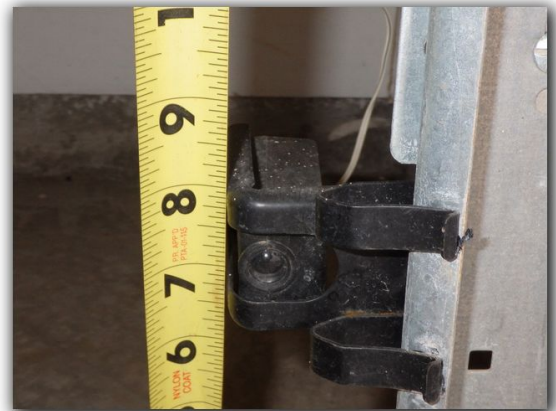
- When an automatic garage door opener is in use, the manual lock should be disabled or removed.

- When an automatic garage door opener is in use, the manual lock should be disabled or removed.
- The garage door reverse sensors are not properly installed. The garage door reverse sensors should be installed within 6-inches of the garage floor.

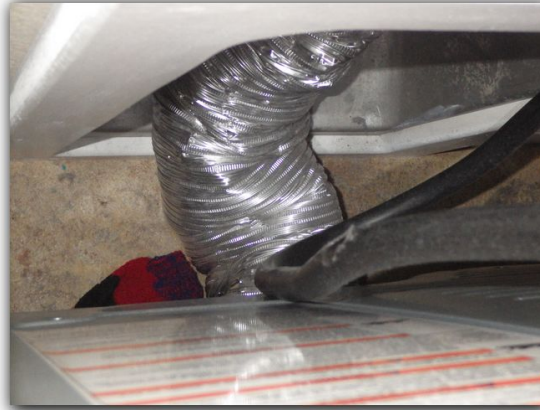
- The dryer flexible vent pipe between the dryer and wall was observed to be damaged/collapsed. This condition may limit the amount of airflow. Recommend replacement.
