March 21, 2018

PROPERTY INSPECTION REPORT

Prepared For: Homeowner
(Name of Client)

Concerning: 2701 Button Willow Pkwy, Abilene, TX 79606
(Address or Other Identification of Inspected Property)

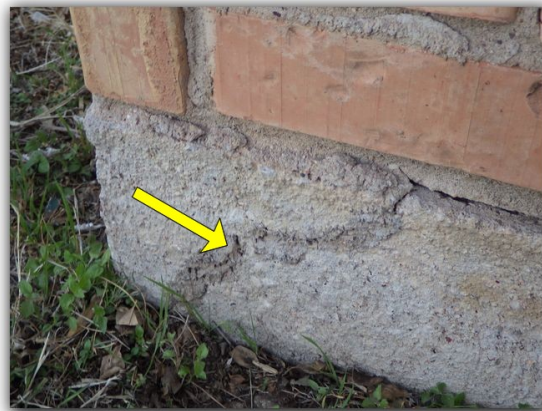
- One or more of the foundation perimeter beam corners were observed to be sheared off (corner pop). This is a common condition in slab on grade foundations. This condition does not adversely affect the performance of the foundation. However, in some cases, some cosmetic improvements may be necessary.

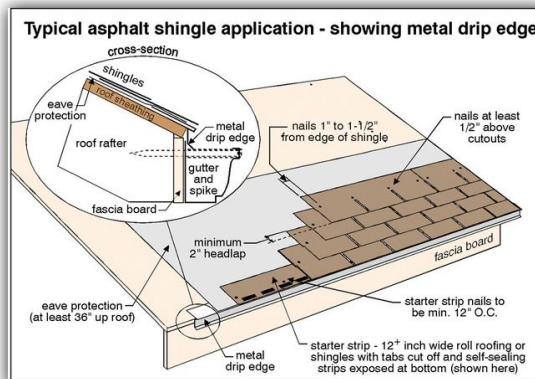
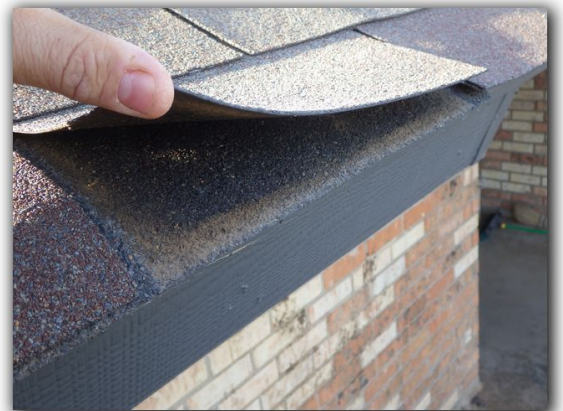
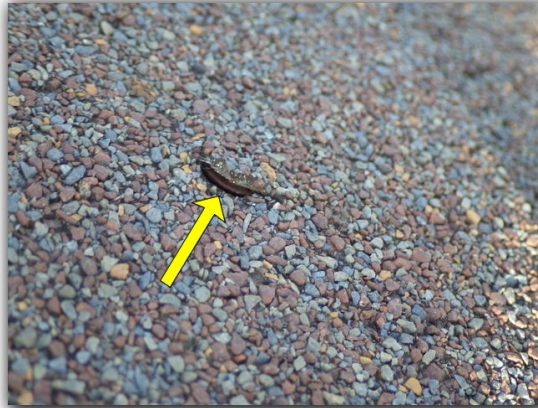
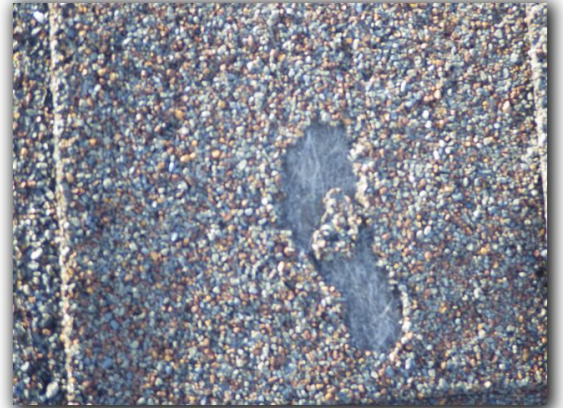
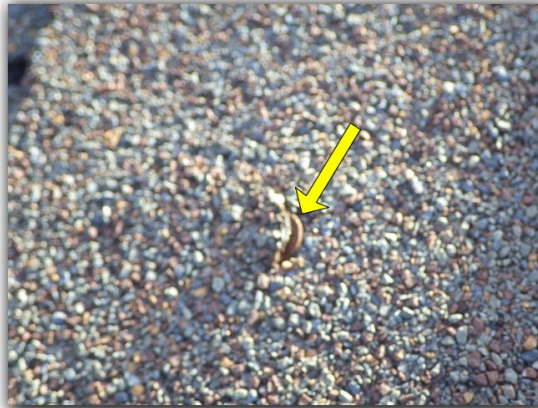
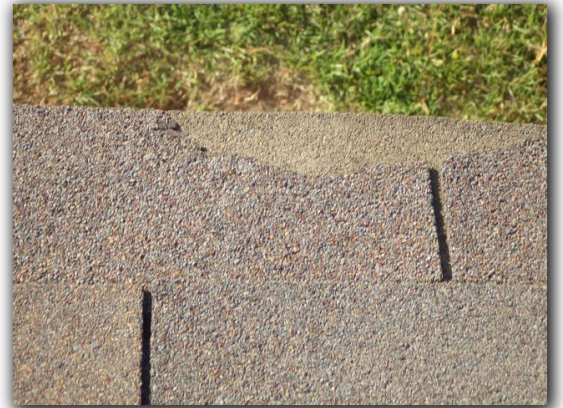
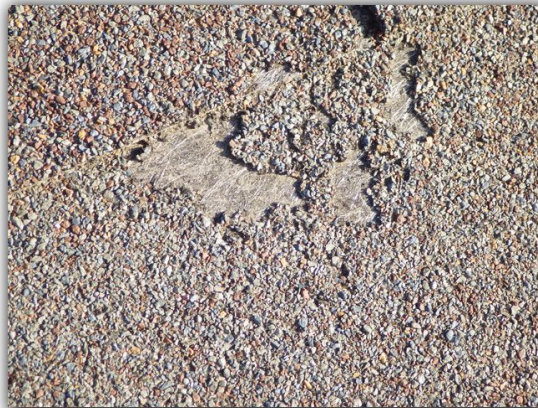
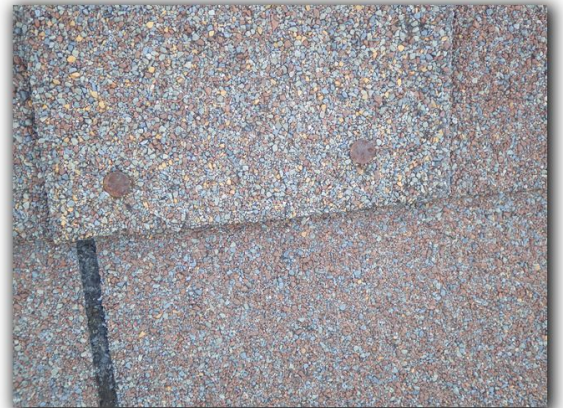
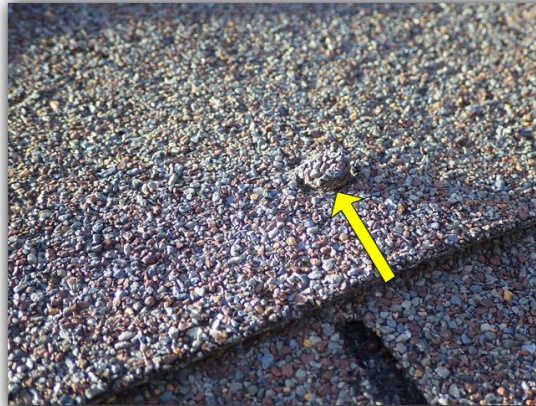
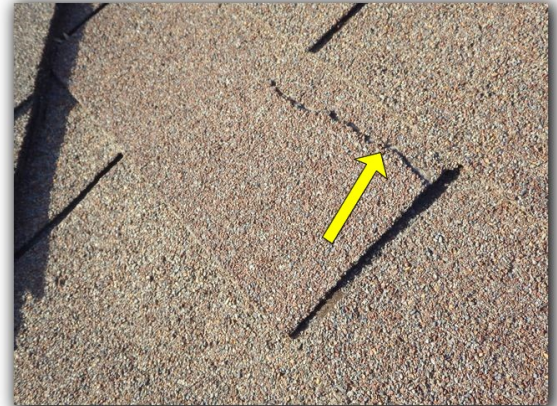
- Damaged shingles were observed on the north and south sides of the roof structure.
- The starter strip of the roofing material was not properly installed per the manufacture installation requirements. The starter course shingle should consist of a strip shingle with the tabs cut off with the self-sealing strip at the lower bottom edge. This will help prevent wind damage or lifting of the shingles in high winds.
- High shingle fasteners (staples and/or nails) were observed in various locations.
- **Note:** Roof fasteners (nails and/or staples) were observed to be exposed and should be properly sealed at the ridge caps and flashing areas.

Repairs were made to the roof covering.

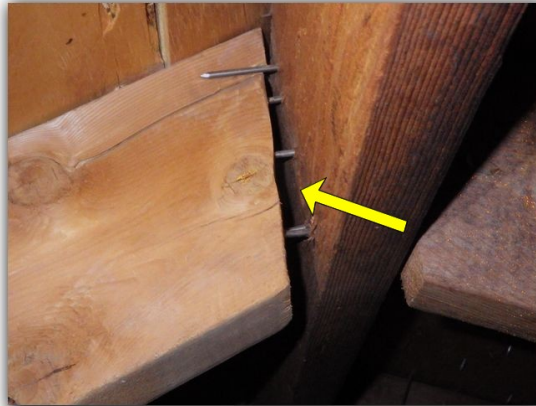
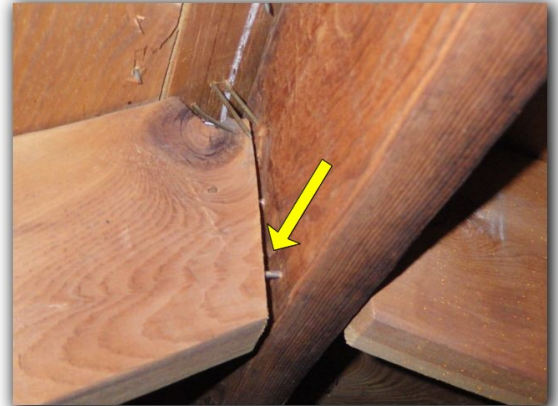
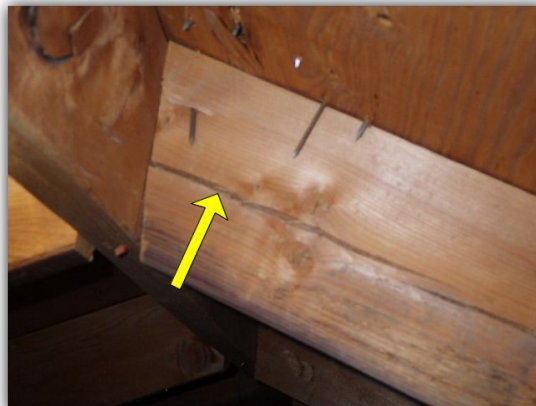
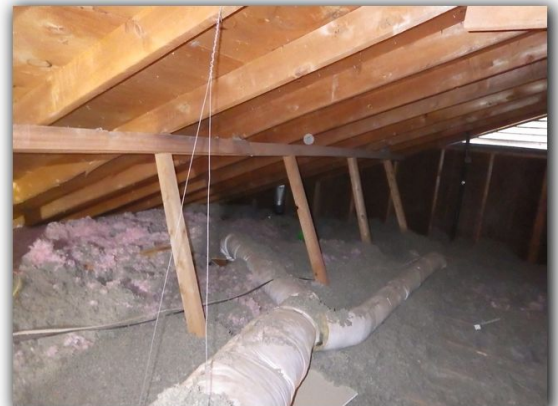
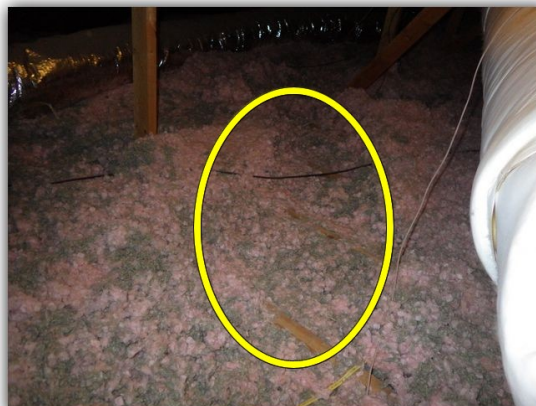
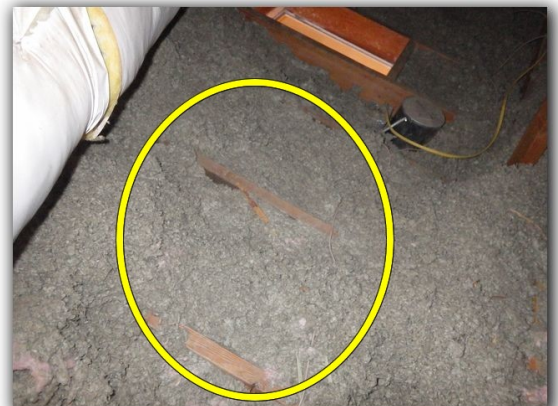
- Split rafter(s) were observed in the attic over garage conversion area(s).
- One or more of the roof structure rafters were observed to be pulling away from the top ridge board. Recommend monitoring and repairs made if needed.
- **Note:** The roof structure purlins are not properly sized to the rafters they support and the purlins are not properly supported. This item met building standards at the time the home was built. The building standards have changed and Per TREC standards of practice we are required to note this item as a deficiency.
- The roof structure purlins are not properly supported in one or more locations. Under current building standards, the purlins should be supported by 2 x 4 braces installed to load-bearing walls at a slope not less than 45 degrees. The bracing should be spaced not more the 4 feet on center and the unbraced length of brace should not exceed 8 feet.

- **Note:** The attic floor insulation needs to be redistributed in one or more locations.

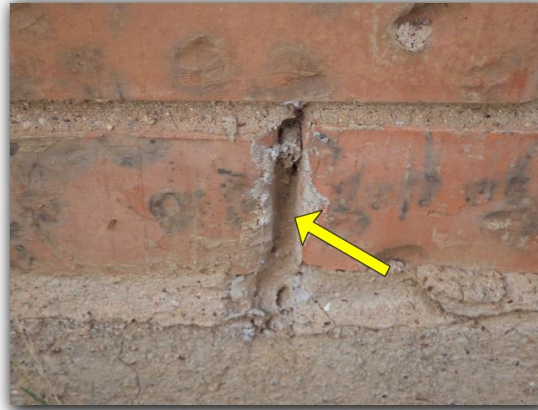
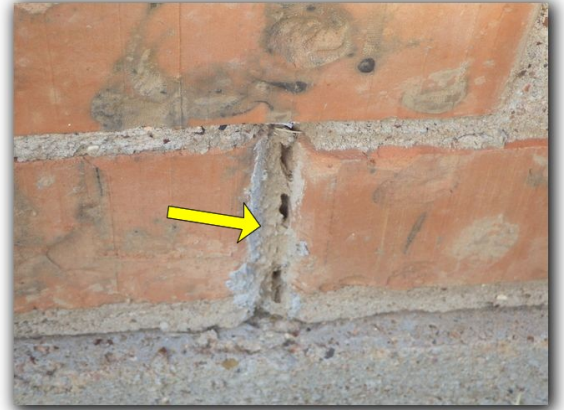
- **Note:** Previous repairs to the exterior masonry mortar / grout was observed on the east side of the structure.
- The weep holes in the lower course of the exterior masonry veneer were observed to be blocked and/or sealed. The weepholes should be reopened to help vent the wall voids and release any absorbed rain water from behind the exterior masonry veneer walls. **Repaired**

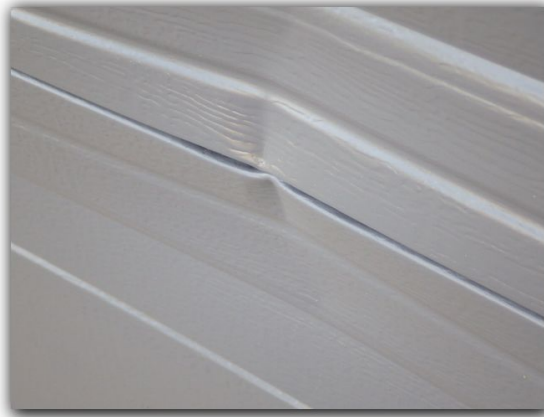
- Some minor damage to the east overhead garage door was observed. Note: This door is no longer in use.

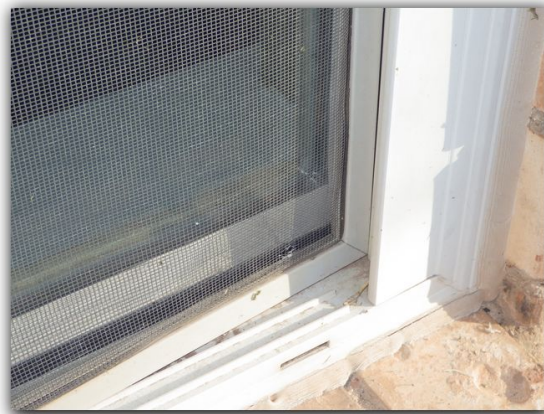
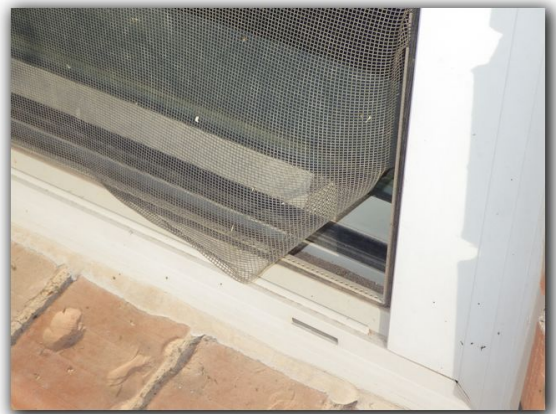
- One or more of the window screens were observed to be damaged. **Repaired.**

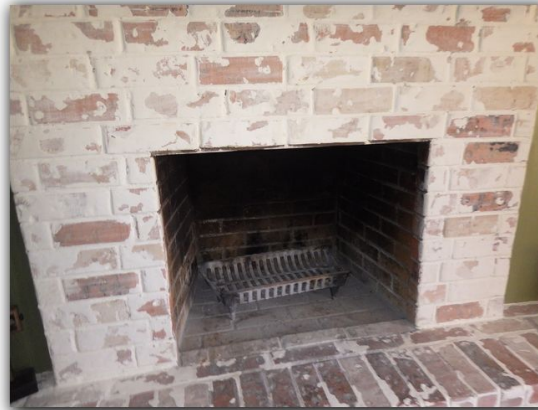
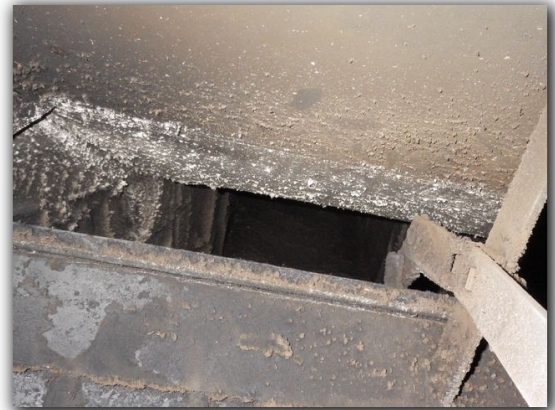
- The chimney flue needs to be cleaned by a Qualified Chimney Sweep. A creosote / soot build-up was observed in the visible flue area.

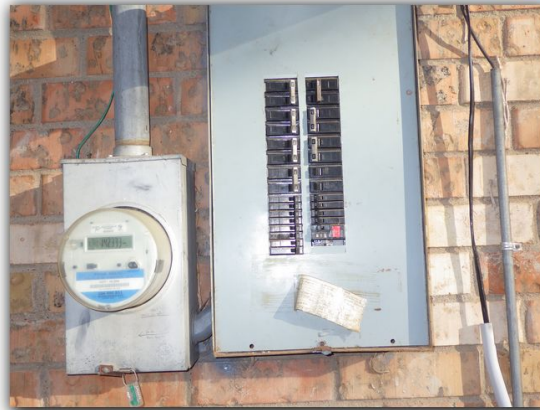
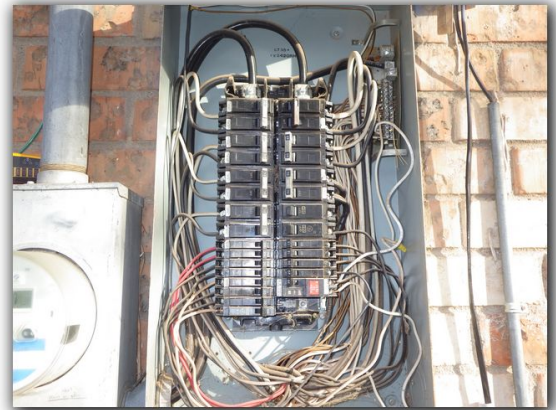
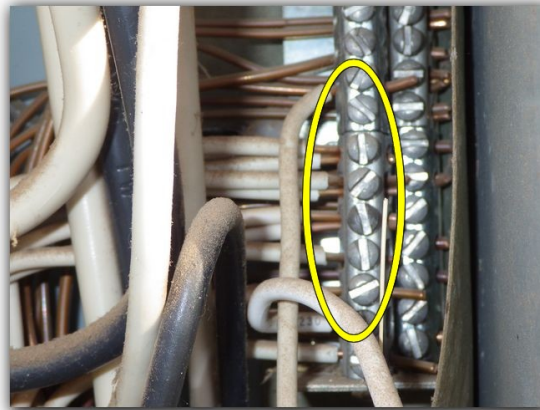
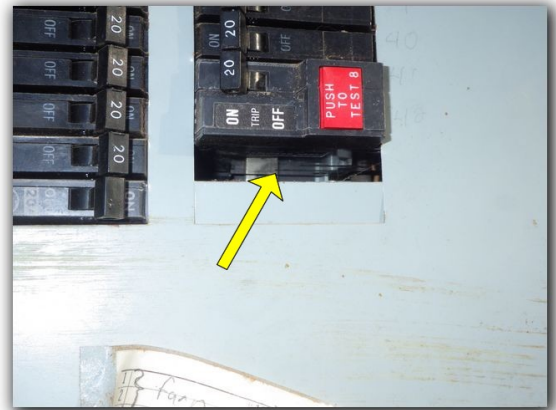
- The breakers (overcurrent devices) in the electrical panel are not properly labeled.
- One or more of the neutral wires are incorrectly connected under a single screw on the grounding/neutral bus bar. Under current installation standards, the ground and neutral wires should be under separate screws with no more than one neutral wire per screw.
- All blank spaces in the electrical cabinet cover plate (dead front) and /or cabinet need to have fillers.
- There was no main disconnect observed in the panel box. This may be an “as-built” condition but Per TREC standards of practice we are required to report this condition as a deficiency.

- The ground electrode conductor could not be located (this is the method of grounding the electrical system to the earth). This item may have met building standards at the time the home was built. Building standards have changed and per the TREC standards of practice we are required to report this item as a deficiency.

The electrical system should be checked by a Qualified Licensed Electrician. The observations made to support the rendering of this opinion are listed but not limited to the following:

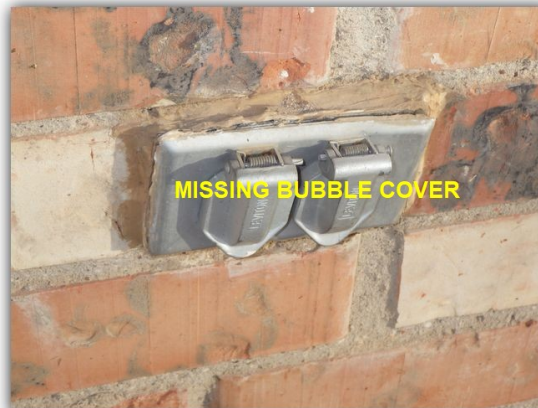
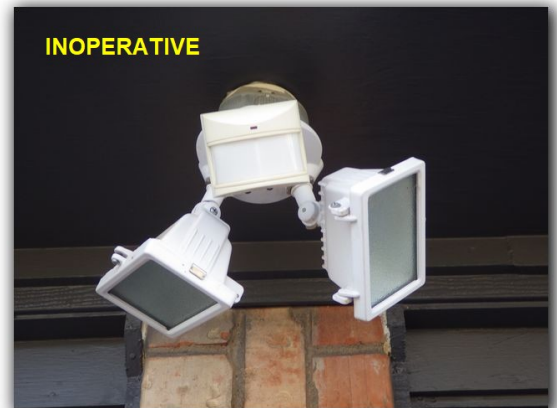
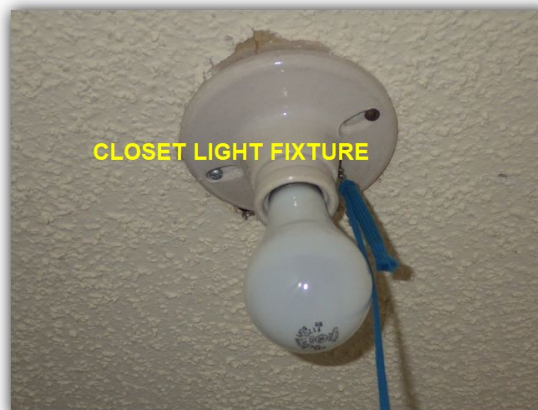
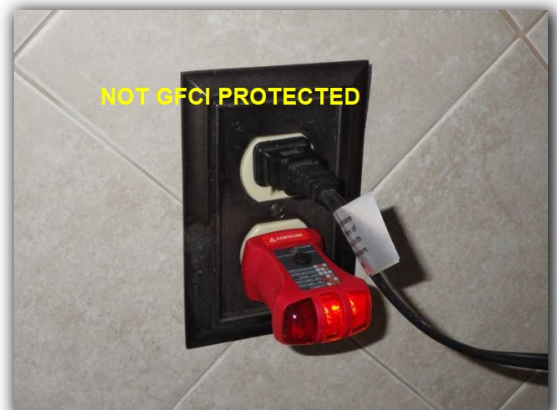
- **Note:** Some of the receptacles in the home were inaccessible and could not be reached for inspection due to personal effects, heavy storage, furniture or conditions outside the control of the inspector.
- The kitchen counter top receptacles do not appear to be connected to a ground fault circuit interrupter (GFCI) device. Under current electrical standards, all of the kitchen counter top receptacles should have GFCI protection.
- All exterior receptacles should have weather tight (bubble) covers. The receptacle weather cover plate is damaged and/or missing on the south exterior wall. **Repaired.**
- One or more of the receptacles were observed to be loose at the wall mount in the kitchen. **Repaired.**

- One or more of the light fixtures appear to be inoperative in the north exterior wall. This may be due to a bad bulb or some other unknown condition. This condition should be further evaluated and corrected as necessary. **Repaired/Replaced.**
- **Note:** One or more of the closet light fixtures appear to be installed without globes and/or covers. Safety precautions should be taken around these light fixtures. **Repaired.**

- There are not enough smoke alarms located in the home. Under current building standards, there should be a smoke alarm located in each sleeping room, outside each separate sleeping area in the immediate vicinity of the sleeping rooms, and on each additional story of the dwelling. **Repaired.**
- **Note:** It is recommended to test for proper operation monthly and replace the batteries in all of the smoke detectors once a year for reasons of safety.

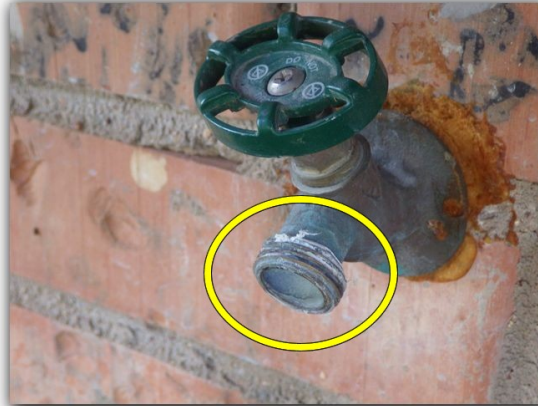
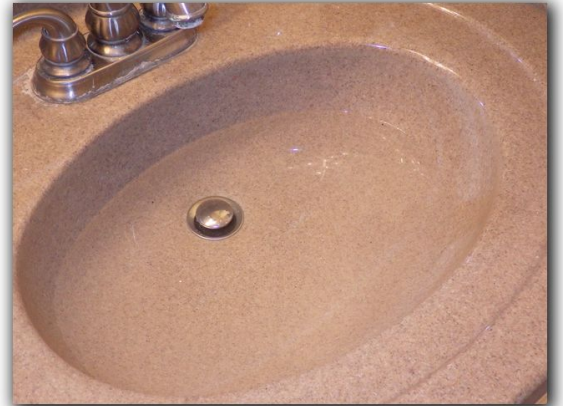
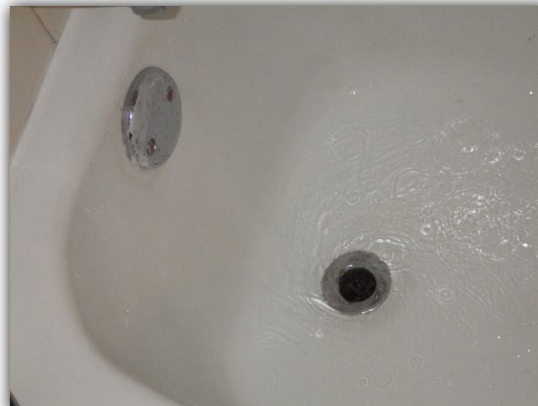
- One or more of the exterior water hose bibbs (faucet) do not have a back-flow or anti-siphon device (Vacuum Breakers) in place. **Note:** *This is not uncommon to observe with a home of this age and can easily be obtained at home improvement stores if desired.*

- The sink was observed to drain slowly, suggesting that an obstruction may exist. **Repaired.**

- The stopper is missing. **Repaired.**

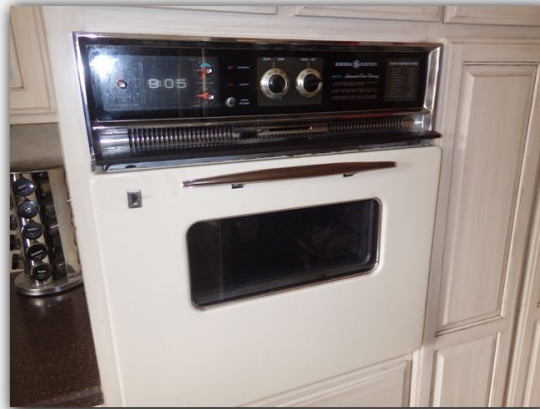
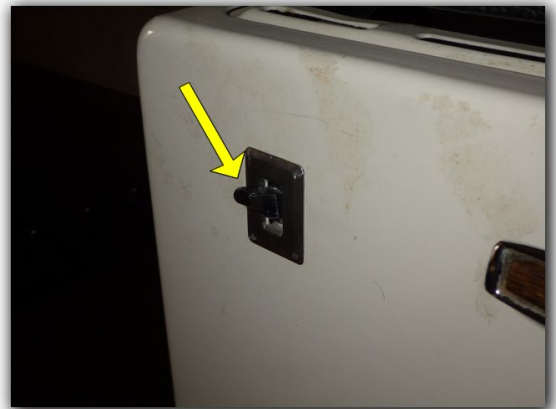
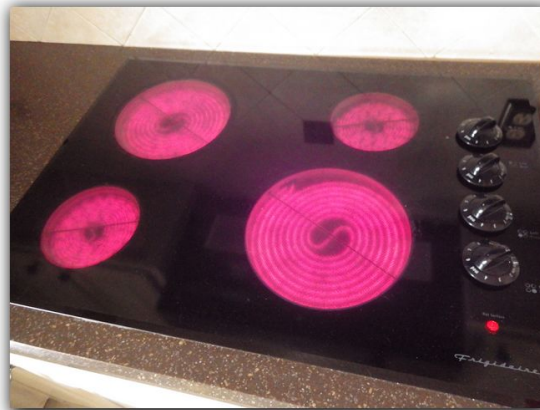
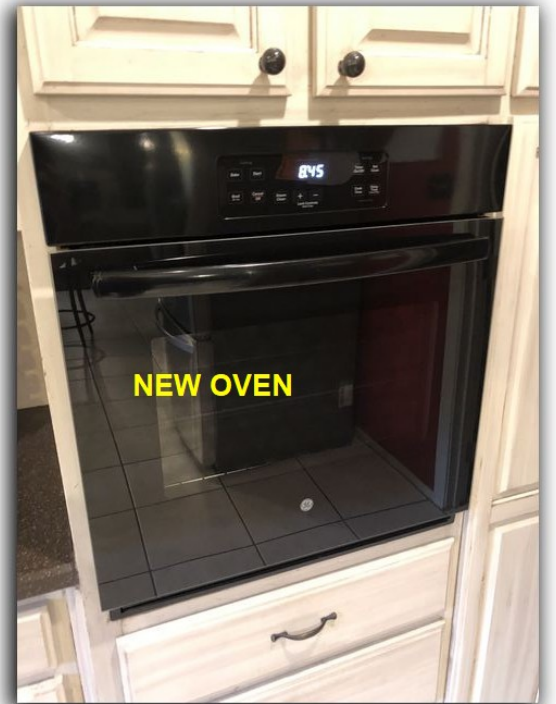
- The oven light/switch is inoperative.

The oven was replaced.
