April 9, 2018

PROPERTY INSPECTION REPORT

Concerning: 781 Ballinger St, Abilene, TX 79605
(Address or Other Identification of Inspected Property)

By: David Renner, Lic #20502 / NAWT #12181ITC 04/09/2018
(Name and License Number of Inspector) (Date)

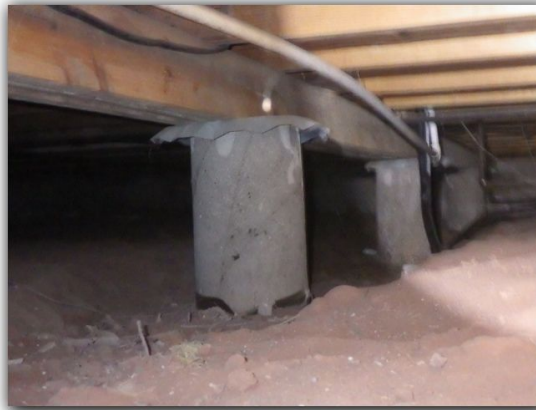
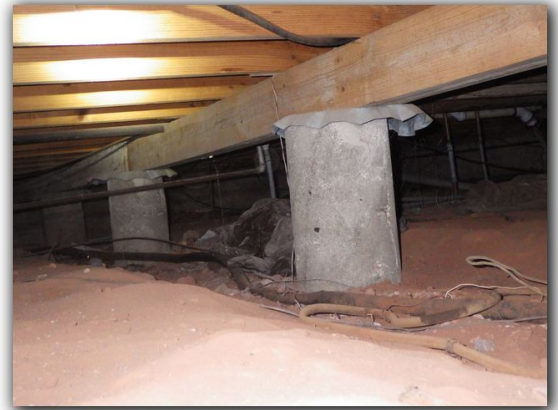
In my opinion, the foundation appears to be providing adequate support for the structure at the time of this inspection. I did not observe any apparent evidence that would indicate the presence of adverse performance or significant deficiencies in the foundation. The interior and exterior stress indicators showed little affects of adverse performance and I perceived the foundation to contain no significant unlevelness after walking the 1st level floors.

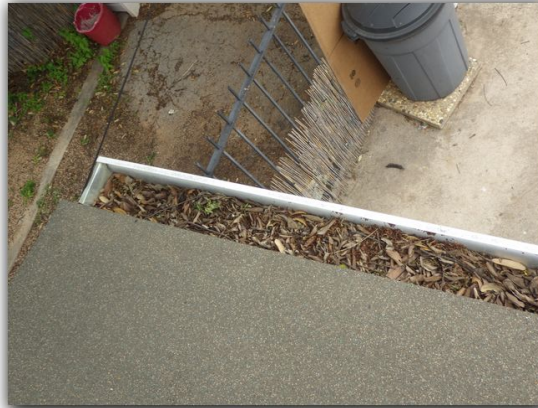
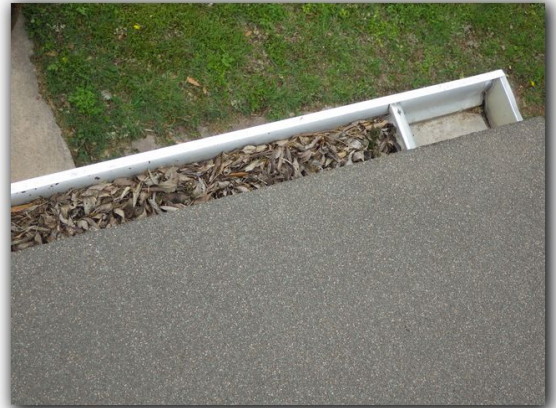
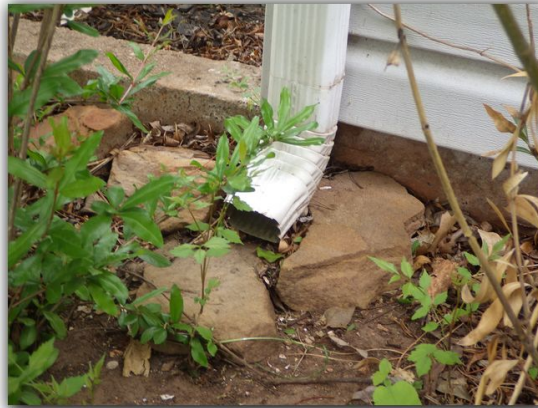
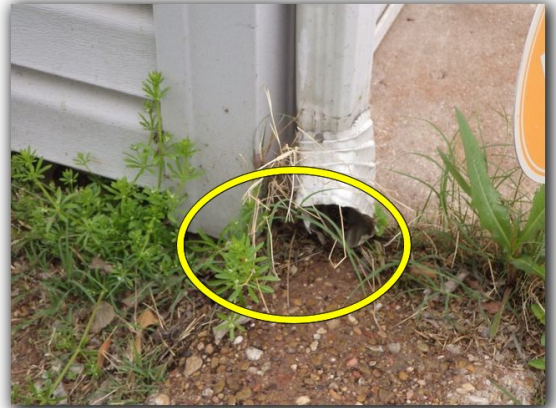
- **Note:** The gutter downspouts should discharge water at least thirty-six inches (36") away from the foundation perimeter beam. Storm water should be encouraged to flow away from the structure at the points of discharge.
- The gutters require cleaning.

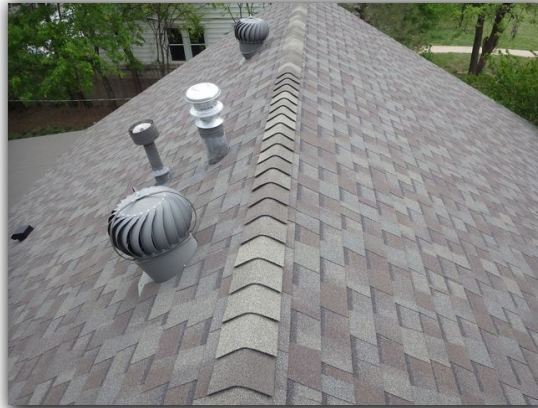
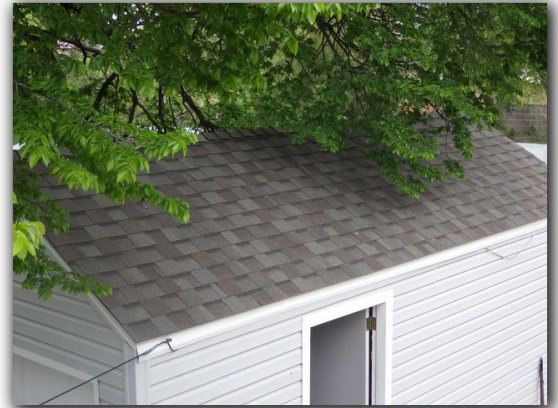
- **Note:** The tree and shrub branches should be trimmed away from the roofing material at all times.

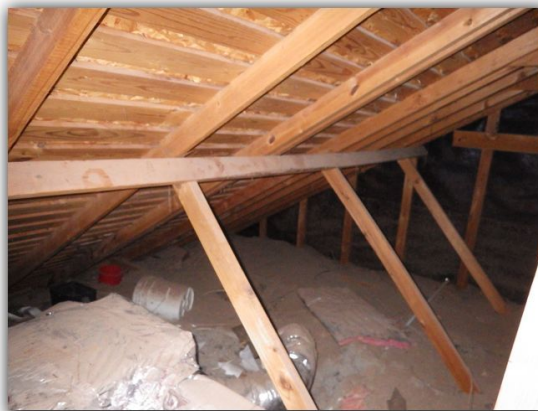
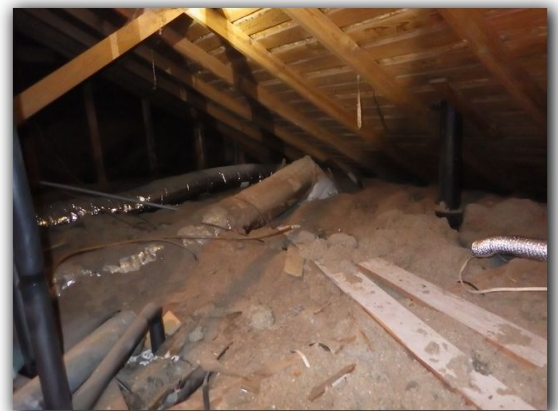
- **Note:** It is recommended to remove the extra storage items/debris from the interior of the attic space.

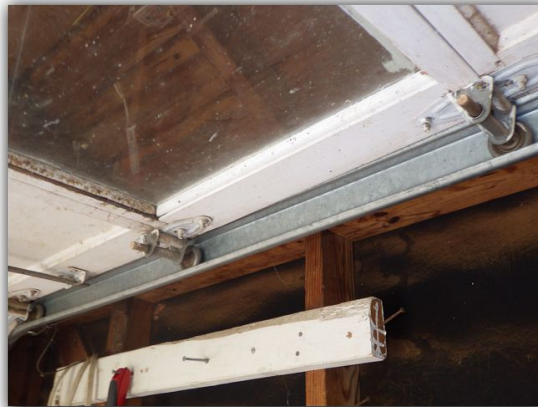
- The garage door track rollers are dragging and/or in need of lubrication.

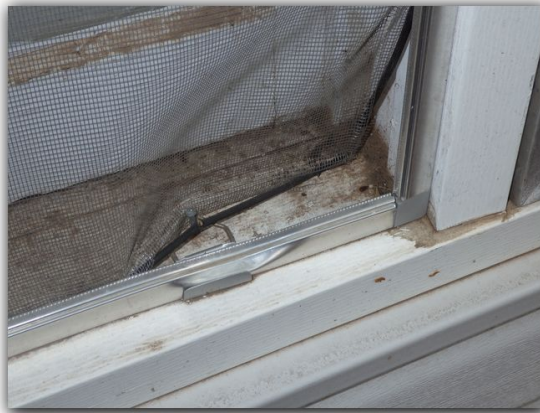
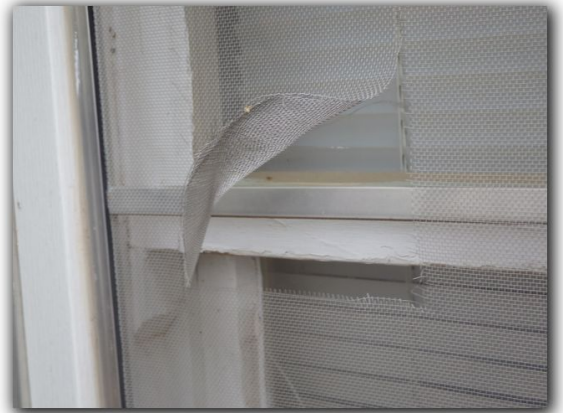
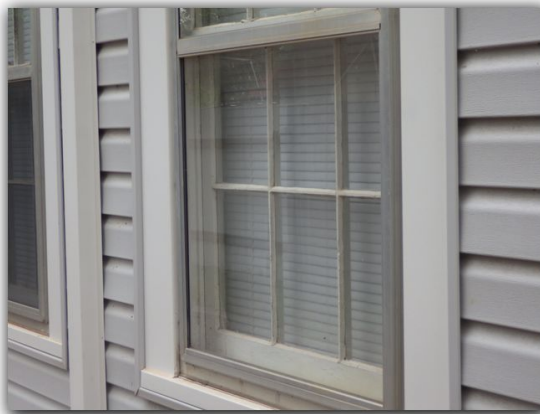
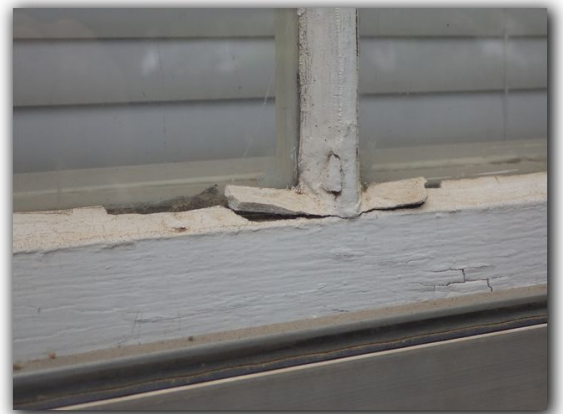
- One or more of the window screens were observed to be damaged.
- One or more of the window screens were observed to be missing.

- **Note:** I was unable to inspect the operation of some of the windows due to window treatments, personal effects, large, heavy or fragile storage and/or furniture.
- Cracked and/or broken window glass was observed in the laundry room, front corner bedroom.
- The window glass glazing-compound is damaged and/or missing at one or more of the windows and improvements are recommended.
- Window lock(s) were observed to be damaged and/or missing in various locations throughout the house.

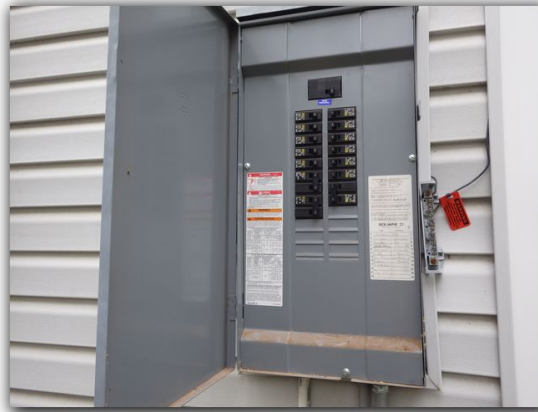
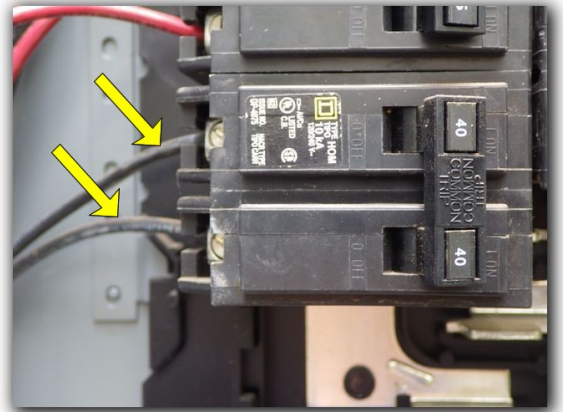
- There is a 40-amp breaker wired with a 30-amp wire. The breaker in place is not listed or labeled for this type of installation. This condition should be further evaluated and corrected as necessary.

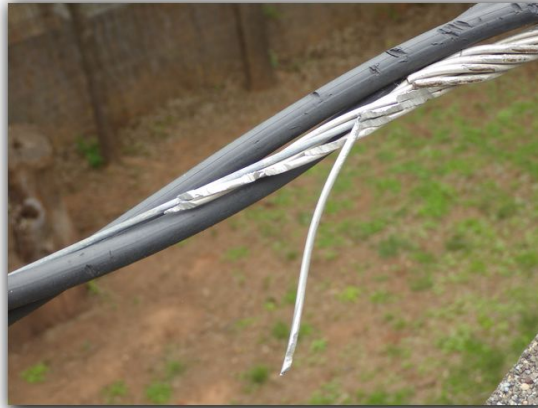
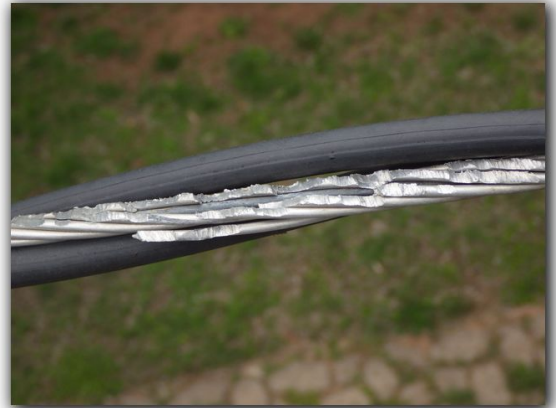
- Damaged wire(s) was observed at the electrical service entrance.

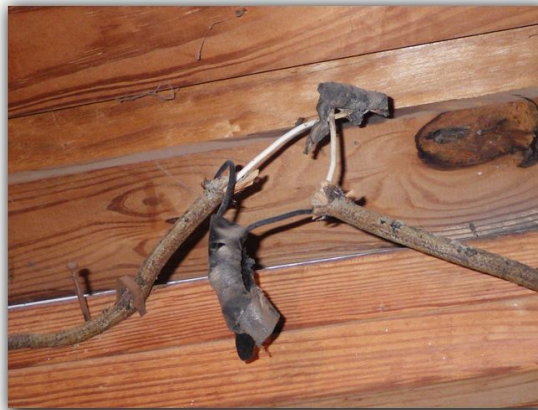
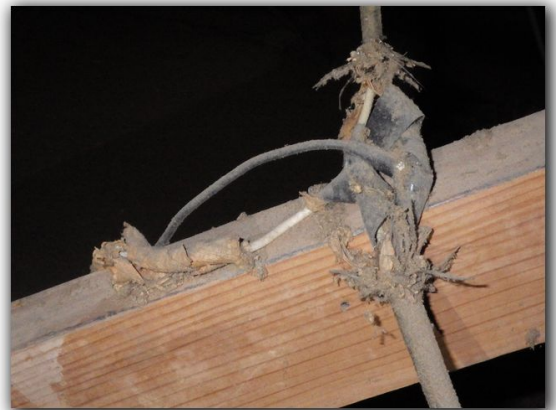
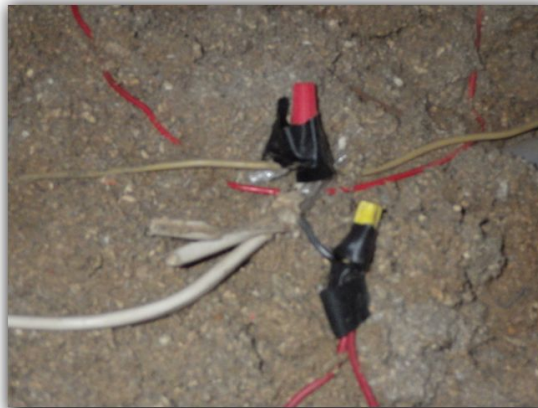
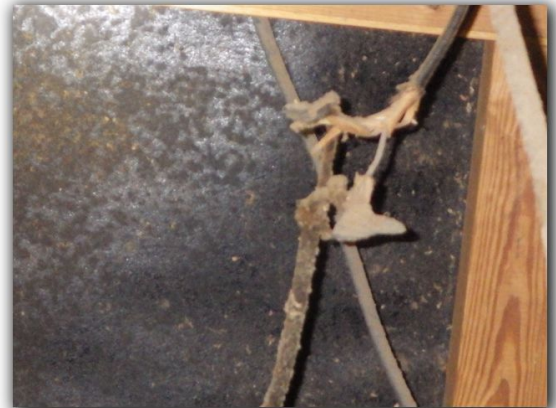
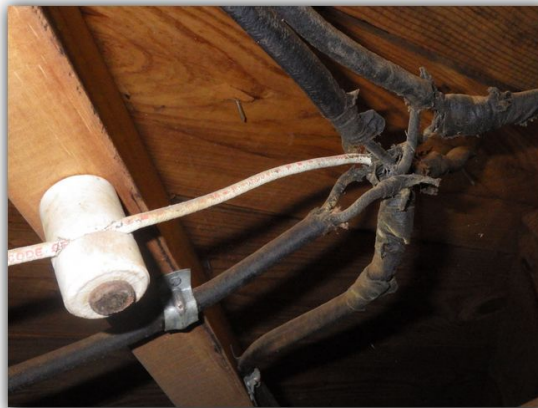
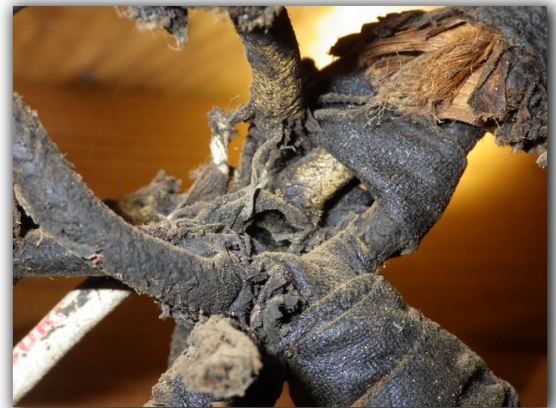
- Open electrical junction box(es) were observed in the attic area. All open junction box(es) in the attic should be properly enclosed. Open junction box(es) were located over several locations throughout the house.
- Spliced electrical wires were observed in the attic area and garage areas. Spliced wires in the attic should be properly enclosed in junction box(es) and secured to the ceiling joist. Spliced wires were located over various locations throughout the house.
- Spliced electrical wires were observed in the crawl space area. Spliced wires in the crawl space should be properly enclosed in junction box(es) and secured to the floor joist or girder. Spliced wires were located under the bedroom hallway.
- All exposed romex type wiring in the garage area should be properly enclosed in conduit.

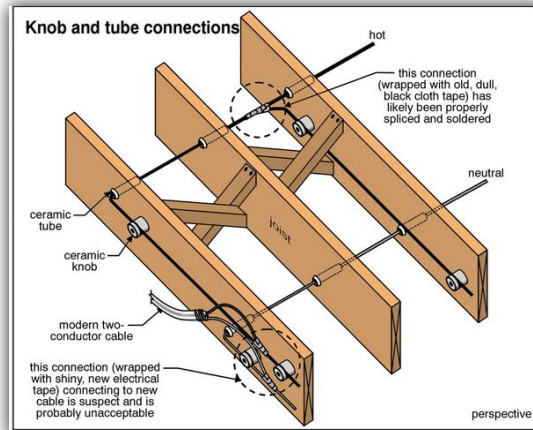
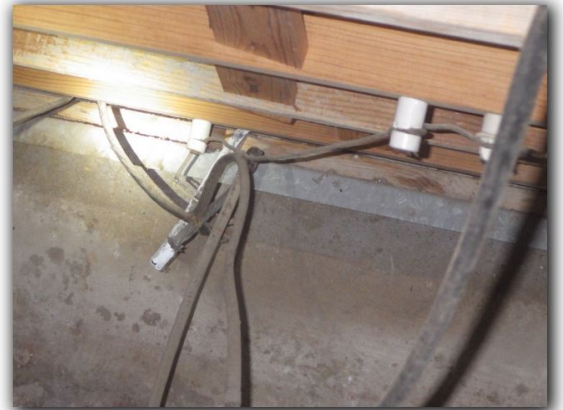
- There is knob and tube wiring in use at the time of this inspection. This is an older obsolete type wiring. This condition should be further evaluated and corrected for reasons of safety. There is insulation covering some of the knob and tube wiring. This condition is a known fire hazard and should be corrected for reasons of safety.

Buyer should have the Electrical System checked by a Qualified Licensed Electrician.

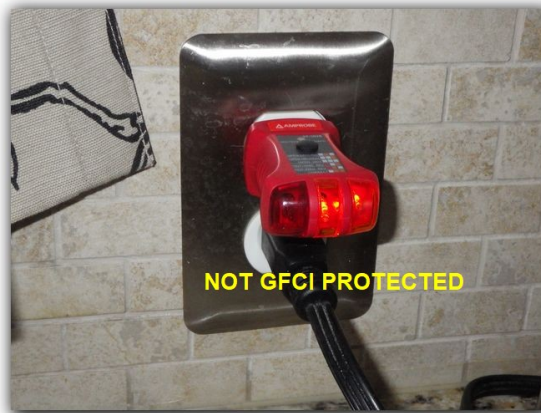
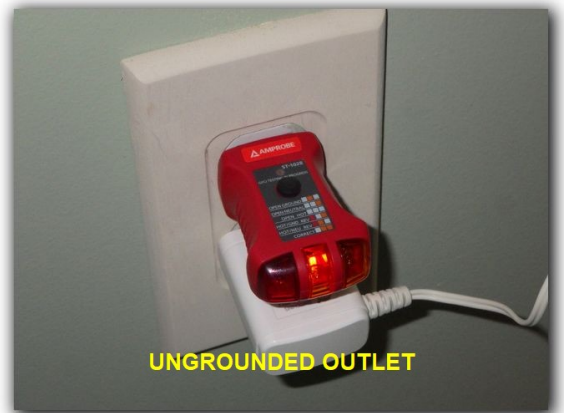
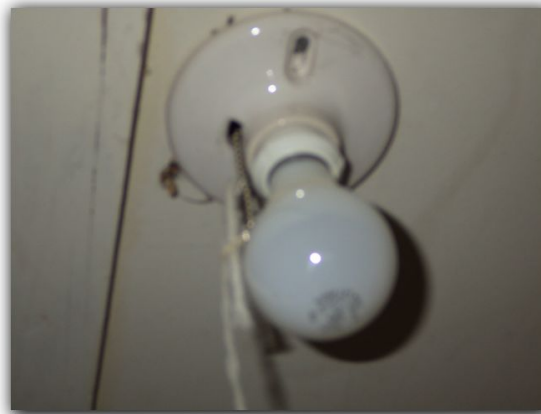
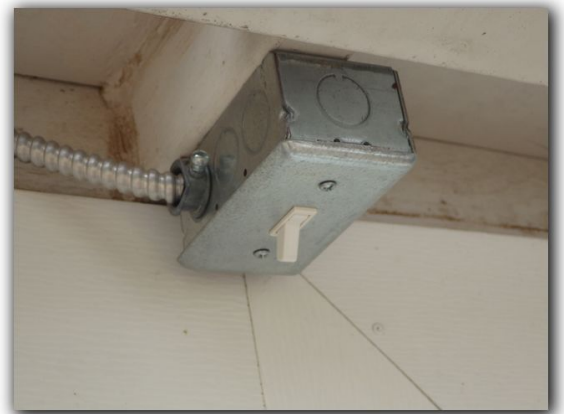
- **Note:** Some of the receptacles in the home were inaccessible and could not be reached for inspection due to personal effects, heavy storage, furniture or conditions outside the control of the inspector.
- The receptacles in the wet/damp areas do not appear to have ground fault circuit interrupter (GFCI) protection. Under current electrical standards all of the exterior receptacles, all kitchen counter top receptacles, all bathroom receptacles, wet bar countertop receptacles, laundry room sink countertop receptacles, garage non-appliance dedicated receptacles and pool lighting should have GFCI protection.
- Most to all of the three-prong receptacles are observed to be ungrounded. This is an older two-wire system. Note: Placing three prong receptacles on an older two-wire system does not meet current National Electrical Code standards.

- All exterior switches should have weather tight covers. The switch weather cover plate is damaged and/or missing on the east soffit.
- A random sampling of switches was made. The cover plates were removed and the snap switches were observed to be ungrounded. Under current National Electrical Code Standards, the electrical snap switches and dimmer switches should be effectively grounded.
- **Note:** I was unable to determine the operation end of one or more of the switches.

- One or more of the light fixtures appear to be inoperative in the front corner bedroom closet. This may be due to a bad bulb or some other unknown condition. This condition should be further evaluated and corrected as necessary.
- **Note:** One or more of the closet light fixtures appear to be installed without globes and/or covers. Safety precautions should be taken around these light fixtures.

- There are not enough smoke alarms located in the home. Under current building standards, there should be a smoke alarm located in each sleeping room, outside each separate sleeping area in the immediate vicinity of the sleeping rooms, and on each additional story of the dwelling.
- **Note:** It is recommended to test for proper operation monthly and replace the batteries in all of the smoke detectors once a year for reasons of safety.

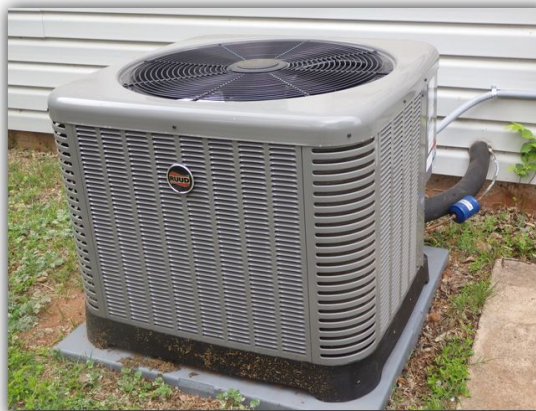
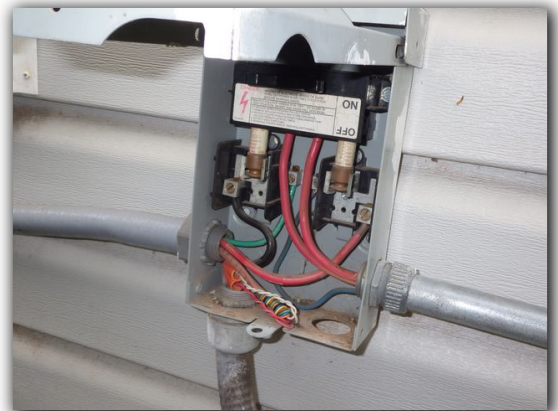
- The electrical disconnect is missing its interior cover plate. Repairs are recommend.

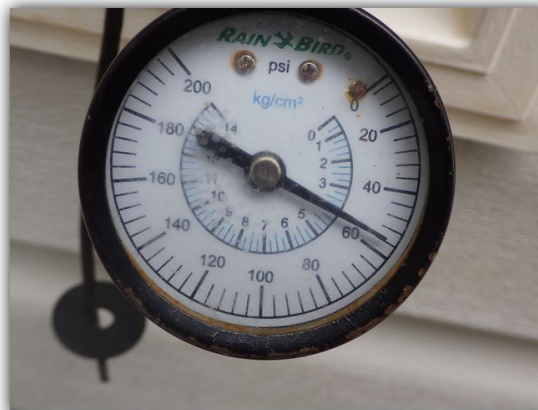
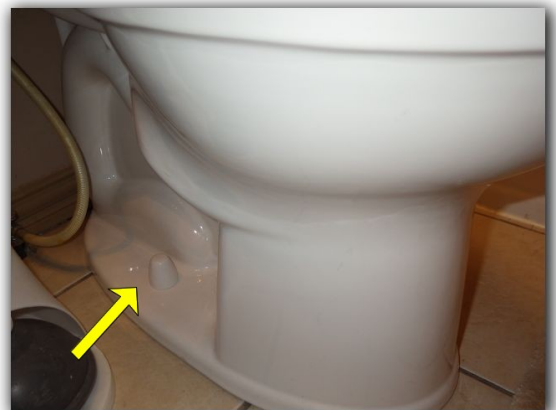
- The commode is loose at the floor mount.

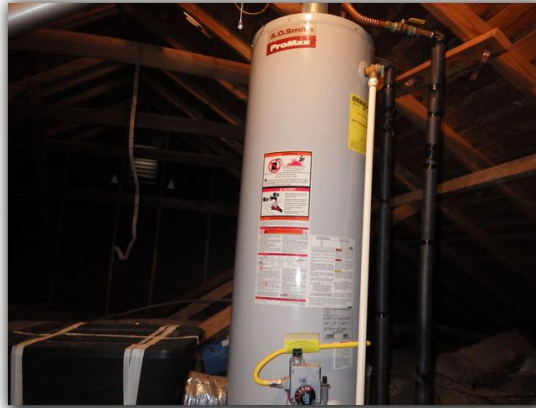
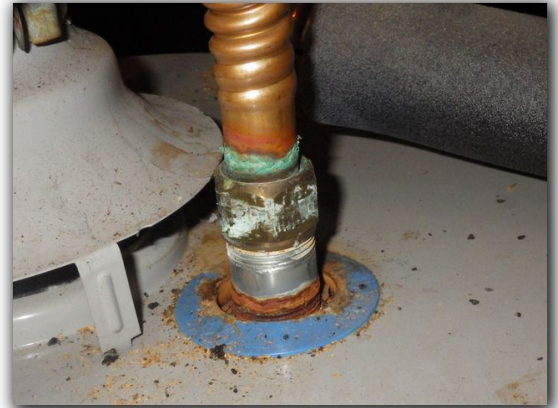
- **Note:** There is evidence of prior leakage on or around the water heater housing. This should be closely monitored.

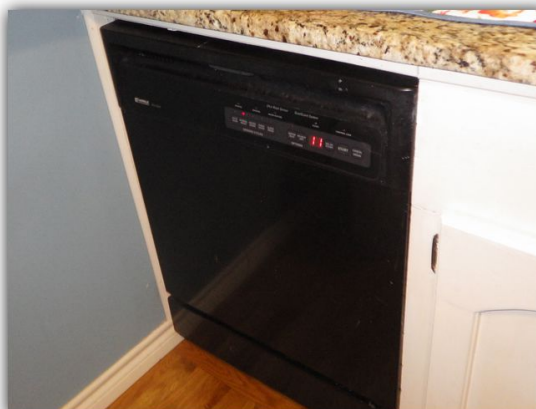
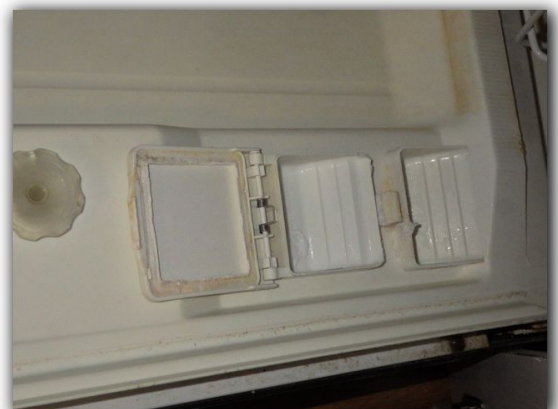
- The dishwasher soap dispenser door does not appear to be functioning properly.

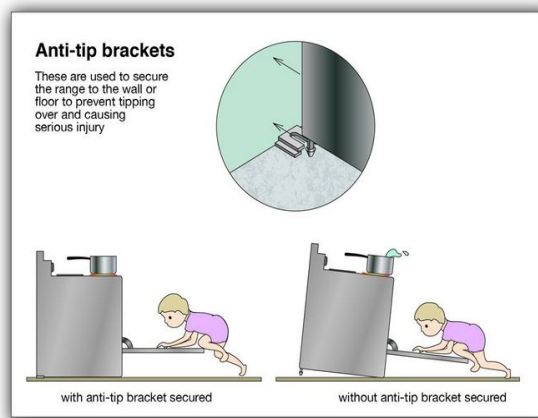
- The range can be easily tipped over and should be equipped with an anti-tip device, for safety.
