**Homeowner**  
**1304 W Lindsey St**  
**Breckenridge, TX 76424**

April 23, 2018

## PROPERTY INSPECTION REPORT

**By:** David Renner, Lic #20502 / NAWT #12181ITC 04/23/2018  
(Name and License Number of Inspector) (Date)

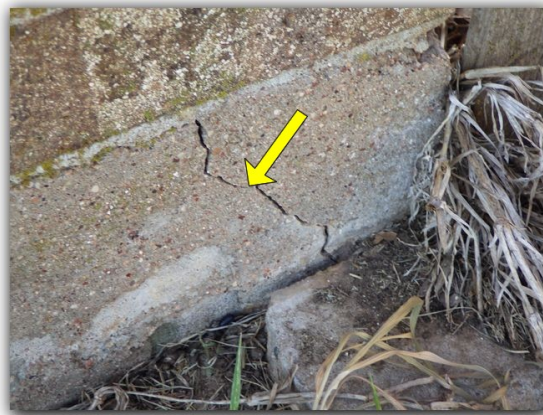
- One or more of the foundation perimeter beam corners were observed to be sheared off (corner pop). This is a common condition in slab on grade foundations. This condition does not adversely affect the performance of the foundation. However, in some cases, some cosmetic improvements may be necessary.

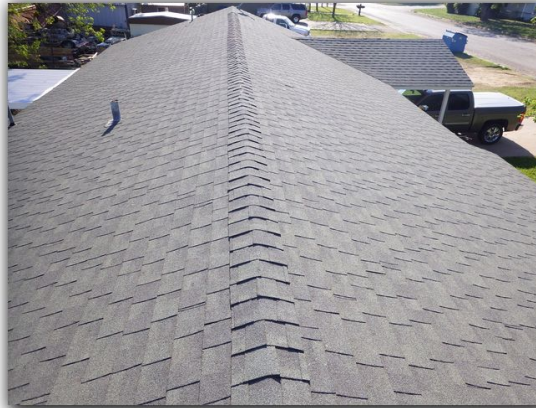
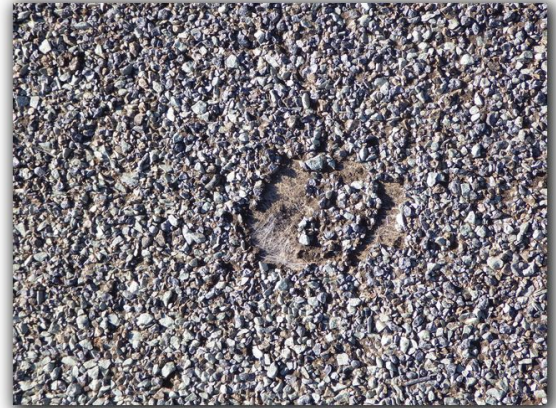
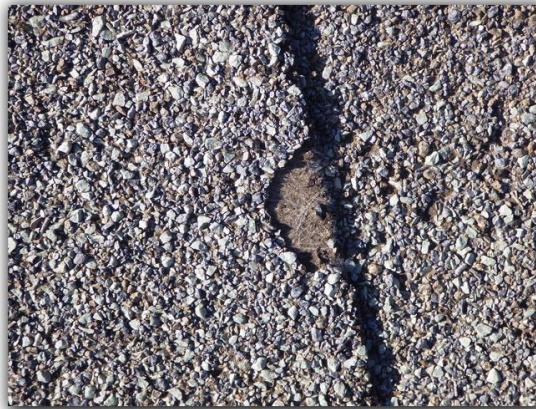
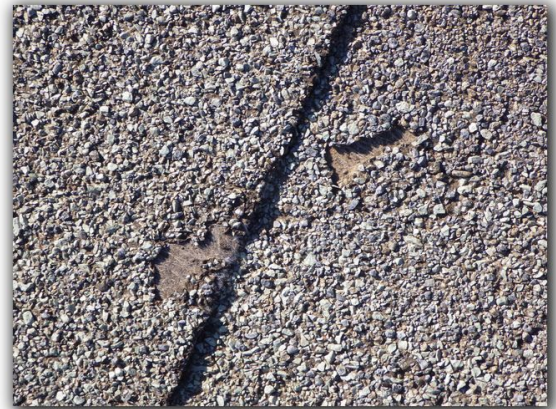
- The roofing material observed to have impact damage in various locations. The impact damage may have been caused by a previous hailstorm and should be further evaluated.
- The fasteners at the satellite dish mount need to be sealed to help prevent water leakage at this point.

- The lead jack flashing detail was observed to be improperly installed at one or more of the roof level plumbing vent pipes. The lead flashing should run full length of the vent pipe and turn down into the top of the vent pipe to help prevent water intrusion at this point.

You are encouraged to have a properly certified roofing contractor physically inspect the roof on all structures to fully evaluate the condition of the roofing material. The observations made to support the rendering of this opinion are listed but not limited to the following:

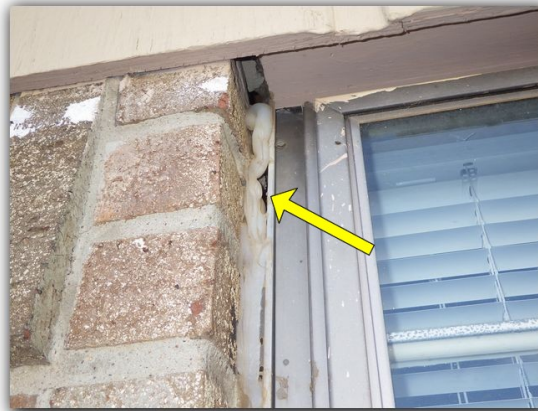
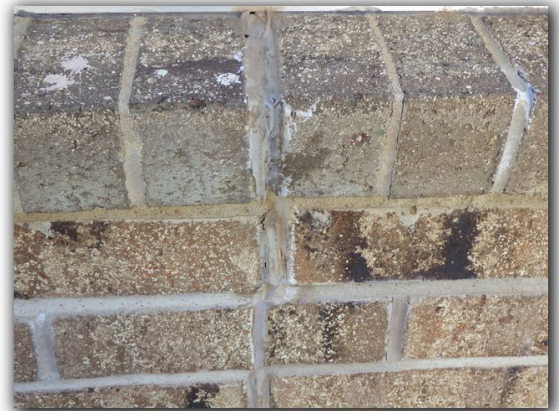
- Caulking improvements are recommended for the area between the exterior veneer and the window frames.
- **Note:** Previous repairs to the exterior masonry mortar / grout was observed on the north and west sides of the structure.

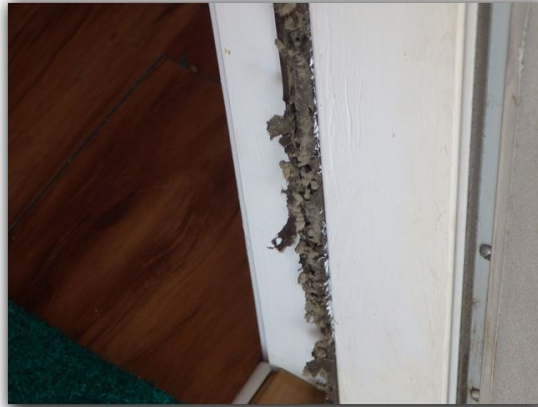
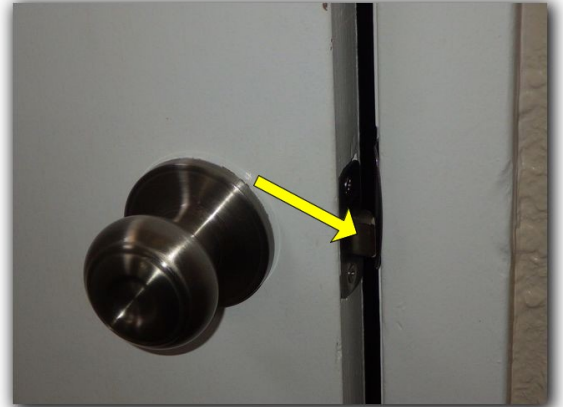
- Weather-stripping improvements are recommended for the exterior doors. **Repaired**

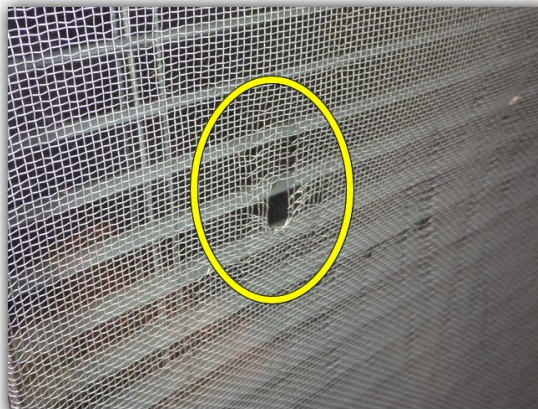
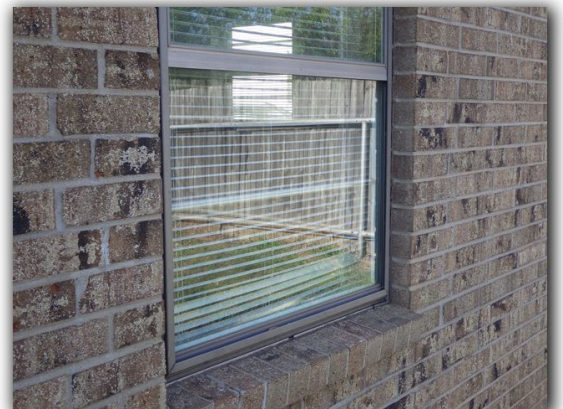
- One or more of the window screens were observed to be damaged.
- One or more of the window screens were observed to be missing.

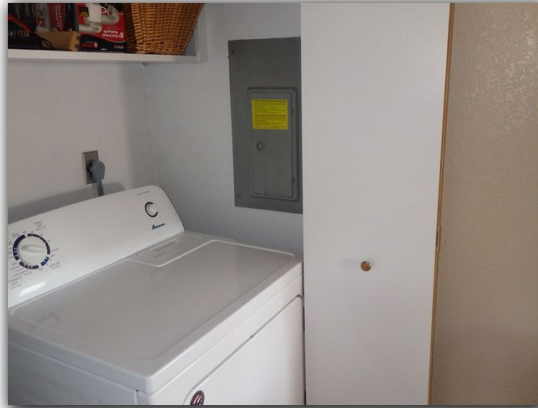
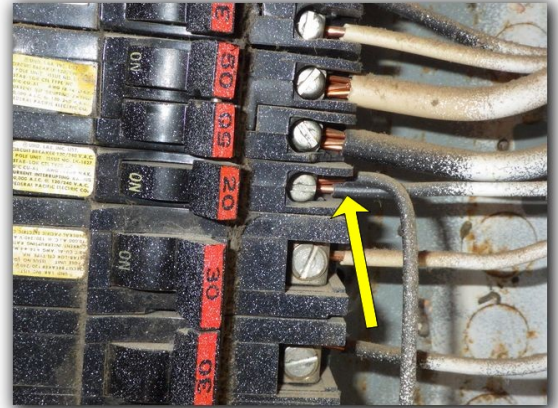
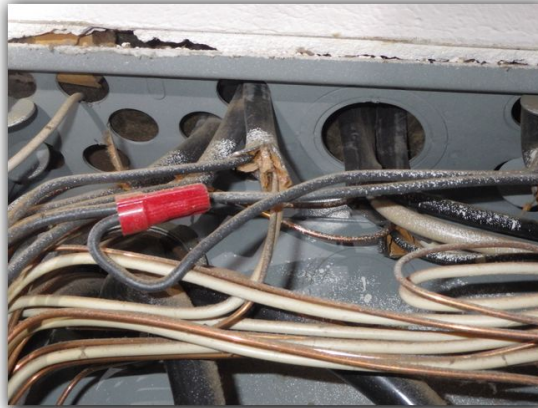
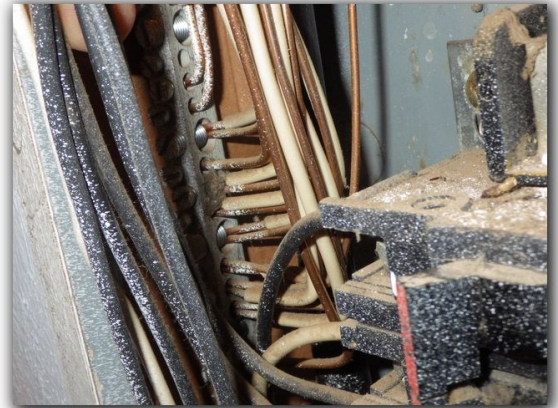
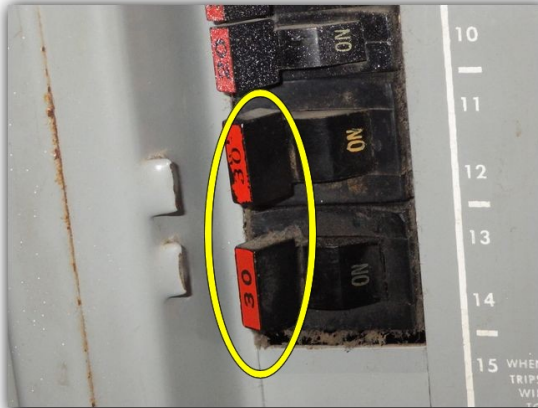
- **Notice:** There is a Federal Pacific Electric - FPE Panel Type Panel Box in place at the time of the inspection. This panel box is known to have various problems and/or deficiencies. Full evaluation of this panel box is beyond the scope of this inspection. For more information [Click Here](#)

- ~~The breakers (overcurrent devices) in the electrical panel are not properly labeled.~~ **Repaired**
- There was no main disconnect observed in the panel box. This may be an “as-built” condition but *Per TREC standards of practice we are required to report this condition as a deficiency.*

- The panel box does not have proper clearance in front of the cabinet. The panel box cover plate (Dead Front) and/or cabinet should be readily accessible and cover easily removable at all times. Under current electrical standards, the accessible workspace around the panel box should be at least 36-inches in depth in front of the cabinet and 30-inches in width or the width of the equipment. Clothes, shelves, cabinets, foliage, etc should not block the workspace in front of the cabinet.

- The wires entering the electrical cabinet are not properly secured or protected from the sharp edges of the cabinet.
- One or more of the neutral wires are incorrectly connected under a single screw on the grounding/neutral bus bar. Under current installation standards, the ground and neutral wires should be under separate screws with no more than one neutral wire per screw.

The electrical system should be checked by a Qualified Licensed Electrician. The observations made to support the rendering of this opinion are listed but not limited to the following:

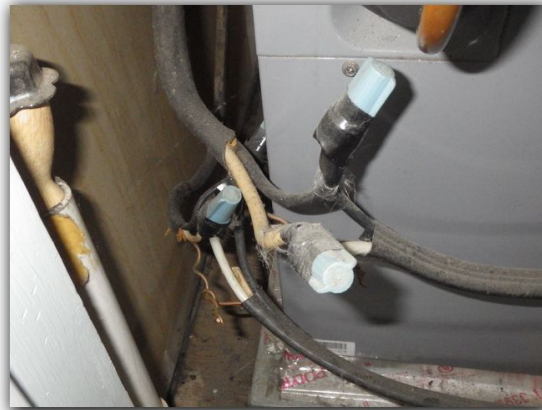
- Spliced wires were observed in the HVAC closet. The spliced wires need to be properly enclosed in an electrical junction box for reasons of safety. **Repaired**

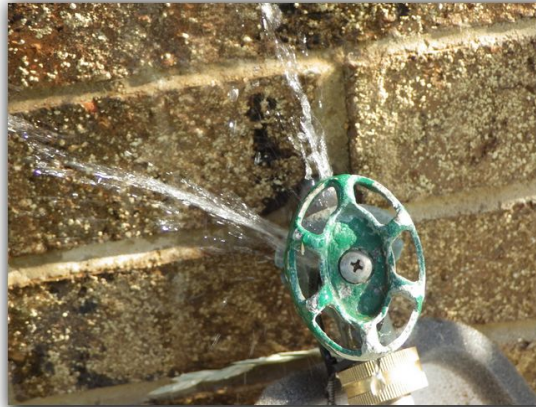
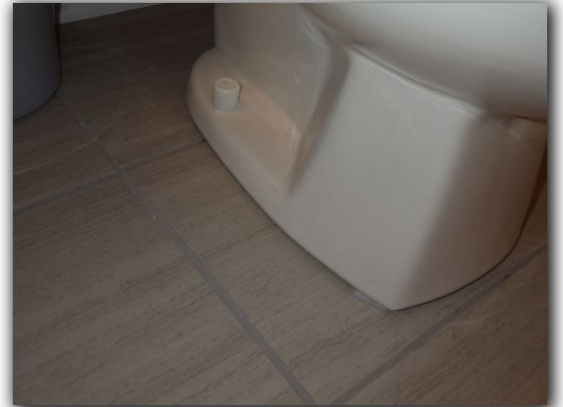
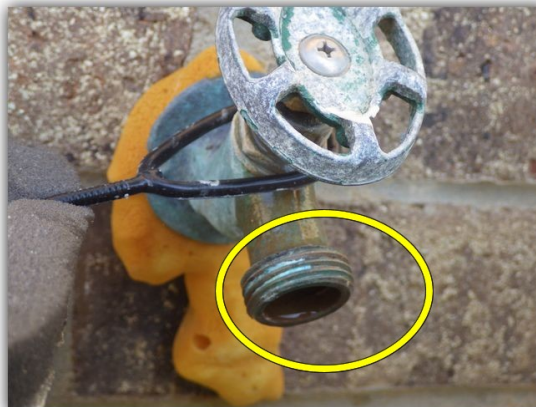
- One or more of the exterior water hose bibbs (faucet) do not have a back-flow or anti-siphon device (Vacuum Breakers) in place. **Note:** *This is not uncommon to observe with a home of this age and can easily be obtained at home improvement stores if desired.*
- The exterior water hose bibb (faucet) is leaking at the handle when operated on the south side of the structure.

- The commode appears to be excessively loose at the floor mount. This condition should be further evaluated and corrected as necessary.

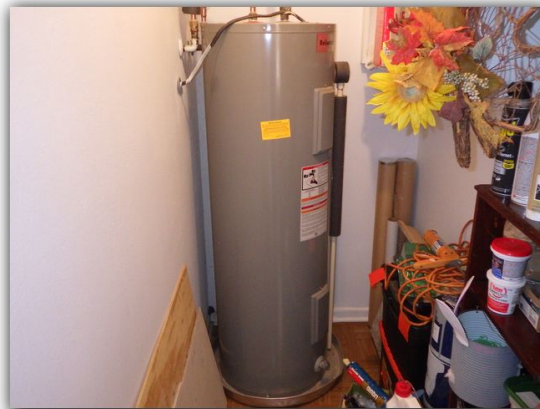
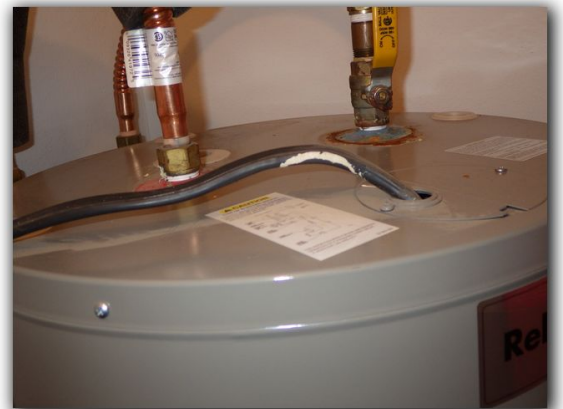
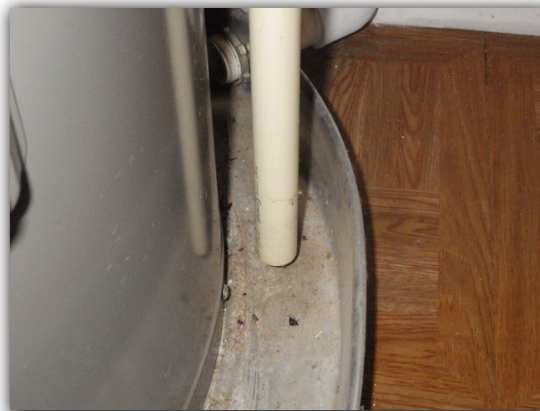
- The temperature and pressure relief discharge pipe is terminating into the water heater drain pan. Under current building standards, this discharge pipe should run downward to the exterior of the structure, turn downward, and terminate within 6-inches of the ground.
- The electrical wiring to the water heater is exposed and should be enclosed in conduit and an electrical disconnect installed.

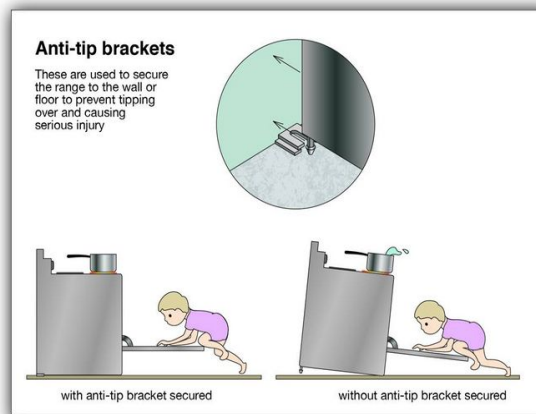
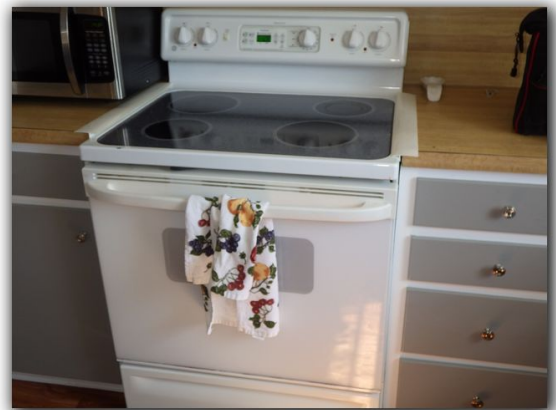
- The range can be easily tipped over and should be equipped with an anti-tip device, for safety.

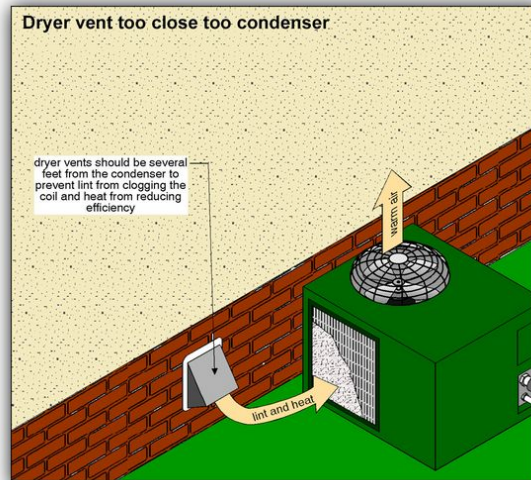
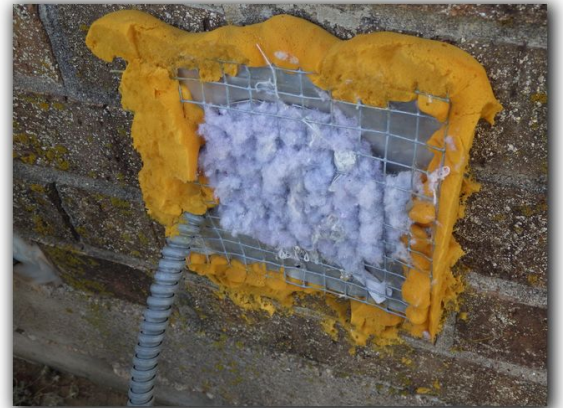
- The dryer exhaust duct (vent pipe) is dirty and needs to be cleaned. **Repaired**
- The dryer duct termination was observed to be screened. Screening the termination is not permitted under current installation standards. **Note:** Screening the dryer termination will cause the dryer duct to clog and will not allow the dryer to operate efficiently. **Repaired**
- **Note:** The dryer exhaust duct terminates in close proximity of the HVAC condenser/coils. This condition will require the condenser/coils to be cleaned more often and should be closely monitored.
