September 17, 2018

PROPERTY INSPECTION REPORT

Concerning: 2709 meadow lake, Abilene, TX 79606
(Address or Other Identification of Inspected Property)

By: River Dillard, Lic #22970 / NAWT #13972ITC 09/17/2018
(Name and License Number of Inspector) (Date)

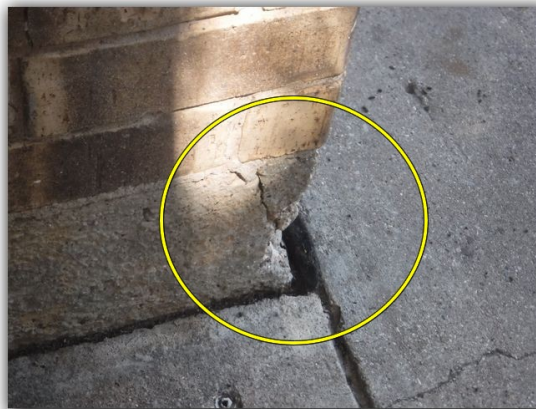
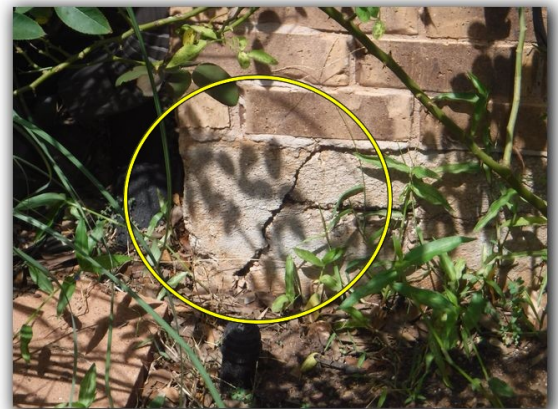
- One or more of the foundation perimeter beam corners were observed to be sheared off (corner pop). This is a common condition in slab on grade foundations. This condition does not adversely affect the performance of the foundation. However, in some cases, some cosmetic improvements may be necessary.

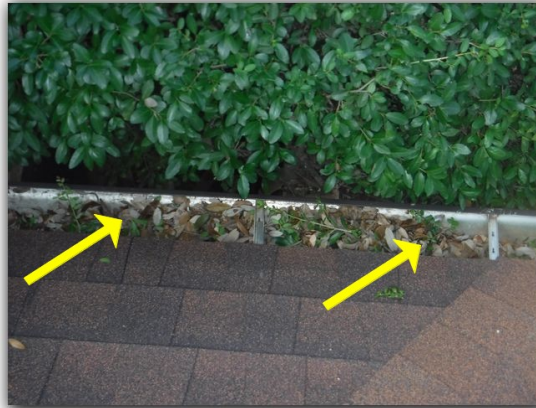
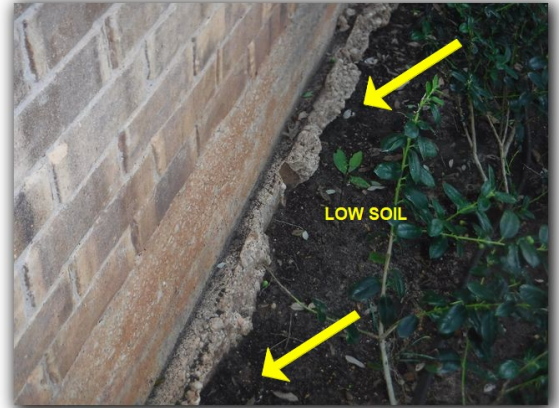
- Fill dirt is needed on the north side of the structure. The low spots in the finished grade (ground) adjacent to the foundation perimeter wall need to be filled in to help prevent water from standing and/or ponding next to the foundation area.

- **Note:** The gutter downspouts should discharge water at least thirty-six inches (36") away from the foundation perimeter beam. Storm water should be encouraged to flow away from the structure at the points of discharge.
- The gutters require cleaning.

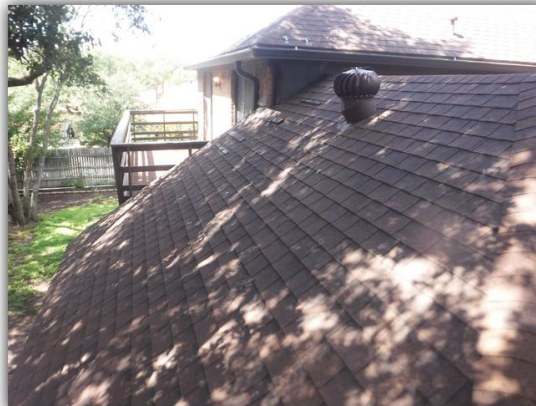
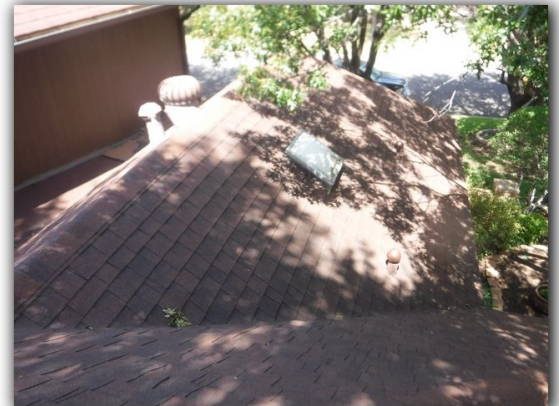
- **Note:** Roof fasteners (nails and/or staples) were observed to be exposed and should be properly sealed at the ridge caps and flashing areas.
- **Note:** Prior repairs to the roofing material and/or flashing were observed in one or more locations.
- **Note:** The tree and shrub branches should be trimmed away from the roofing material at all times.

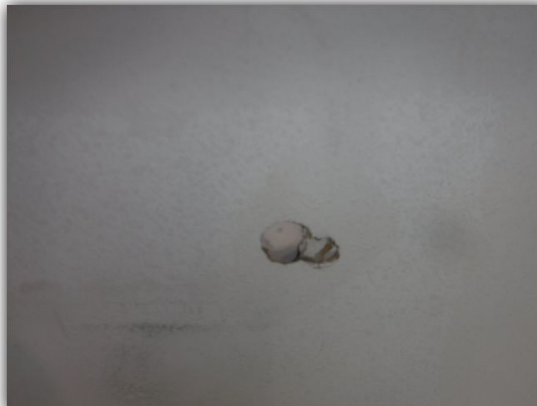
- The floor tile(s) were observed to be cracked and/or damaged in kitchen, front entry hallway.

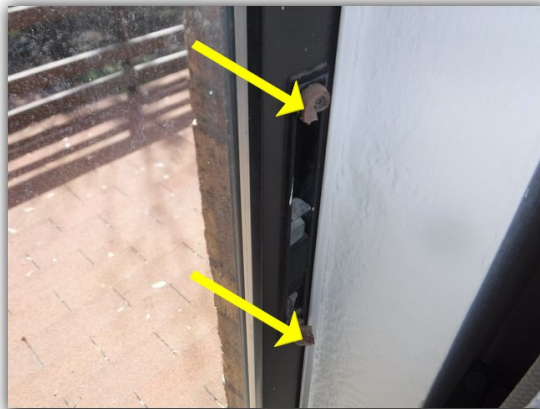
- One or more of the window screens were observed to be damaged.

- **Note:** I was unable to inspect the operation of some of the windows due to window treatments, personal effects, large, heavy or fragile storage and/or furniture.
- One or more of the windows were observed to be stiff and hard to operate in the front entrance area.
- Cracked and/or broken window glass was observed in the garage.

- One or more of the window screens were observed to be damaged.
- One or more of the windows were observed to be stiff and hard to operate in the front entrance area.
- Cracked and/or broken window glass was observed in the garage.

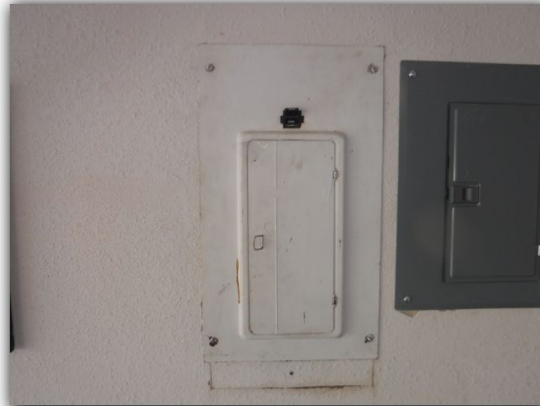
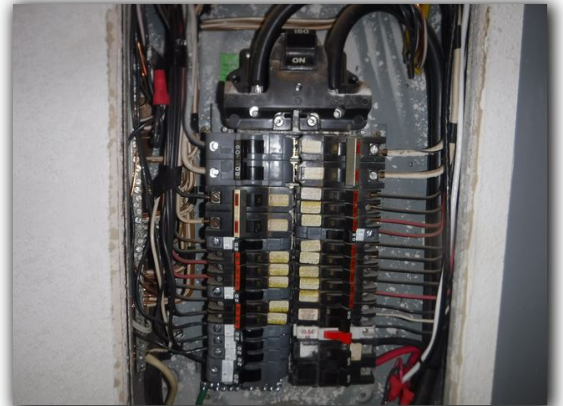
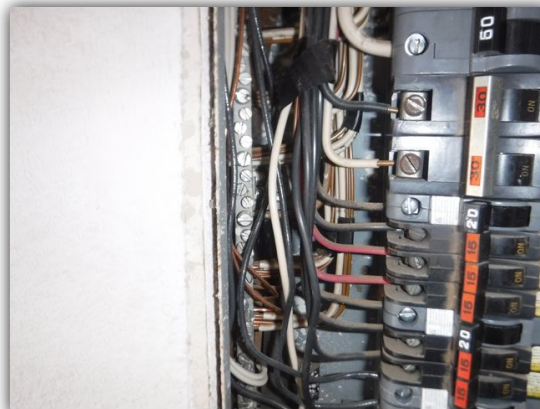
- **Notice:** There is a Federal Pacific Electric - FPE Panel Type Panel Box in place at the time of the inspection. This panel box is known to have various problems and/or deficiencies. Full evaluation of this panel box is beyond the scope of this inspection. For more information [Click Here](#)
- One or more of the neutral wires are incorrectly connected under a single screw on the grounding/neutral bus bar. Under current installation standards, the ground and neutral wires should be under separate screws with no more than one neutral wire per screw.

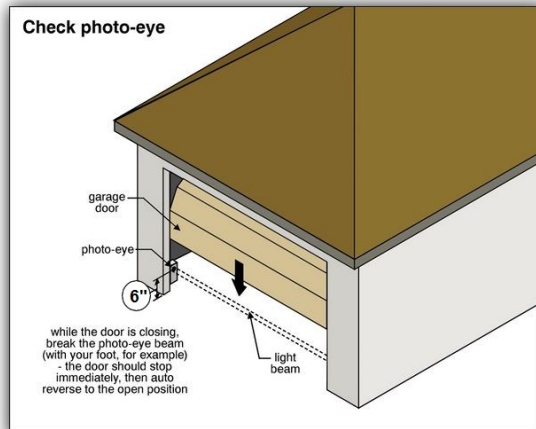
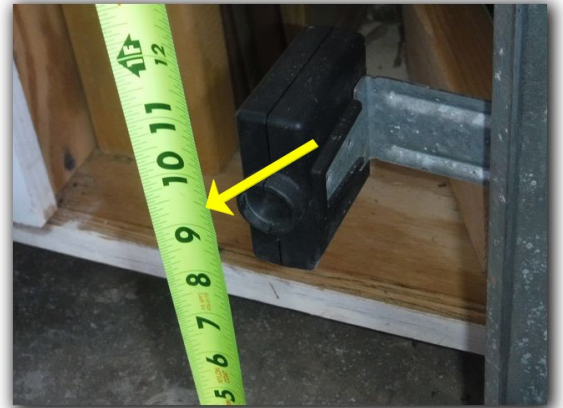
- When an automatic garage door opener is in use, the manual lock should be disabled or removed.
- The garage door reverse sensors are not properly installed. The garage door reverse sensors should be installed within 6-inches of the garage floor.

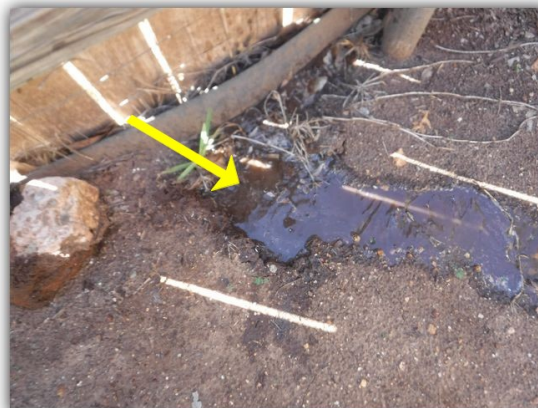
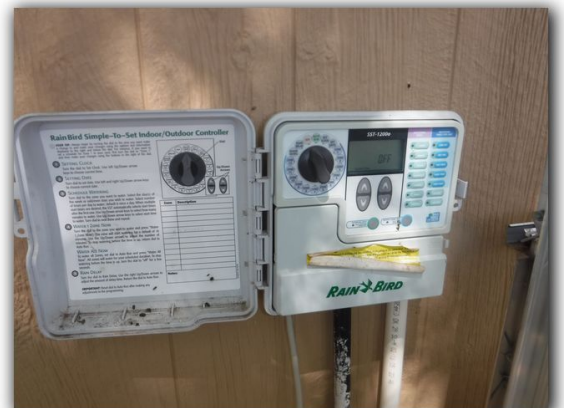
- I was unable to locate a moisture (rain / freeze) sensor device for the sprinkler system. This is an **“as-built” condition**, but Per TREC standards of practice we are required to report this condition as a deficiency.
- The sprinkler system control panel does not appear to be functioning properly. The cause and remedy should be further evaluated and corrected as necessary.
- One or more of the sprinkler heads need to be adjusted so not to spray water onto the exterior walls, surfaces or windows.
- One or more of the sprinkler heads were observed to be damaged and/or missings.
- The irrigation water supply valves leak at the handle when on.
- This is a manually operated system.

- I was unable to locate a moisture (rain / freeze) sensor device for the sprinkler system. This is an **"as-built" condition**, but *Per TREC standards of practice we are required to report this condition as a deficiency.*
- The sprinkler system control panel does not appear to be functioning properly. The cause and remedy should be further evaluated

- One or more of the sprinkler heads need to be adjusted so not to spray water onto the exterior walls, surfaces or windows.
- One or more of the sprinkler heads were observed to be damaged and/or missings.
- The irrigation water supply valves leak at the handle when on.
- This is a manually operated system.

The sprinkler system and associated components should be further evaluated and/or serviced by a Licensed Irrigation Technician. The observations made to support the rendering of this opinion are listed but not limited to the following:
