July 19, 2019

PROPERTY INSPECTION REPORT

Concerning: 7901 Skyline Dr, Abilene, TX 79606
(Address or Other Identification of Inspected Property)

By: David Renner, Lic #20502 / NAWT #12181ITC 07/19/2019
(Name and License Number of Inspector) (Date)

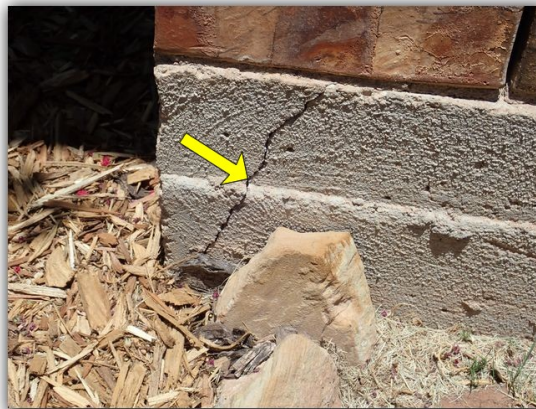
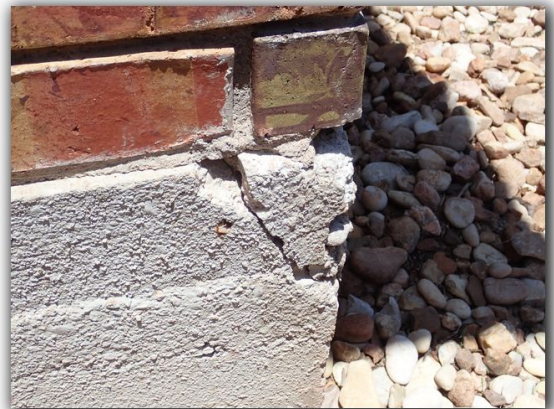
- One or more of the foundation perimeter beam corners were observed to be sheared off (corner pop). This is a common condition in slab on grade foundations. This condition does not adversely affect the performance of the foundation. However, in some cases, some cosmetic improvements may be necessary.

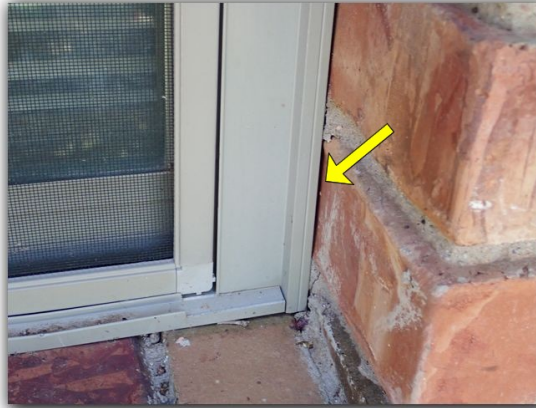
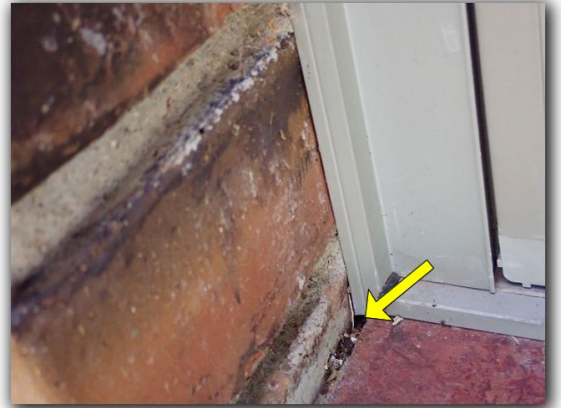
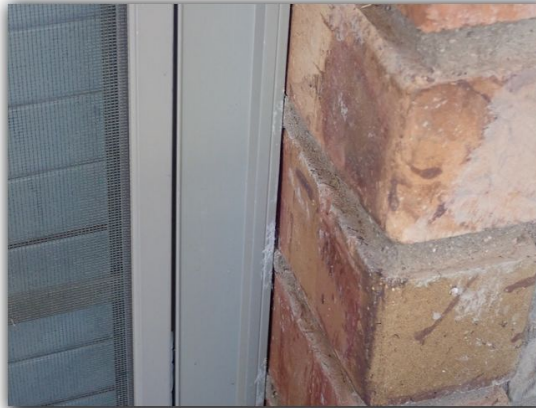
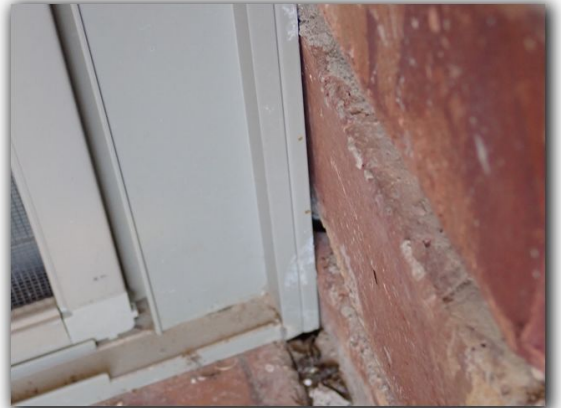
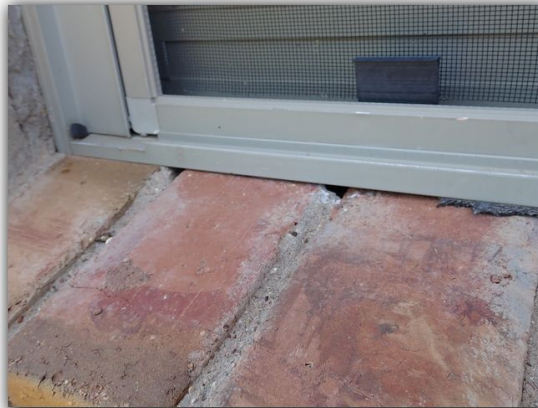
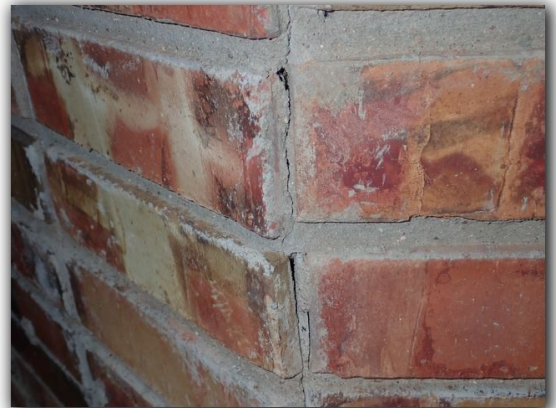
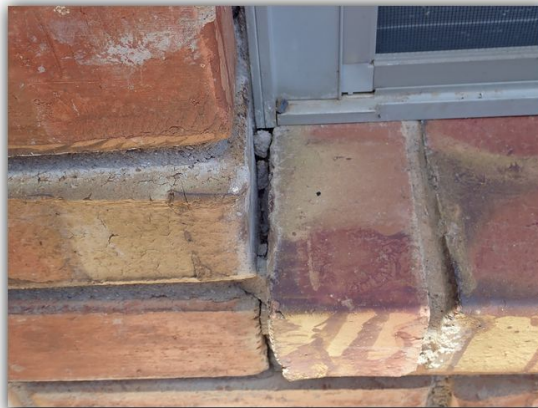
- Caulking improvements are recommended for the area between the exterior veneer and the exterior door frames.
- Caulking improvements are recommended for the area between the exterior veneer and the window frames.
- Minor mortar improvements are recommended for the exterior masonry veneer on the north, east, west and south sides of the structure.

- Caulking improvements are recommended for the area between the exterior veneer and the exterior door frames.
- Caulking improvements are recommended for the area between the exterior veneer and the window frames.

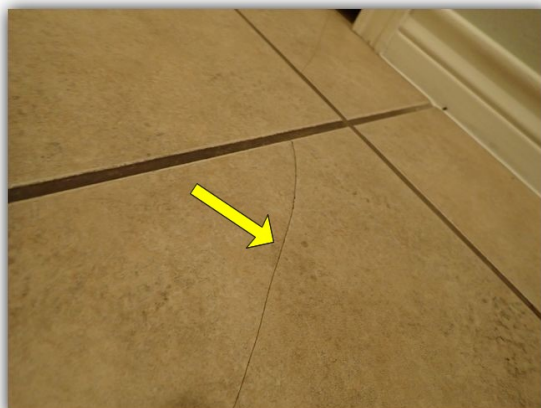
- The floor tile(s) were observed to be cracked and/or damaged in a few various locations throughout the house.

- The floor tile(s) were observed to be cracked and/or damaged in a few various locations throughout the house.

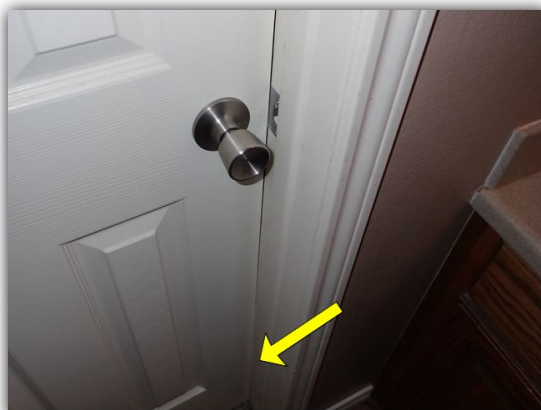
- The door is sticking and will not close properly to the master bathroom closet.

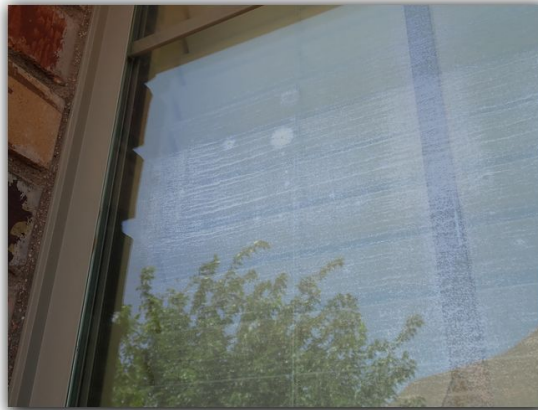
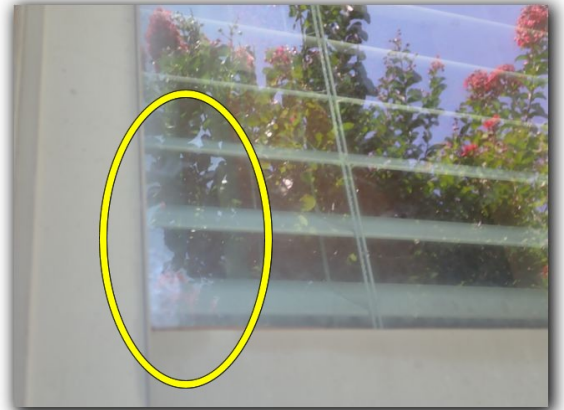
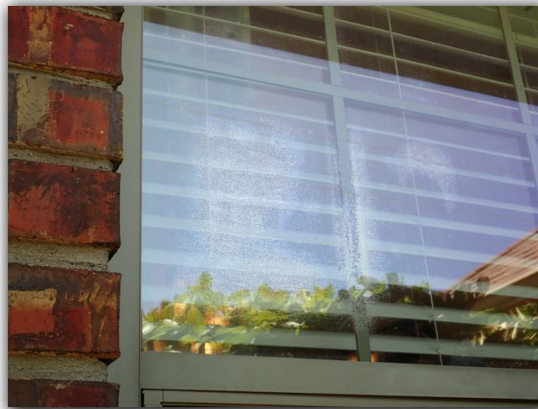
- One or more of the thermal pane windows were observed to have lost their seals. This has resulted in condensation or a fog like film to develop between the panes of glass. The thermal pane windows no longer function as designed when they loose their seal and replacement may be necessary. The windows that have noticeably lost their seals are listed but may not be limited to the following: breakfast area, master bedroom.

Special Notice: Signs of lost seals in the thermal pane windows may appear and disappear as temperature and humidity changes. Some windows with lost seals may not be evident at the time of this inspection. Windows are checked in a non-exhaustive manner for obvious fogging. When lost thermal pane window seals were noted, we recommend all windows be rechecked by a window specialist for further evaluation.

- One or more of the thermal pane windows were observed to have lost their seals. This has resulted in condensation or a fog like film to develop between the panes of glass. The thermal pane windows no longer function as designed when they lose their seal and replacement may be necessary. The windows that have noticeably lost their seals are listed but may not be limited to the following:
breakfast area, master bedroom.

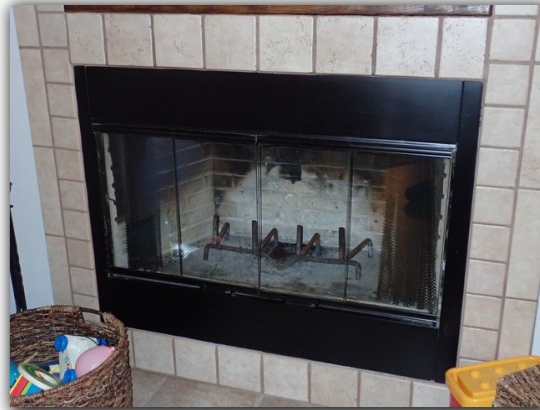
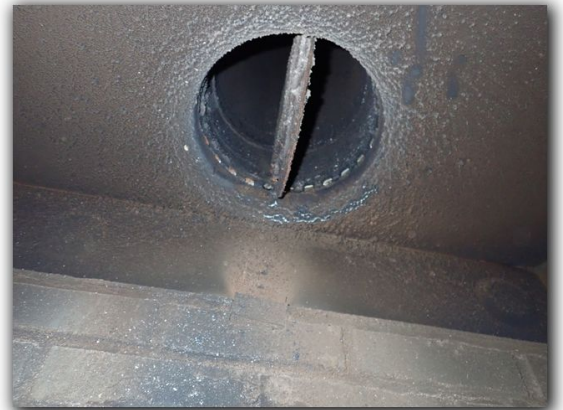
- The chimney flue needs to be cleaned by a Qualified Chimney Sweep. A creosote / soot build-up was observed in the visible flue area.

- The chimney flue needs to be cleaned by a Qualified Chimney Sweep. A creosote / soot build-up was observed in the visible flue area.

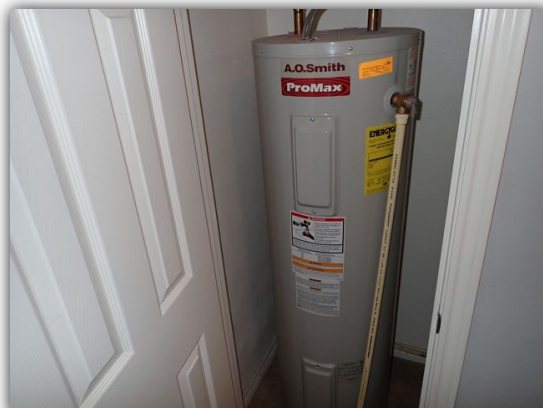
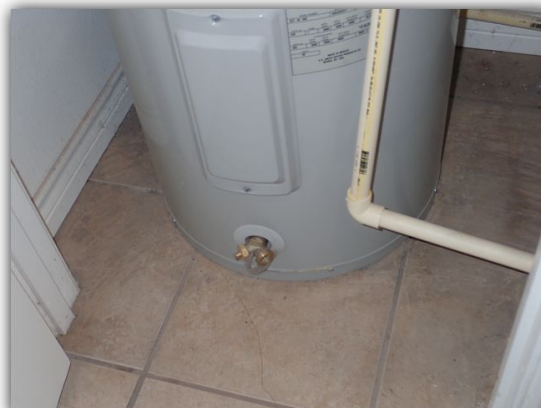
- There is no pan installed under the water heater. It is suggested that the correct sized pan and associated drain pipe system be installed per current installation requirements; at least the next time the water heater is replaced.

- There is no pan installed under the water heater. It is suggested that the correct sized pan and associated drain pipe system be installed per current installation requirements; at least the next time the water heater is replaced.
