August 12, 2019

PROPERTY INSPECTION REPORT

Concerning: 1 Mission Hills, Abilene, TX 79606
(Address or Other Identification of Inspected Property)

By: River Dillard, Lic #22970 / NAWT #13972ITC 08/12/2019
(Name and License Number of Inspector) (Date)

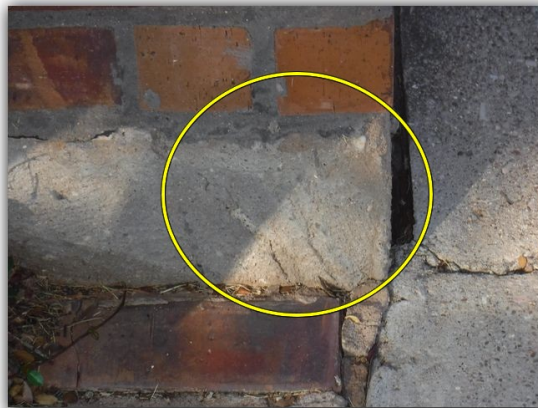
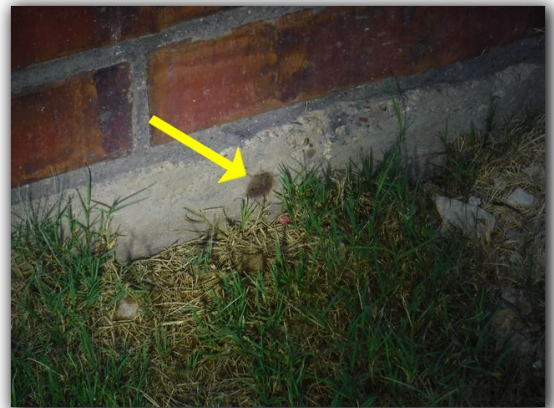
- One or more of the foundation perimeter beam corners were observed to be sheared off (corner pop). This is a common condition in slab on grade foundations. This condition does not adversely affect the performance of the foundation. However, in some cases, some cosmetic improvements may be necessary.
- One or more of the post tension cable ends are exposed and need to be properly sealed on the south side of the structure.

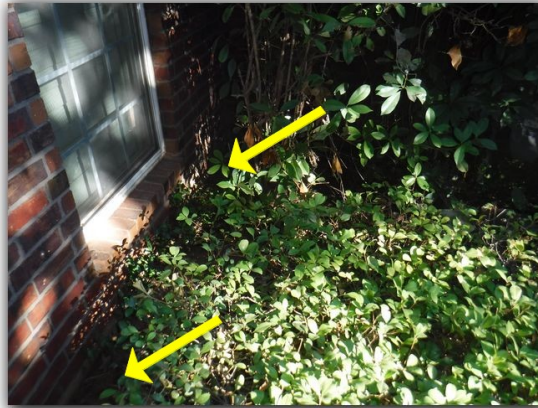
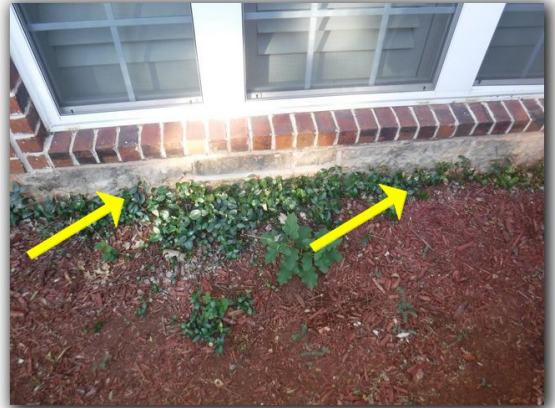
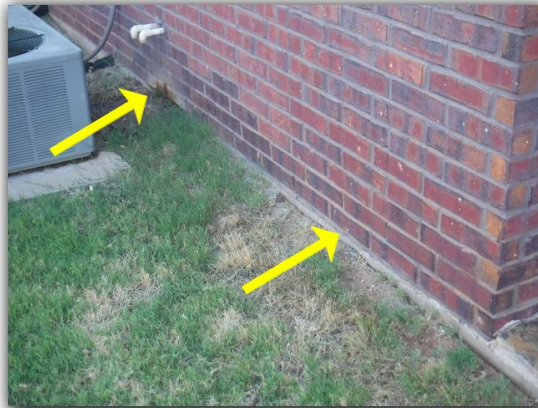
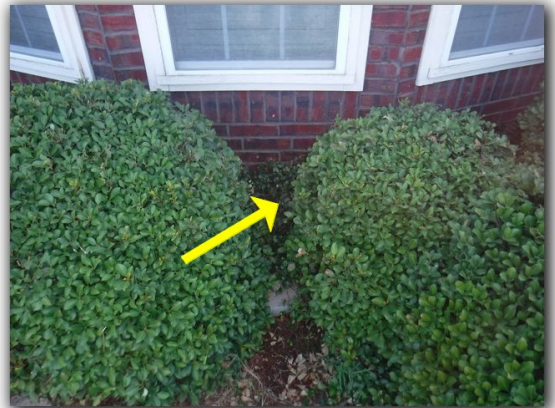
- The soil line is too high on the north, east, west and south sides of the structure. Under current building standards there should be at least 4-inches of foundation visible below masonry veneer and 6-inches of foundation visible below wood type veneer.

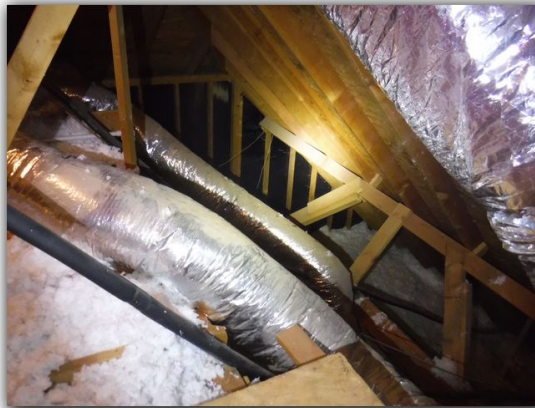
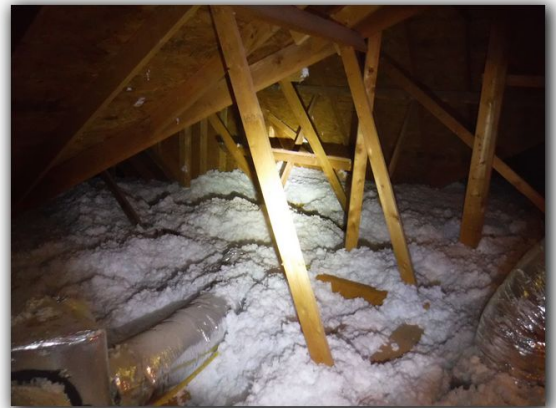
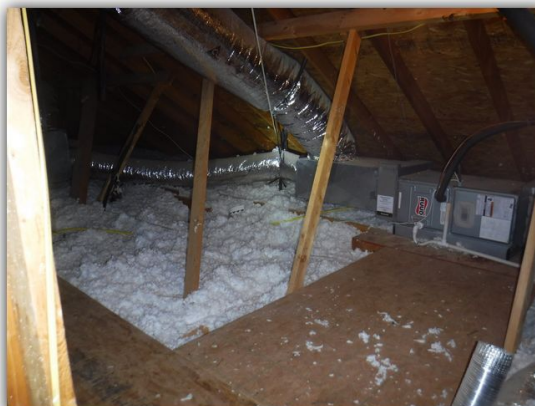
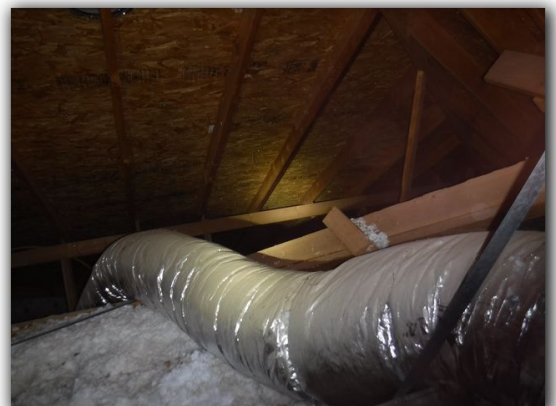
- **Note:** There are visible water stains on the roof sheathing (decking) in one or more locations.

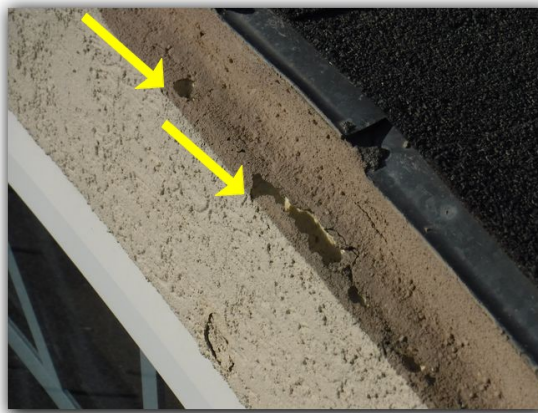
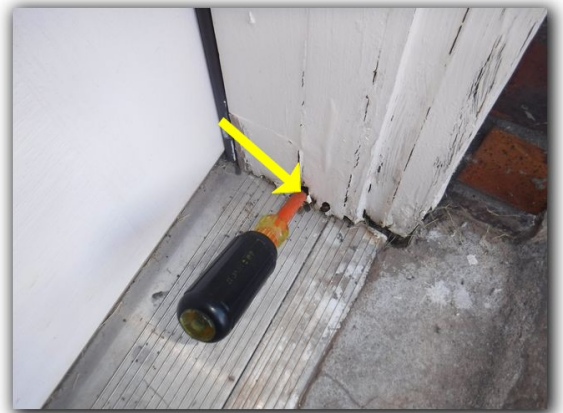
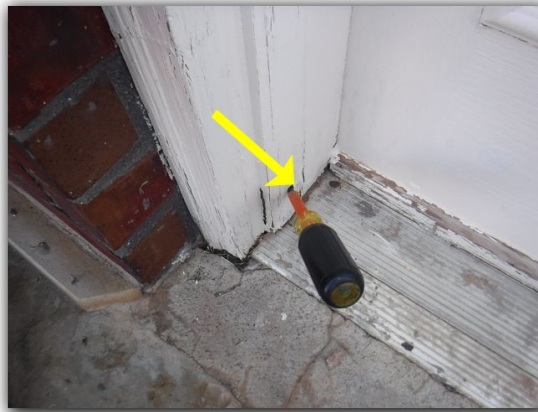
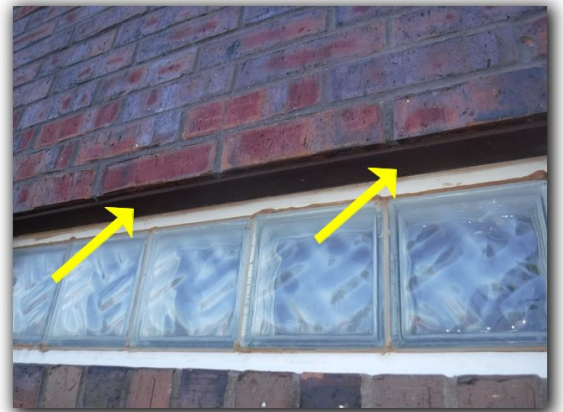
- The steel lintels over the exterior doors and windows should be painted.
- The wood veneer has some deterioration and/or damage on the west side of the structure.
- Caulking improvements are recommended for the area between the exterior veneer and the exterior door frames.

- Some deterioration and/or damage to the stucco type veneer/cladding was observed on the east side of the structure.

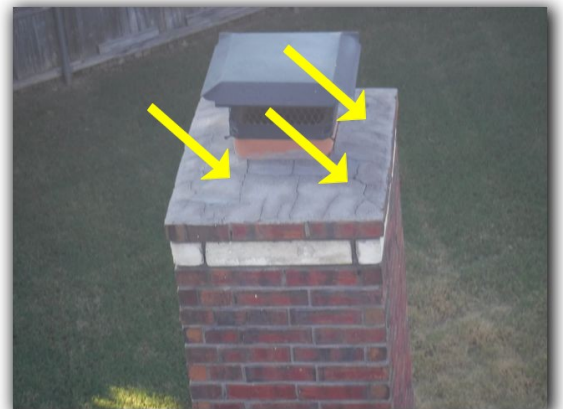
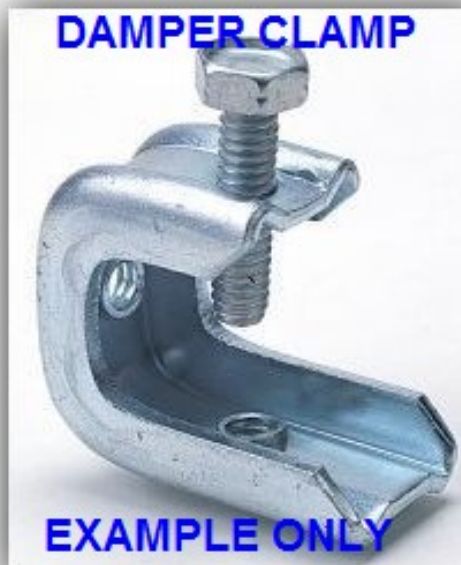
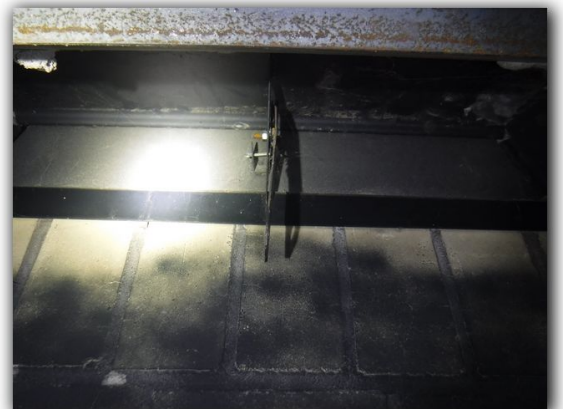
Master Bedroom Fireplace / Chimney

- When artificial gas logs are installed in a firebox with a damper; the damper should be permanently blocked open with a damper clamp to prevent accidental spillage of carbon monoxide into the living space.
- The roof level chimney mortar cap/crown is in need of improvement.

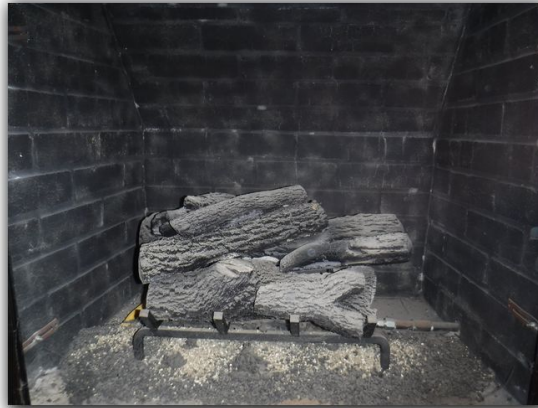
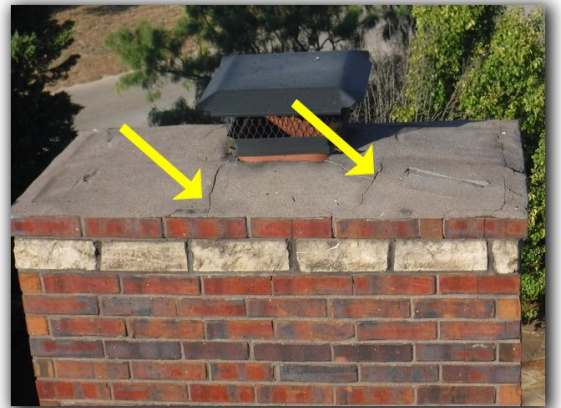
Living Area Fireplace / Chimney

- The firebox damper does not appear to be functioning properly.
- When artificial gas logs are installed in a firebox with a damper; the damper should be permanently blocked open with a damper clamp to prevent accidental spillage of carbon monoxide into the living space.
- The roof level chimney mortar cap/crown is in need of improvement.

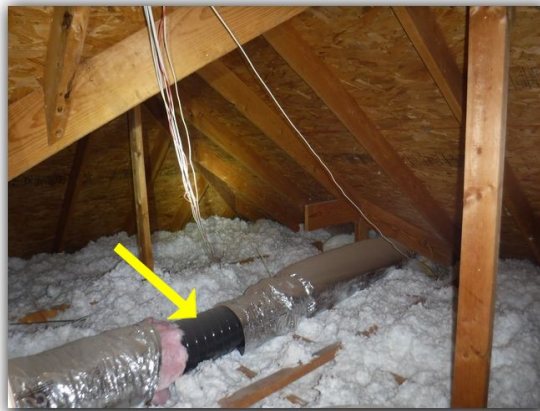
- Ductwork insulated covering was observed to be damaged and/or pulling loose.

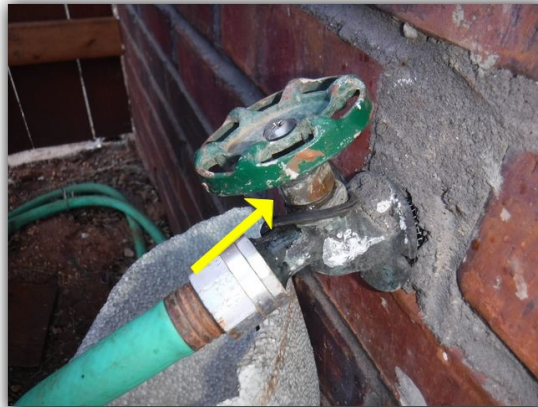
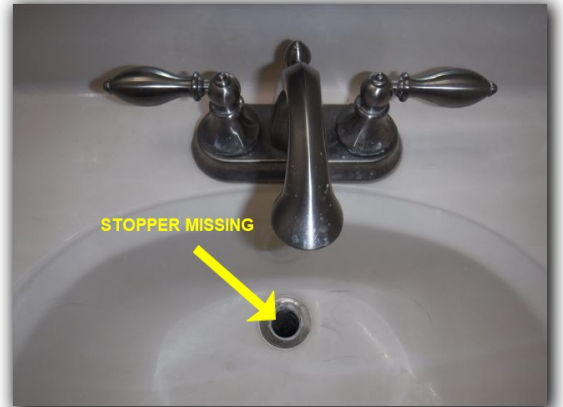
Right Lavatory / Sink

- The stopper does not appear to be functioning properly.
- The sink was observed to drain slowly, suggesting that an obstruction may exist.

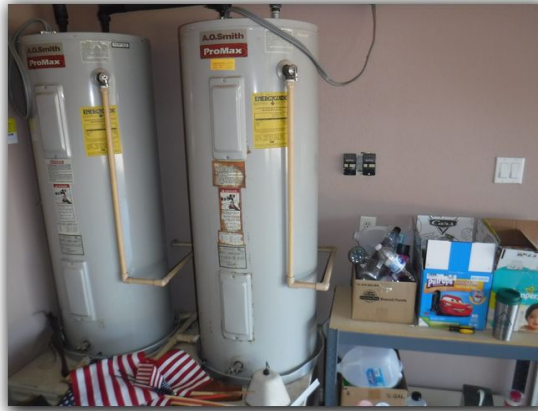
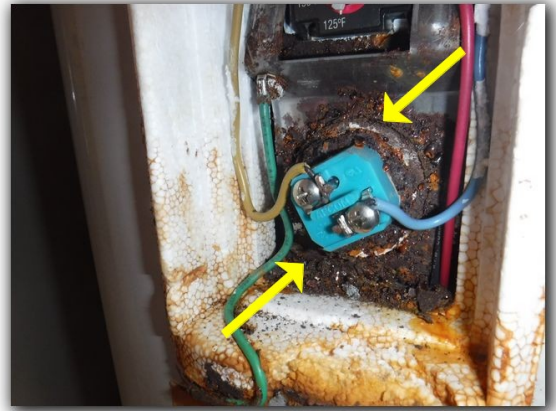
- Some corrosion was observed at the top element of the water heater. Recommend further evaluation and repairs as needed.

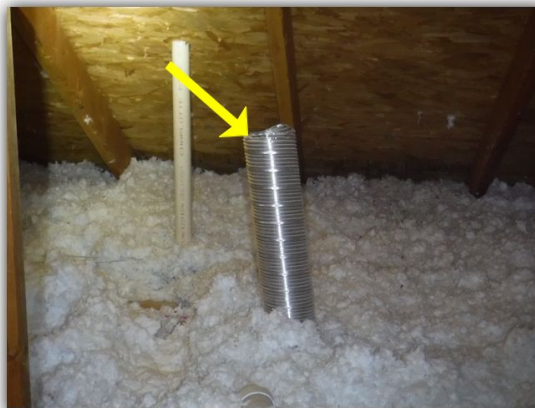
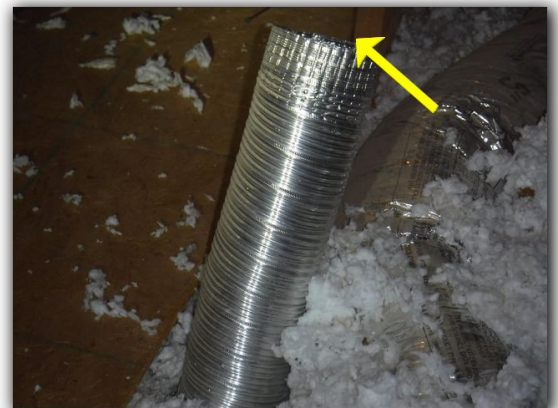
- **Note:** The bathroom exhaust vents were observed to be venting into the attic area and not to the exterior of the structure. This is an “as-built” condition per local building codes but we are required to mark it as deficient per the TREC standards of practice.

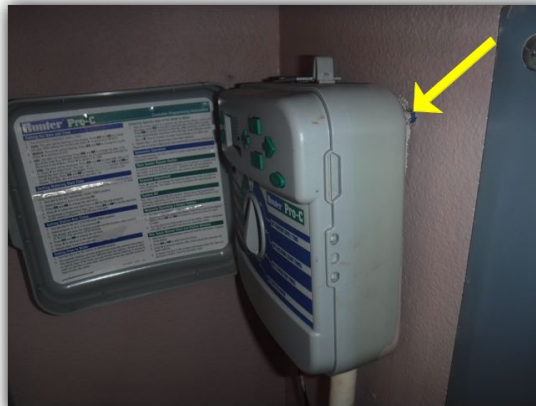
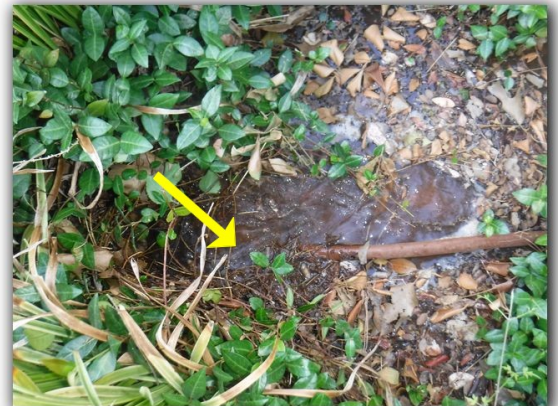
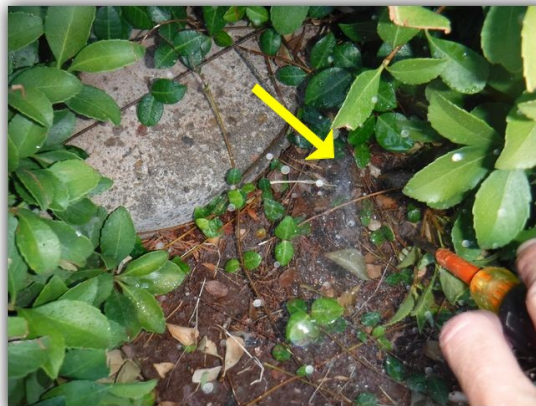
- I was unable to locate a moisture (rain / freeze) sensor device for the sprinkler system. This is an “*as-built*” condition, but *Per TREC standards of practice we are required to report this condition as a deficiency.*
- The sprinkler system control panel (box) is loose at the wall and should be better secured.
- There appears to be a sub-surface leak or damaged water lines in station(s); **4, 5**. The cause and remedy should be further evaluated and corrected as necessary.

The sprinkler system and associated components should be further evaluated and/or serviced by a Licensed Irrigation Technician. The observations made to support the rendering of this opinion are listed but not limited to the following:
