**Thomas Moreno
7682 Florence Dr
Abilene, TX 79606**

February 21, 2020

PROPERTY INSPECTION REPORT

Concerning: 7682 Florence Dr, Abilene, TX 79606
(Address or Other Identification of Inspected Property)

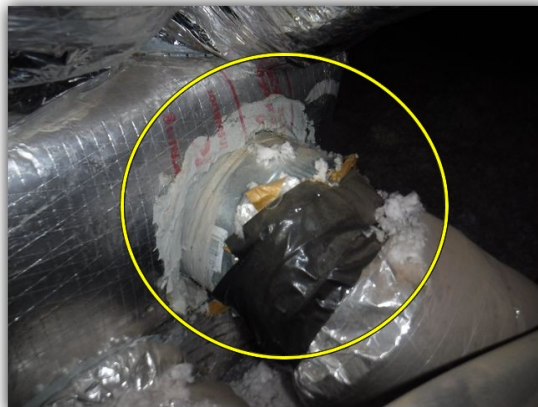
- Some of the ductwork in the attic area is separated and should be repaired.

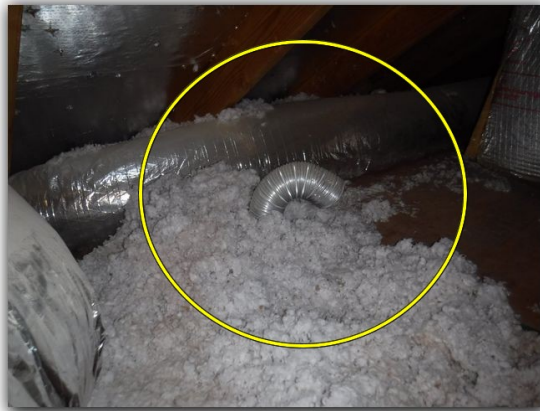
- **Note:** The bathroom exhaust vents were observed to be venting into the attic area and not to the exterior of the structure. This is an “**as-built**” condition per local building codes but we are required to mark it as deficient per the TREC standards of practice.

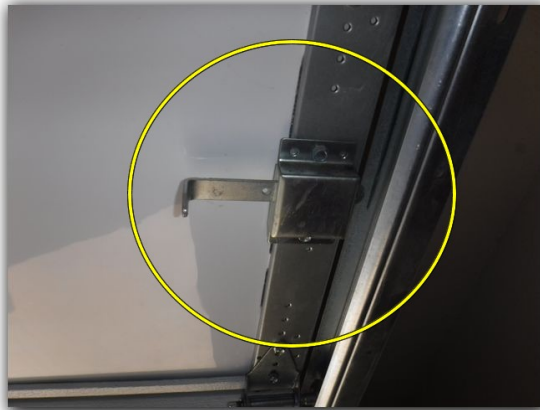
- When an automatic garage door opener is in use, the manual lock should be disabled or removed.
