**5101 Bridle Path Ln  
Abilene, TX 79606**

**September 12, 2022**

# PROPERTY INSPECTION REPORT FORM

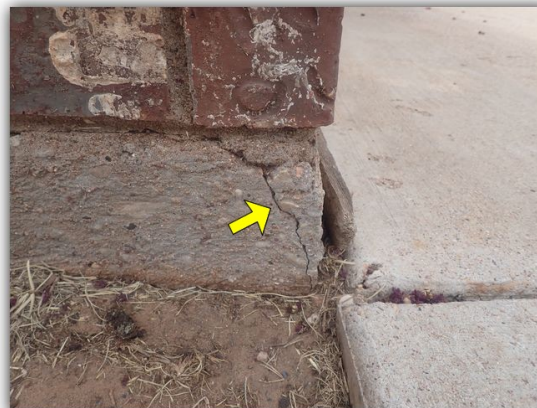
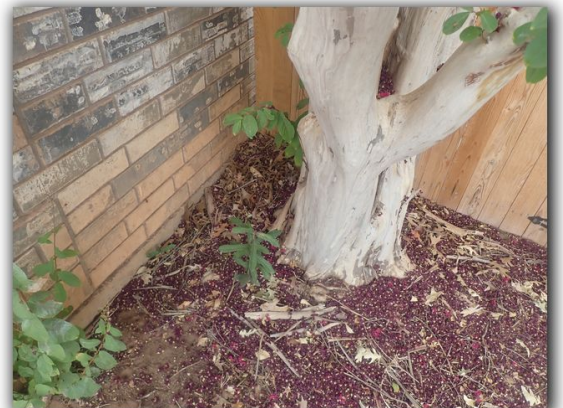
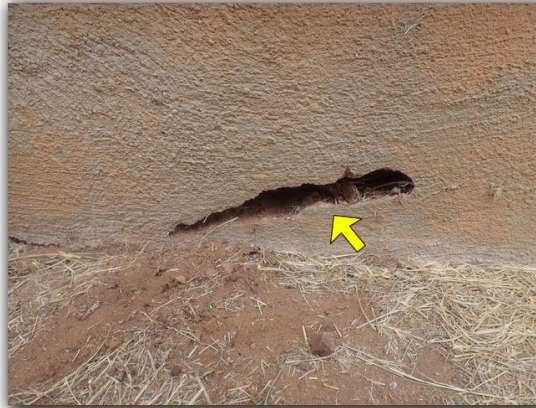
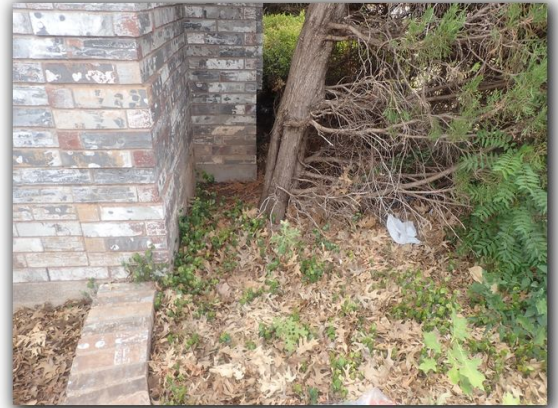
- One or more of the foundation perimeter beam corners were observed to be sheared off (corner pop). This is a common condition in slab on grade foundations. This condition does not adversely affect the performance of the foundation. However, in some cases, some cosmetic improvements may be necessary.
- **Note:** Some minor damage/voids were observed in the exterior foundation perimeter beam which appears to be from the original concrete pour. Minor repairs may be made if desired.
- **Note:** Tree(s) in close proximity of the foundation was observed. Client should consider the installation of a root barrier to reduce the possibility of damage to the foundation from tree roots and moisture removal.

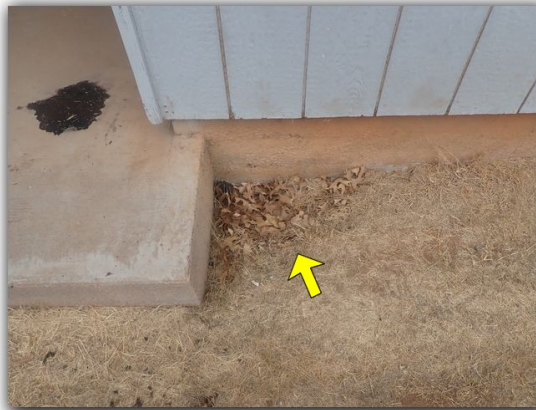
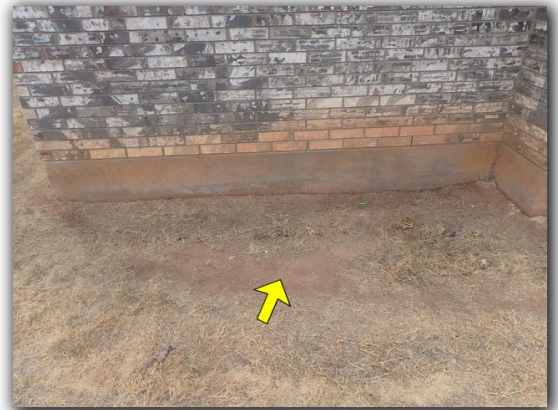
- Fill dirt is needed on the north and east sides of the structure. The low spots in the finished grade (ground) adjacent to the foundation perimeter wall need to be filled in to help prevent water from standing and/or ponding next to the foundation area.
- **Note:** No gutters have been installed on this property. Gutters are recommended for proper water drainage away from the structure's foundation.

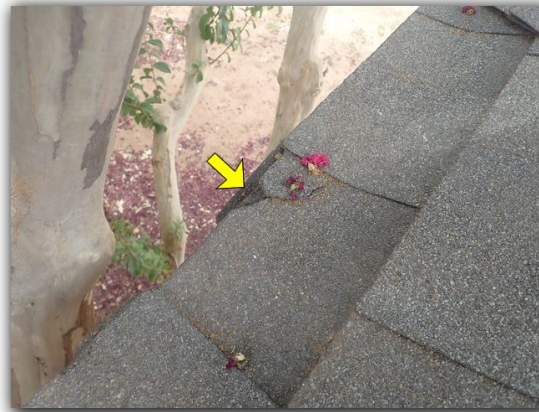
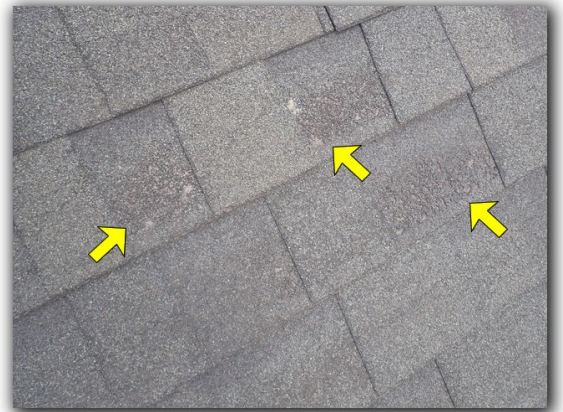
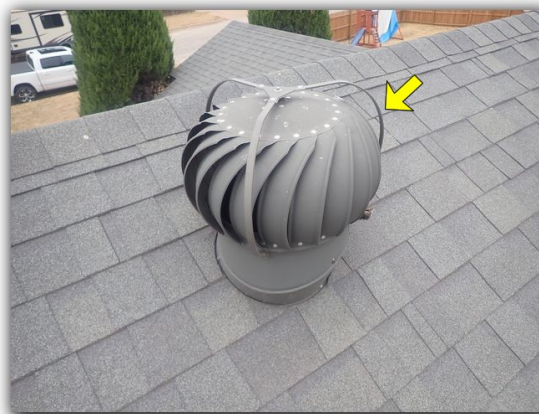
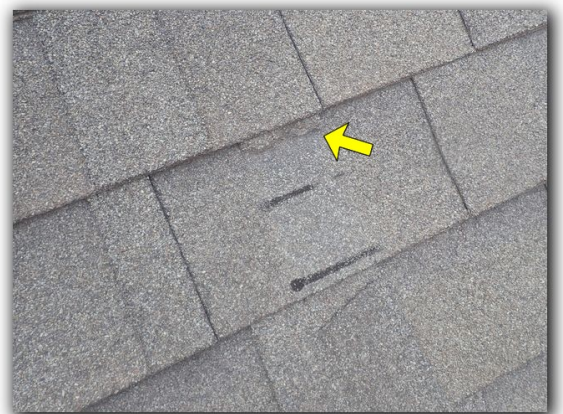
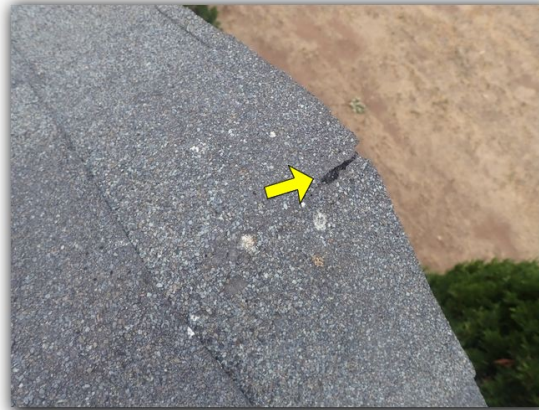
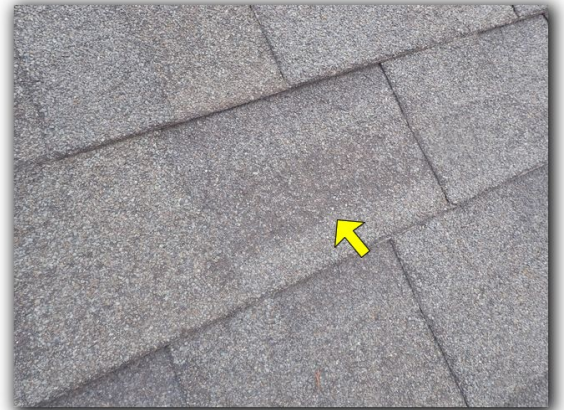
- Damaged shingles were observed on the north and south sides of the roof structure.
- One or more of the ridge cap shingles were observed to be damaged.
- The composition roofing material has experienced granular loss in various locations throughout the roof.

- One or more of the roof structure turbine(s) is not working properly.

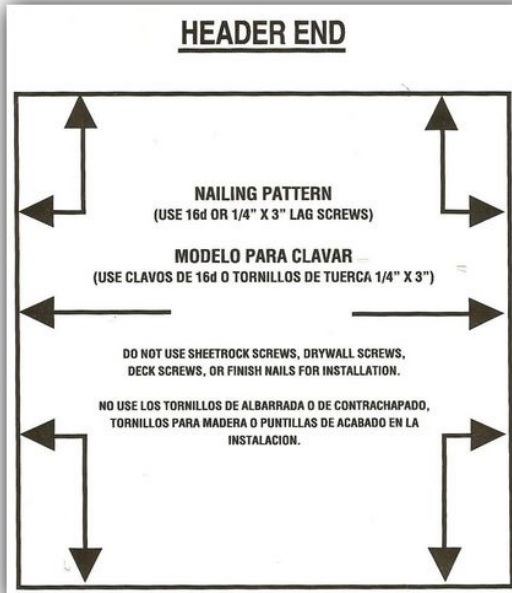
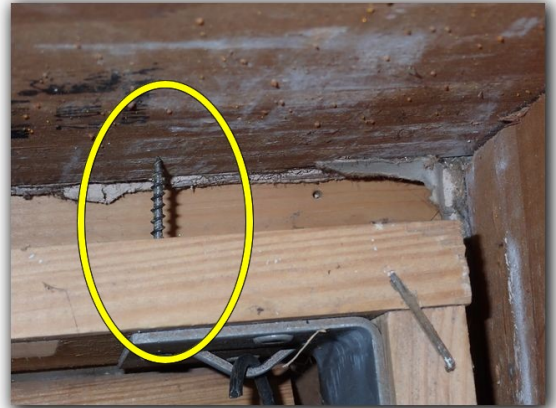
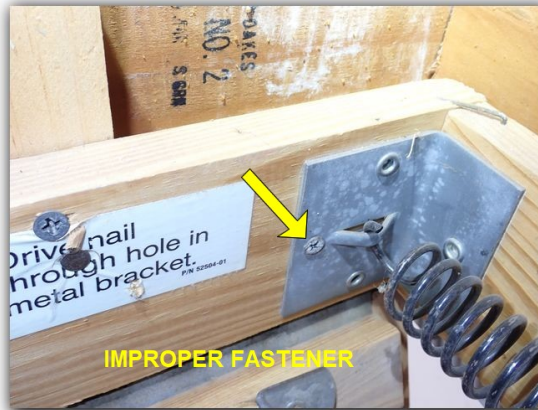
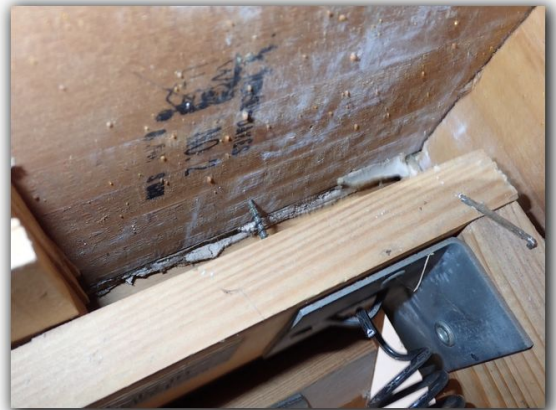
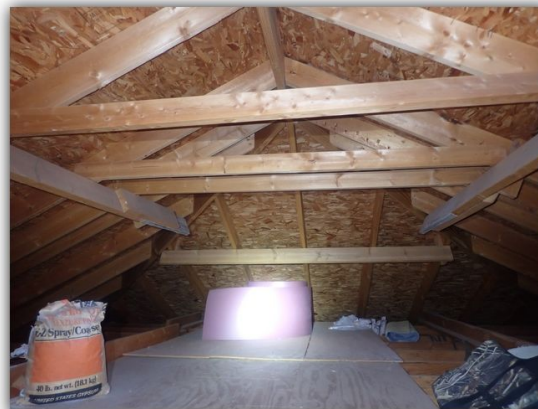
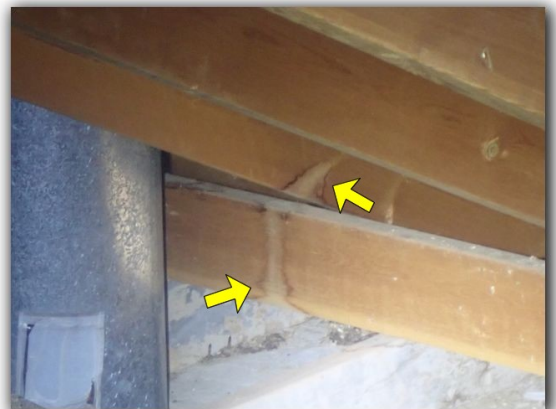
- The attic ladder was observed to be installed with improper fasteners. The attic ladder should be secured in place with 16d nails or 3-inch lag bolts. This condition should be further evaluated and corrected as necessary. Note: The fasteners in place are too short and not engaging the framing.

- **Note:** There are some minor visible water stains on the roof sheathing (decking) in one or more locations.

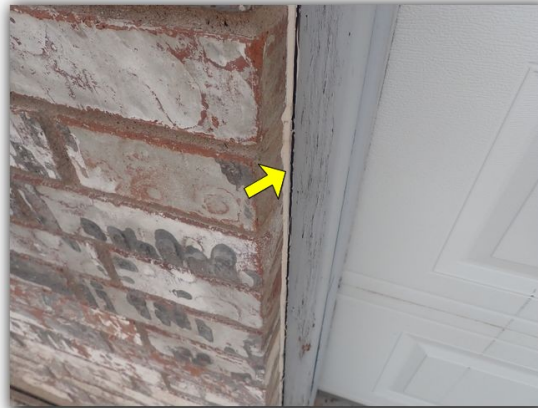
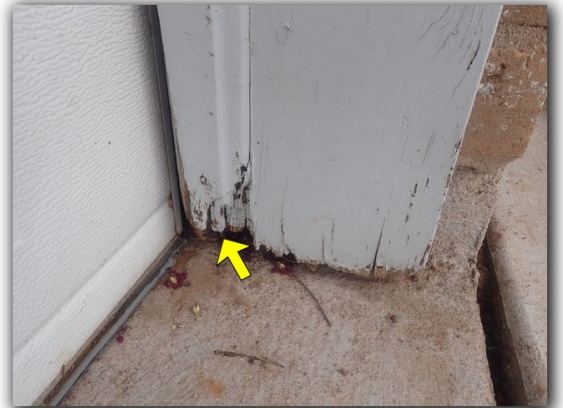
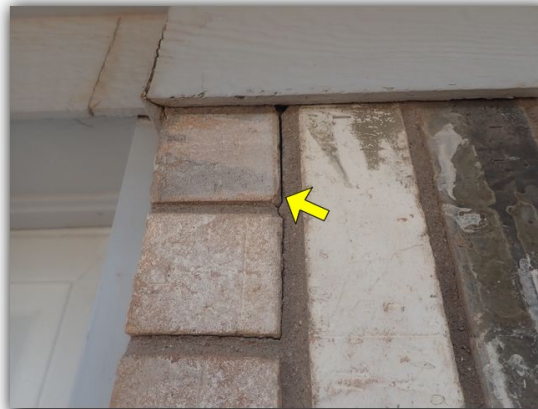
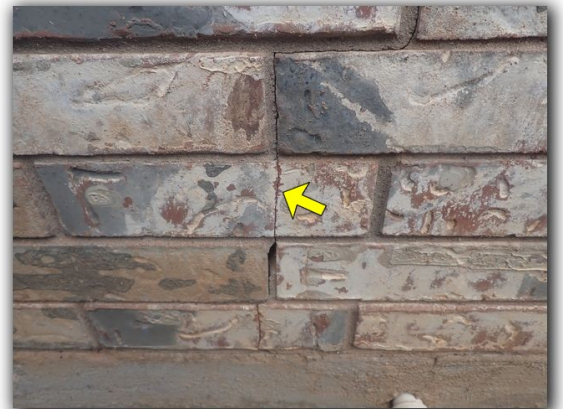
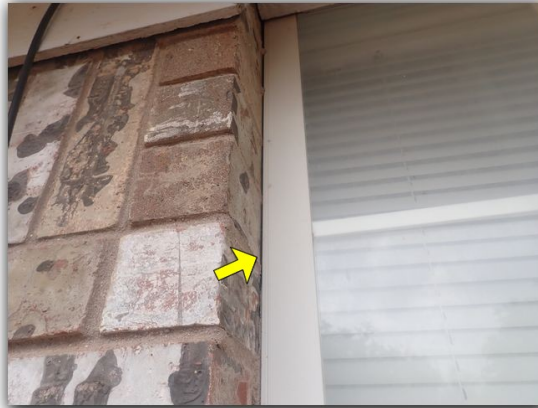
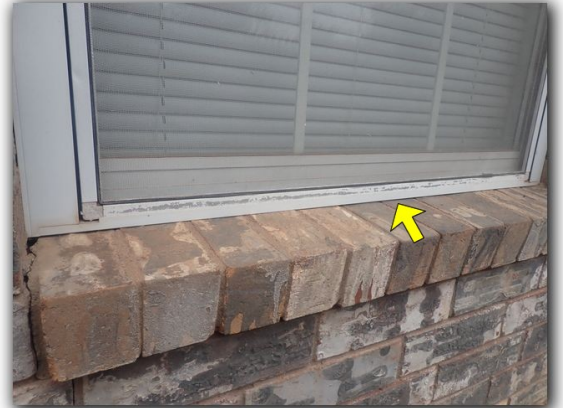
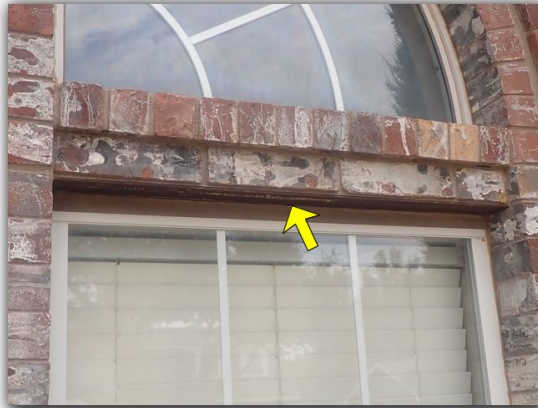
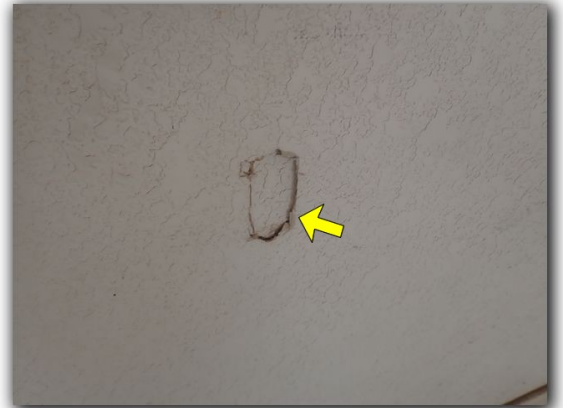
- Wall surface damage was observed in the garage, rear corner bedroom.

- Caulking improvements are recommended for the area between the exterior veneer and the garage door trim boards.
- Caulking improvements are recommended for the area between the exterior veneer and the window frames.
- The garage door trim has some deterioration and/or damage at the bottom.
- **Note:** Typical minor mortar and/or brick cracks were observed in the exterior veneer on the north, south and west sides of the structure.
- Frieze board separations were observed.
- The wood veneer has some deterioration and/or damage on the east side of the structure.
- The exterior wood window casing has some deterioration and/or damage on the east side of the structure.
- The steel lintels over the exterior doors and windows should be painted.
- Some of the exterior wood surfaces needs a fresh coat of paint.

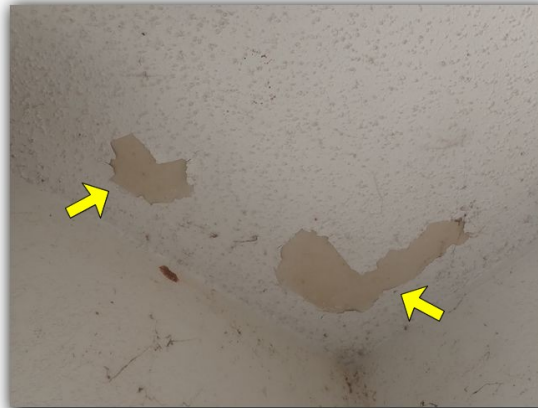
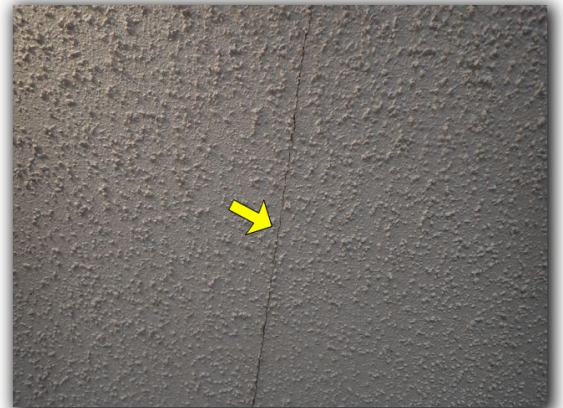
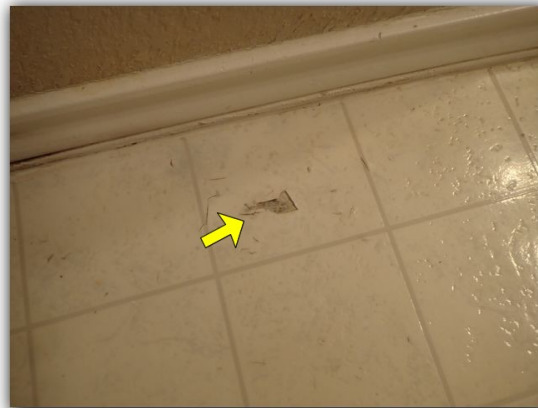
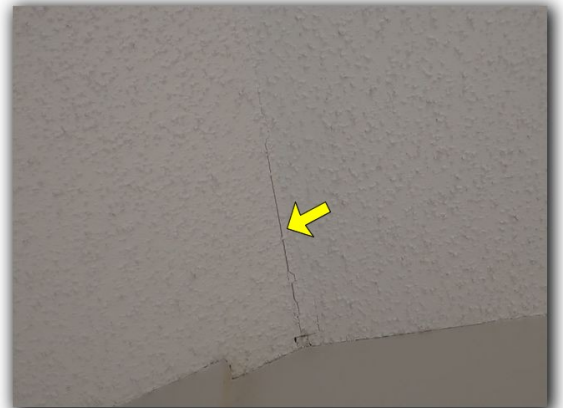
- The ceiling texture has some deterioration and/or damage in the garage.
- Typical ceiling joint cracks were observed in the various locations throughout the house.

- The floor covering is noticeably worn and/or damaged in the guest bathroom.

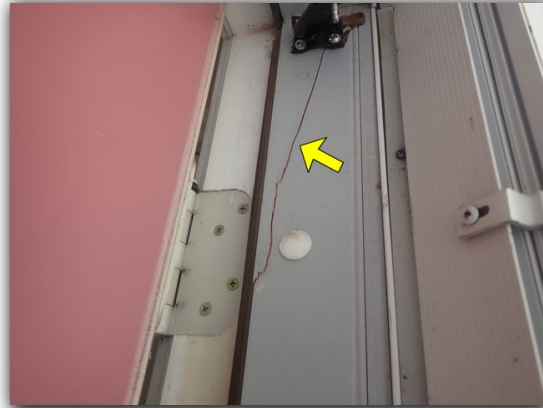
- The exterior door frame has some deterioration and/or damage to the front entry door(s).

- The garage entry door is not equipped with a self-closing device. This is an “as-built” condition per local building standards but we are required to mark it as deficient per the TREC standards of practice.

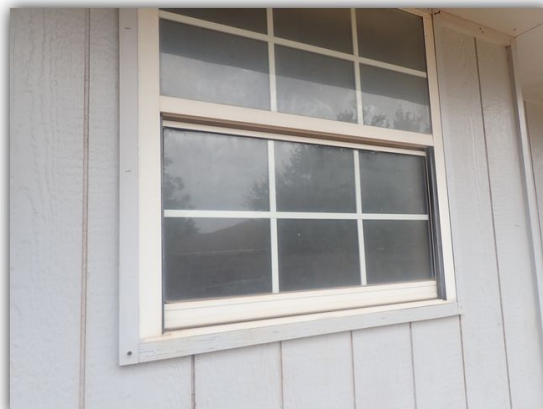
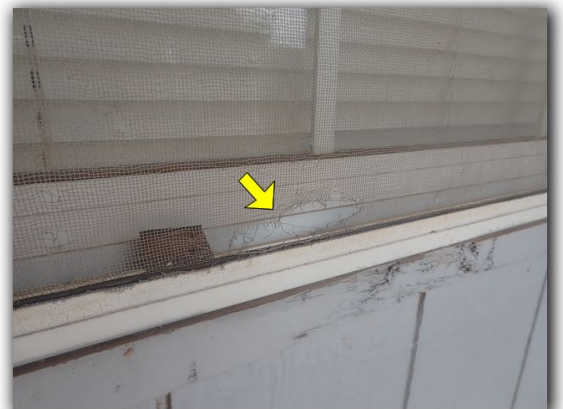
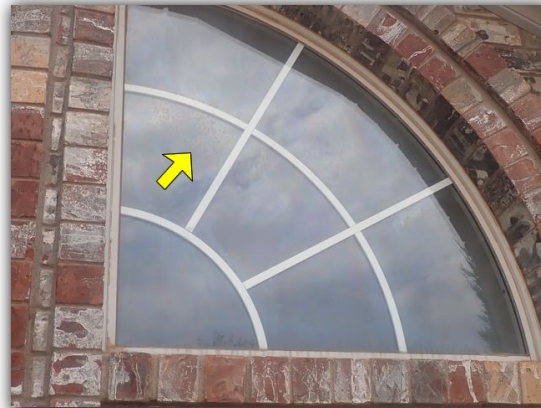
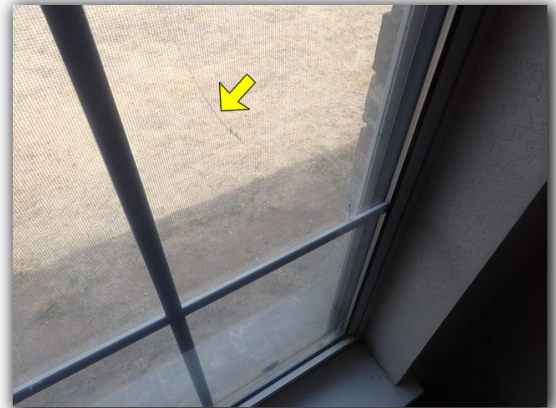
- One or more of the window screens were observed to be damaged.
- One or more of the window screens were observed to be missing.

- Cracked and/or broken window glass was observed in the rear corner bedroom.
- One or more of the thermal pane windows were observed to have lost their seals. This has resulted in condensation or a fog like film to develop between the panes of glass. The thermal pane windows no longer function as designed when they loose their seal and replacement may be necessary. The windows that have noticeably lost their seals are listed but may not be limited to the following: front corner bedroom.

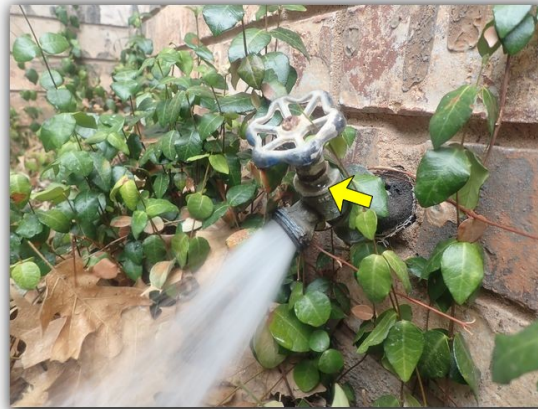
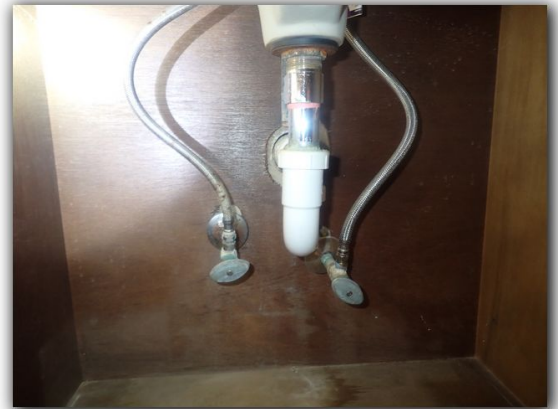
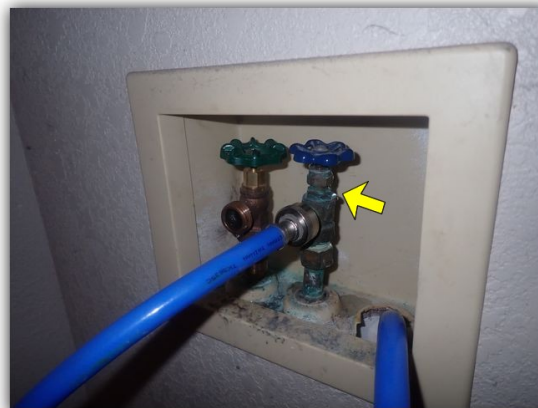
- One or more of the exterior water hose bibbs (faucet) do not have a back-flow or anti-siphon device (Vacuum Breakers) in place. **Note:** *This is not uncommon to observe with a home of this age and can easily be obtained at home improvement stores if desired.*
- The exterior water hose bibb (faucet) is leaking at the handle when operated on the west side of the structure.

- One of the laundry connection hose bibbs were observed to be leaking at the bibb handles.

- **Note:** Some corrosion was observed at one and/or both of the water supply shutoff valves.

- **Note:** Some corrosion was observed on the metal p-trap under the sink. This condition should be closely monitored and replaced when necessary.
- **Note:** Some corrosion was observed at one and/or both of the water supply shutoff valves.

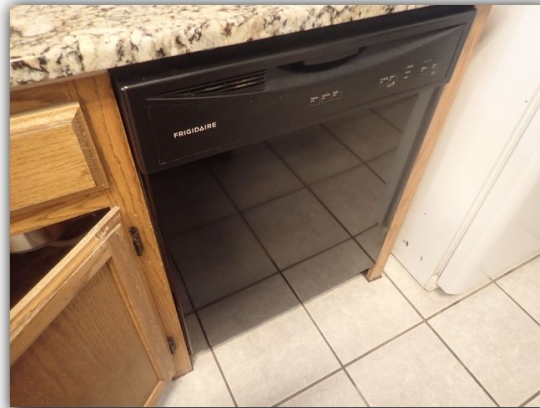
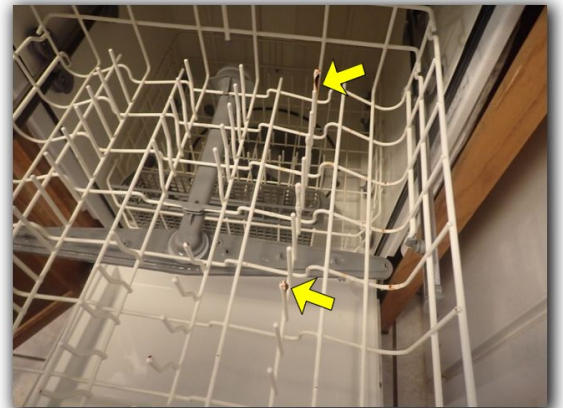
- Some rusting of the dishwasher interior components was observed.

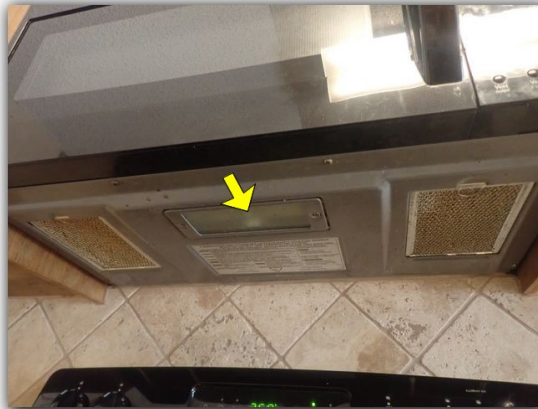
- The light at the range hood is inoperative.

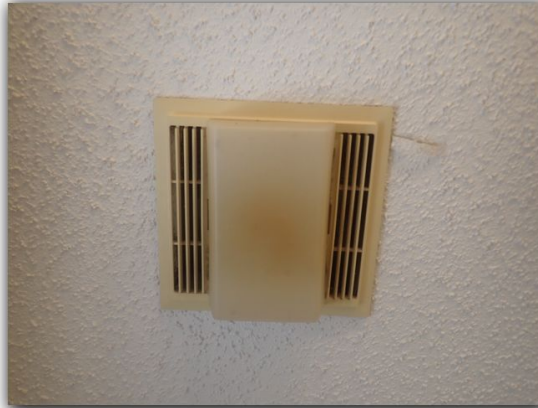
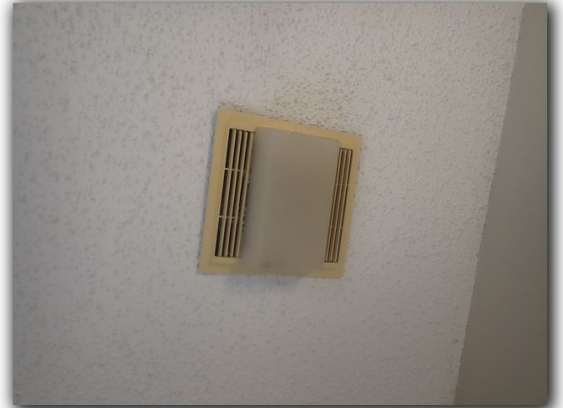
- **Note:** The bathroom exhaust vents were observed to be venting into the attic area and not to the exterior of the structure. This is an “as-built” condition per local building codes but we are required to mark it as deficient per the TREC standards of practice.

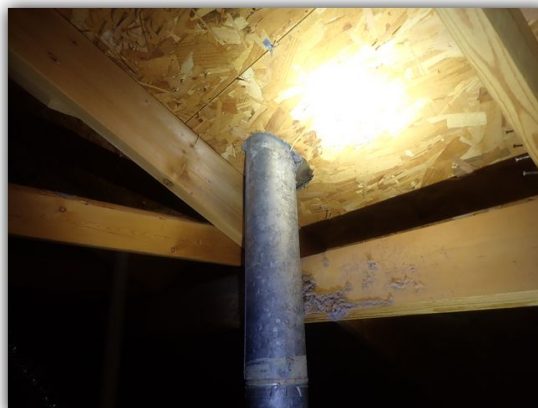
- The dryer exhaust duct (vent pipe) is dirty and needs to be cleaned.
