**Derrick & Akiko Beale
3417 Chimney Rock Rd
Abilene, TX 79606**

October 18, 2018

PROPERTY INSPECTION REPORT

By: Felipe Cruz, Lic #22478 / NAWT #13743ITC 10/18/2018
(Name and License Number of Inspector) (Date)

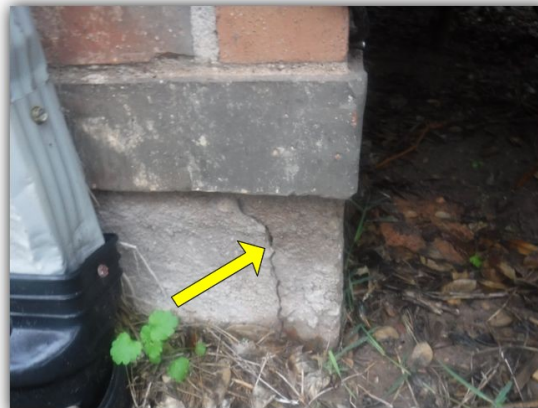
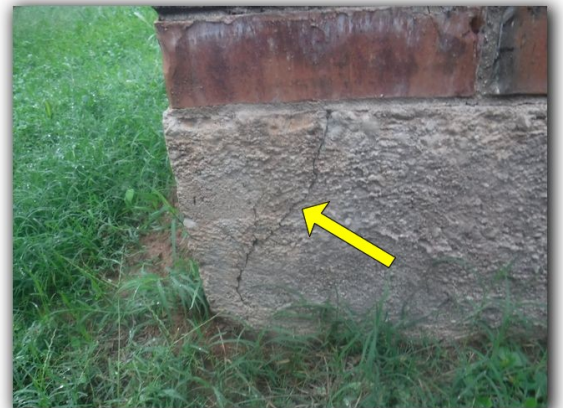
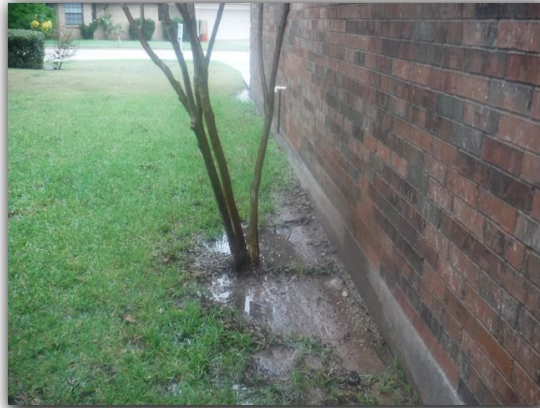
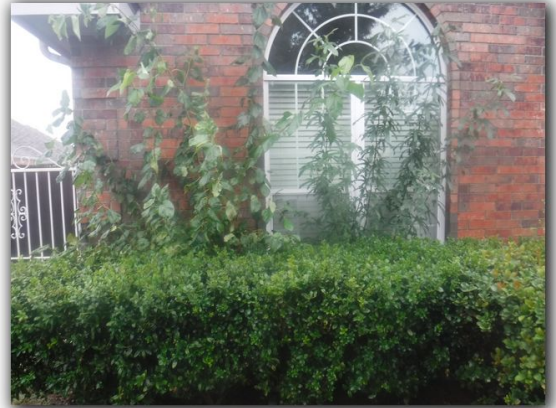
- One or more of the foundation perimeter beam corners were observed to be sheared off (corner pop). This is a common condition in slab on grade foundations. This condition does not adversely affect the performance of the foundation. However, in some cases, some cosmetic improvements may be necessary.
- **Note:** Tree(s) in close proximity of the foundation was observed. Client should consider the installation of a root barrier to reduce the possibility of damage to the foundation from tree roots and moisture removal.

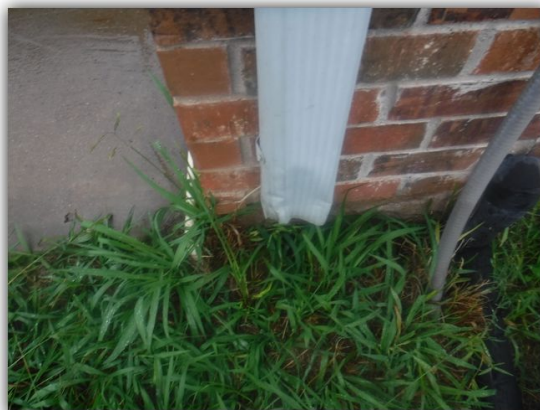
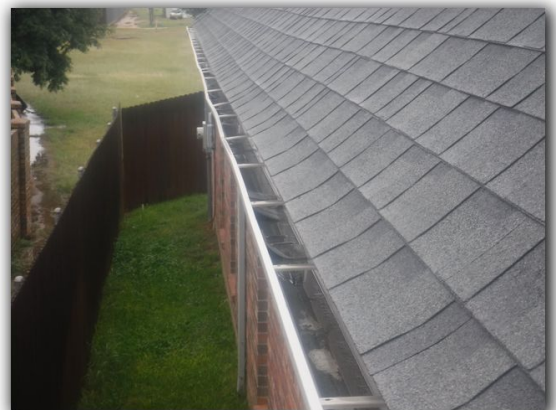
- **Note:** The gutter downspouts should discharge water at least thirty-six inches (36") away from the foundation perimeter beam. Storm water should be encouraged to flow away from the structure at the points of discharge.
- The gutters require cleaning.

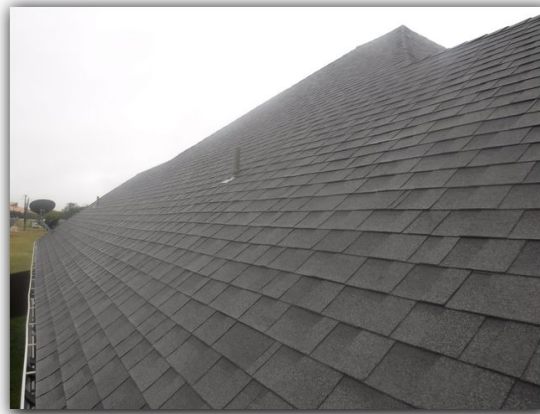
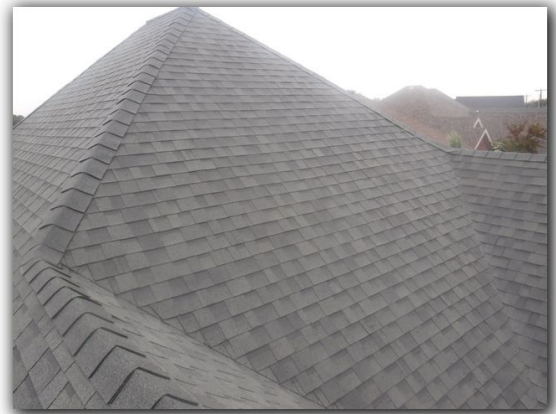
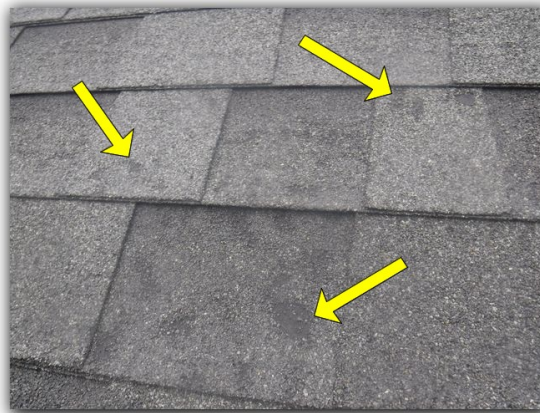
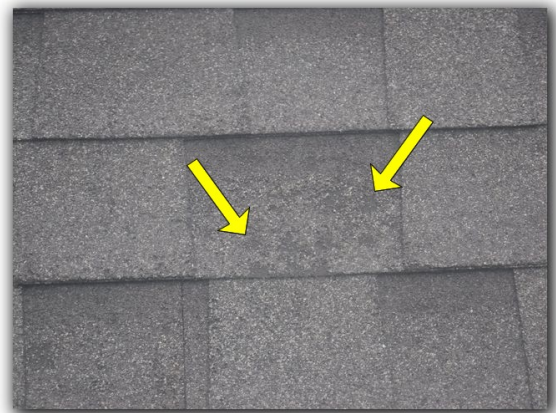
- The composition roofing material has experienced considerable granular lose in various locations throughout the roof.

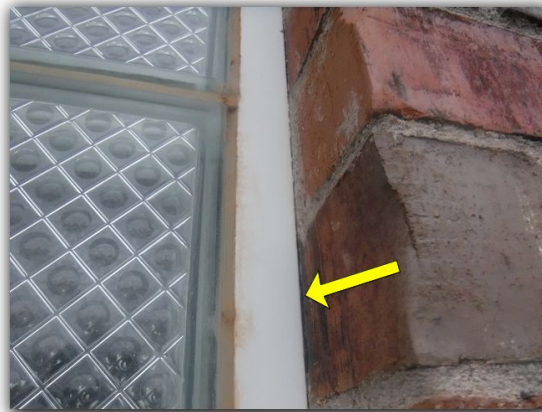
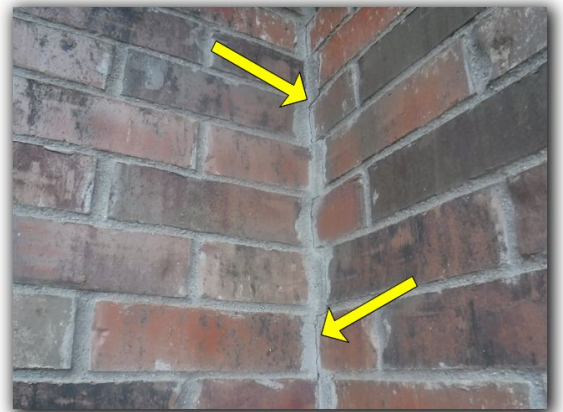
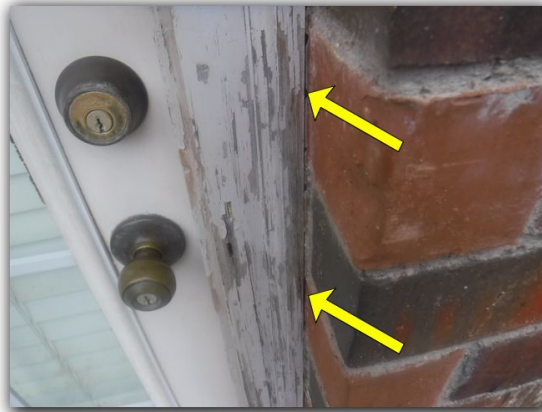
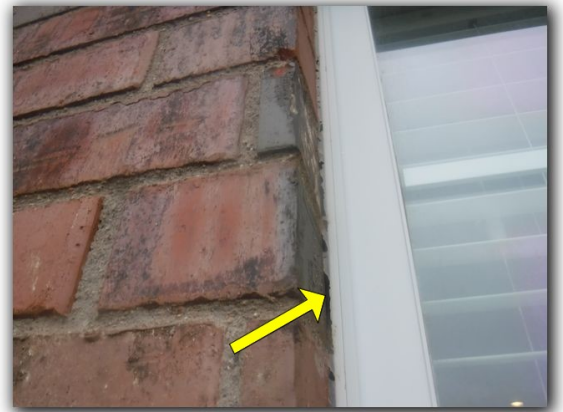
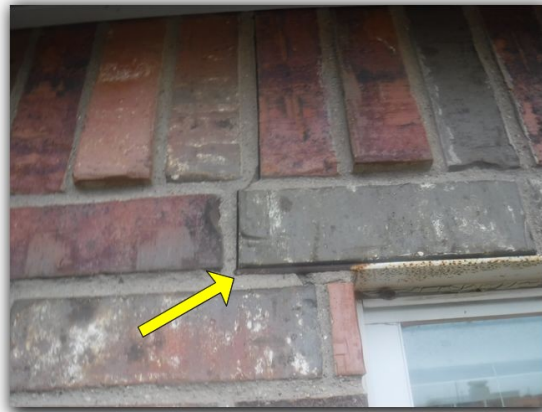
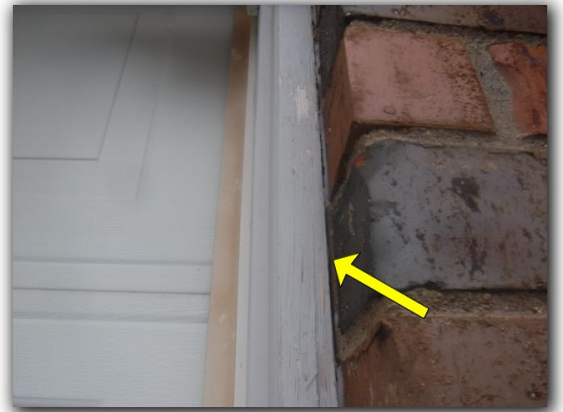
- **Note:** There is evidence of painting and patching to the interior finish and prior interior finish repairs. This condition could limit the Inspectors visual observations and ability to render accurate opinions as to the performance of the structure.
- Interior wall stress cracks were observed in the various locations throughout the house.
- Recommend sealant material improvements for the area between the interior walls and window frames.

- Caulking improvements are recommended for the area between the exterior veneer and the exterior door frames, window frames and garage door trim boards.
- Mortar improvements are recommended for the exterior masonry veneer on the south side of the structure.
- Exterior wall trim was observed to be pulling away in the north side of the structure.
- Some of the exterior wood trim surfaces needs a fresh coat of paint.

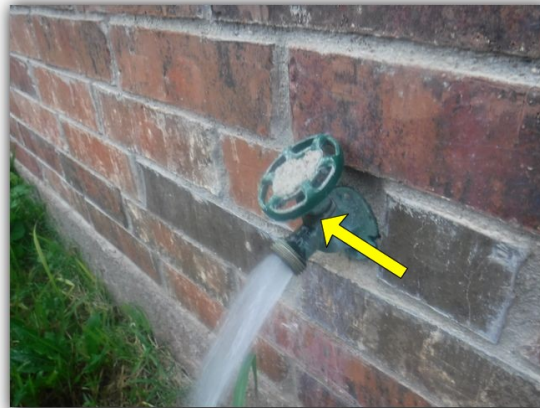
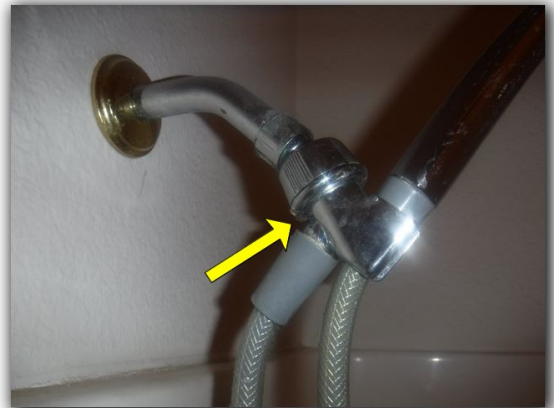
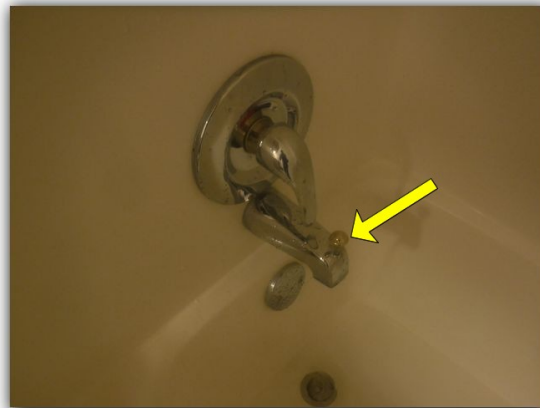
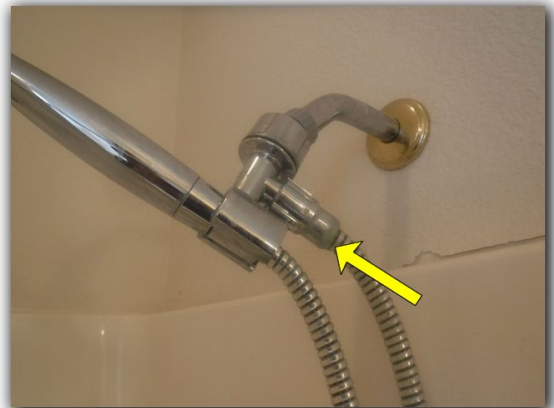
- One or more of the exterior water hose bibbs (faucet) do not have a back-flow or anti-siphon device (Vacuum Breakers) in place. **Note:** *This is not uncommon to observe with a home of this age and can easily be obtained at home improvement stores if desired.*
- The exterior water hose bibb (faucet) is leaking at the handle when operated on the south side of the structure.

- The shower spout is leaking at the neck connection.
- The bathtub shower head diverter is not functioning properly.

- The shower spout is leaking at the neck connection.

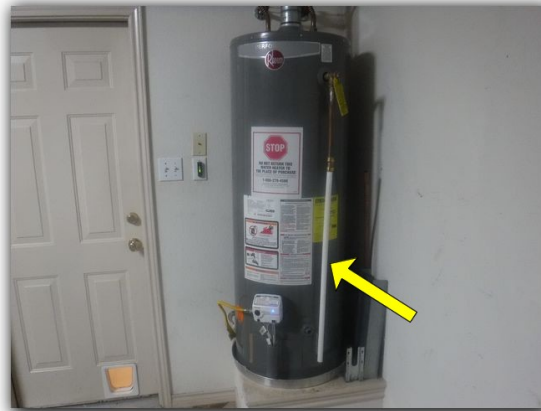
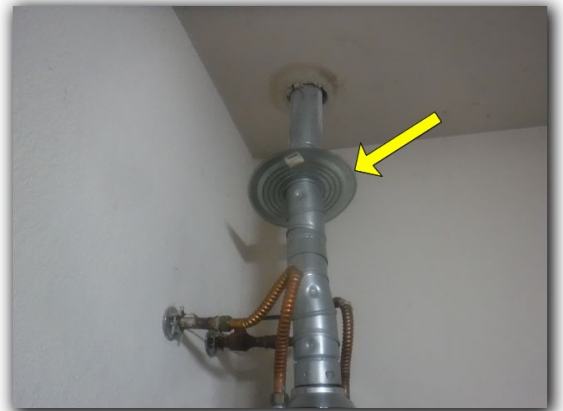
- The plastic tubing / piping being used for the temperature and pressure relief (TPR) valve discharge pipe is not listed nor labeled for this type of use.
- The temperature and pressure relief discharge pipe is terminating into the water heater drain pan. Under current building standards, this discharge pipe should run downward to the exterior of the structure, turn downward, and terminate within 6-inches of the ground.
- The water heater flue collar is loose.

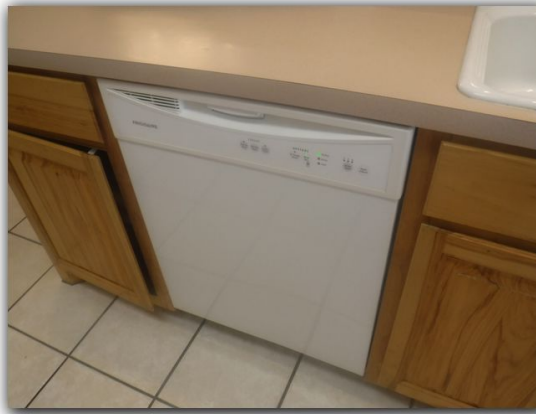
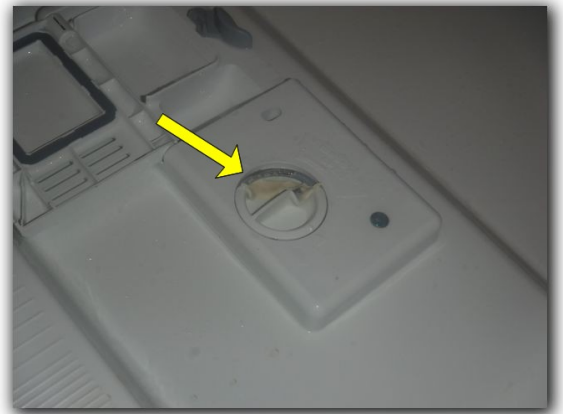
- The dishwasher soap dispenser component was observed to be damaged.

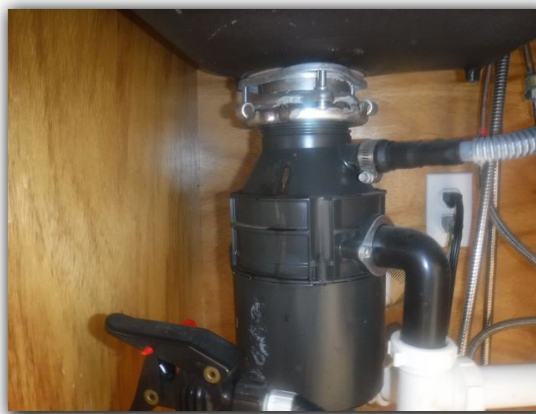
- **Note:** Rust was observed at the food waste disposal.

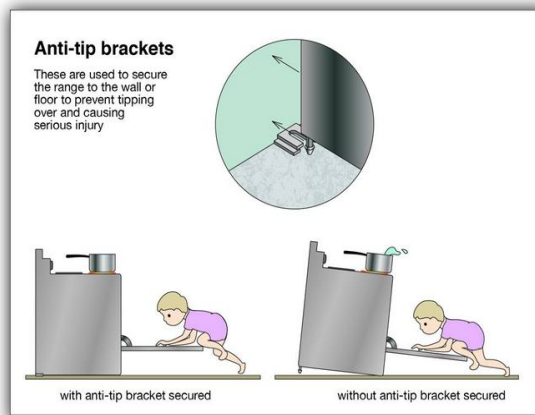
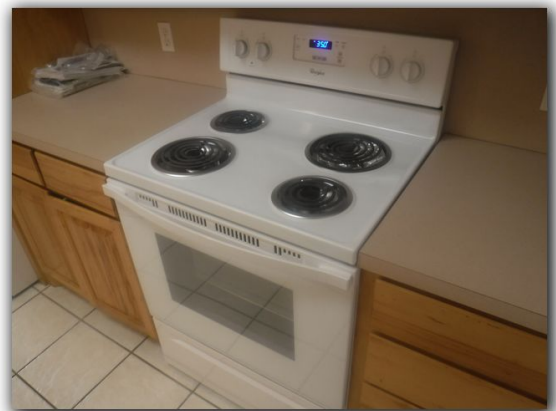
- The range can be easily tipped over and should be equipped with an anti-tip device, for safety.

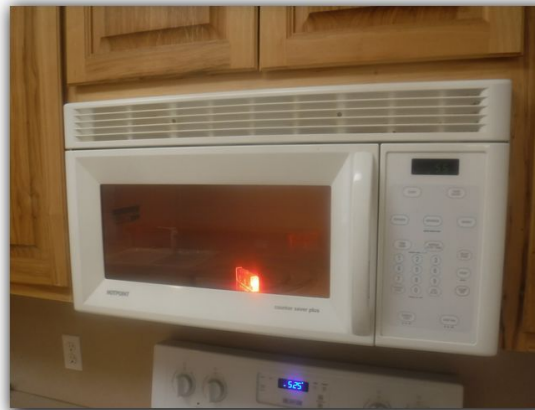
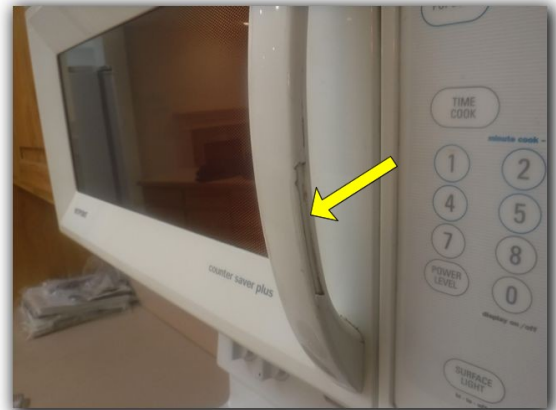
- The microwave oven exterior handle was observed to be damaged.
- The microwave oven turn table does not appear to be functioning properly.

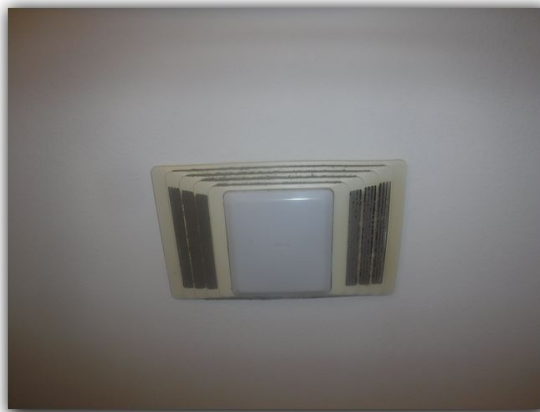
- One or more of the light bulbs were observed to be inoperative in the hall bathroom.
- **Note:** The bathroom exhaust vents were observed to be venting into the attic area and not to the exterior of the structure. This is an “as-built” condition per local building codes but we are required to mark it as deficient per the TREC standards of practice.
- **Note:** Recommend cleaning the mechanical exhaust vent to improve the air flow.

- The bathroom heater is inoperative in the hall bathroom.

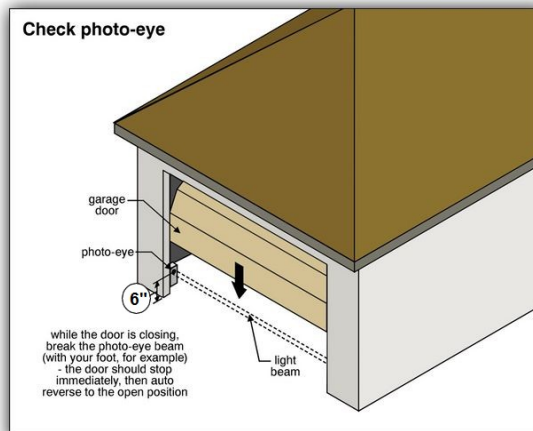
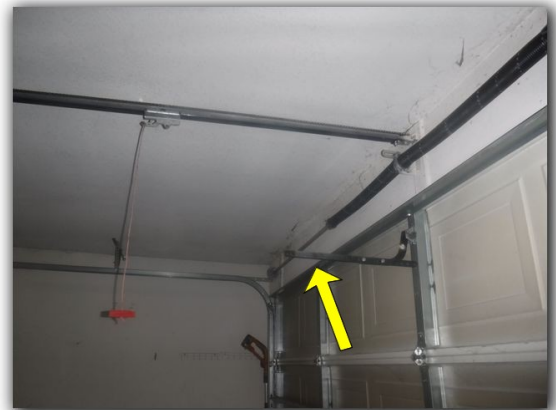
- The opener arm is loose at the door connection and needs to be re-secured.
- The garage door reverse sensors are not properly installed. The garage door reverse sensors should be installed within 6-inches of the garage floor.

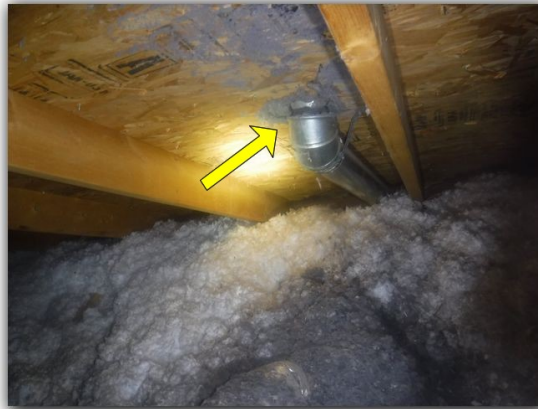
- The dryer exhaust duct (vent pipe) is dirty and needs to be cleaned.
- The dryer duct termination is not properly sealed on the attic side of the roof structure penetration and is allowing dryer lint to fall back into the attic area.

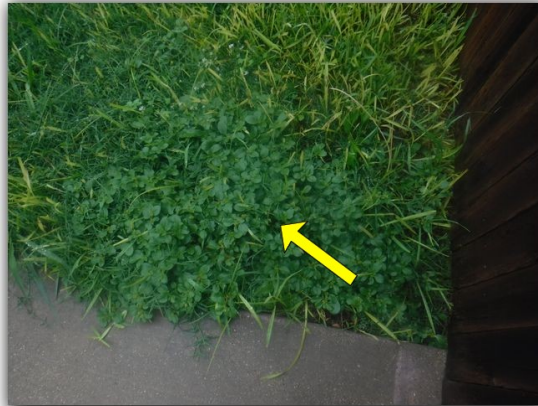
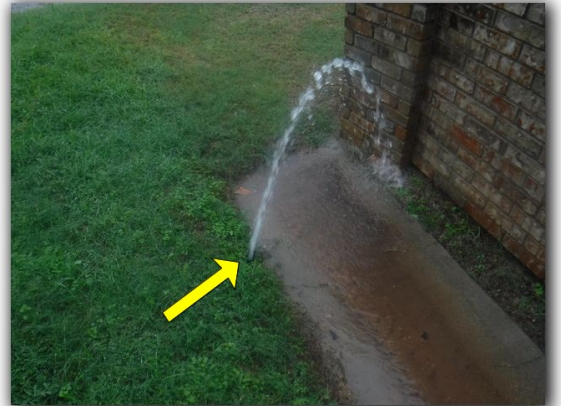
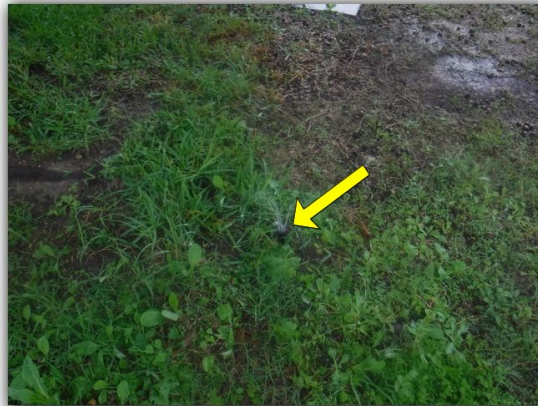
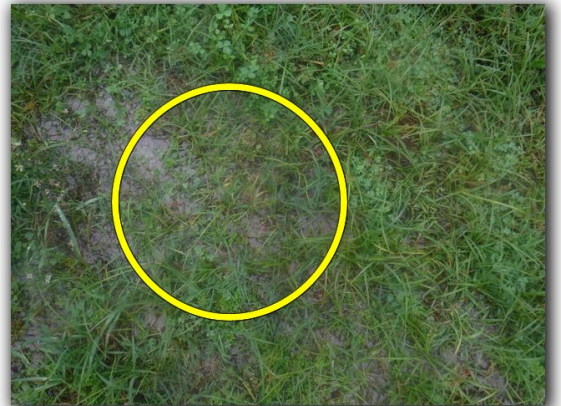
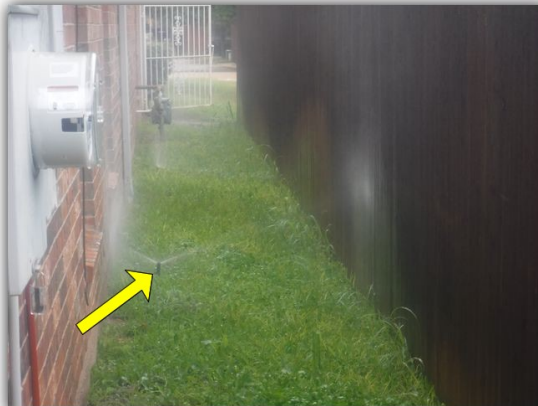
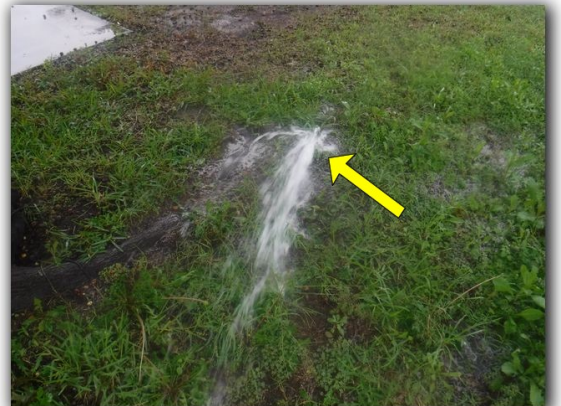
- I was unable to locate a moisture (rain / freeze) sensor device for the sprinkler system. This is an “*as-built*” condition, but Per TREC standards of practice we are required to report this condition as a deficiency.
- One or more of the sprinkler heads need to be adjusted so not to spray water onto the exterior walls, surfaces or windows in stations; **2.**
- One or more of the sprinkler heads do not pop-up high enough to disperse water properly in station(s); **1.**
- One or more of the sprinkler heads do not disperse water properly in stations(s); **1.**
- One or more of the sprinkler heads were observed to be damaged and/or missing in station(s); **1, 3.**
- The drip irrigation line below the grass appears to be damaged in station(s); **1.**
