PROPERTY INSPECTION REPORT

Concerning: 816 E 6th St, Baird, TX 79504
(Address or Other Identification of Inspected Property)

By: River Dillard, Lic #22970 02/26/2018
(Name and License Number of Inspector) (Date)

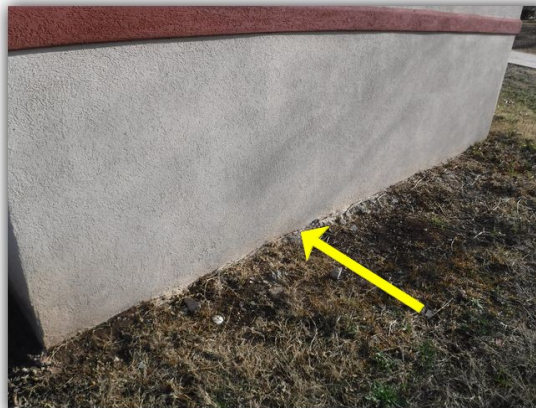
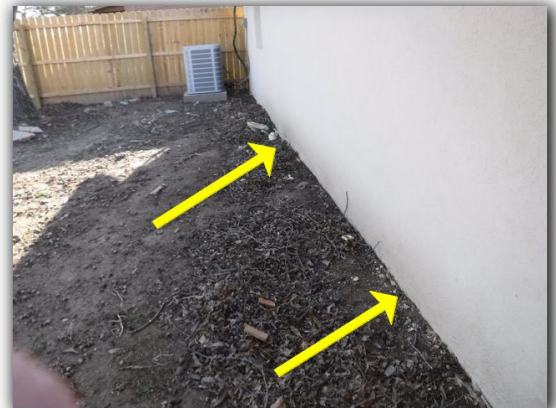
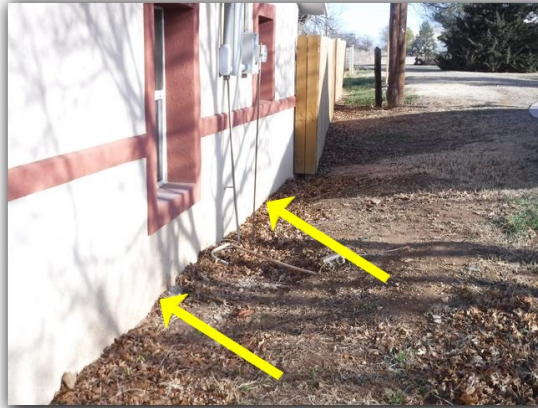
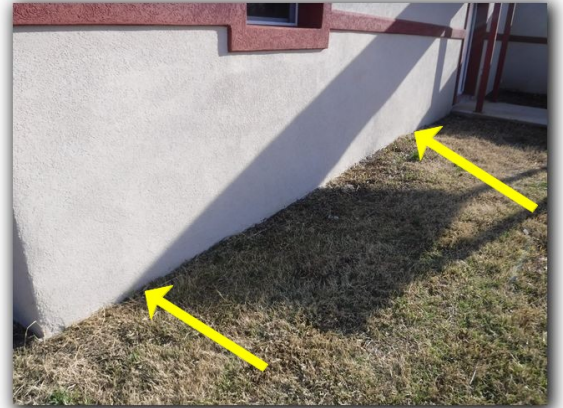
- Poor to negative site drainage was observed on the north and east sides of the structure. Proper drainage is needed to help prevent water from standing and/or ponding next to the foundation beam. Corrective measures may be needed if the water stands within 10-feet of the foundation perimeter beam for more than 24-hours.
- The soil line is too high on the north, east, west and south sides of the structure. Under current building standards there should be at least 4-inches of foundation visible below masonry veneer and 6-inches of foundation visible below wood type veneer.

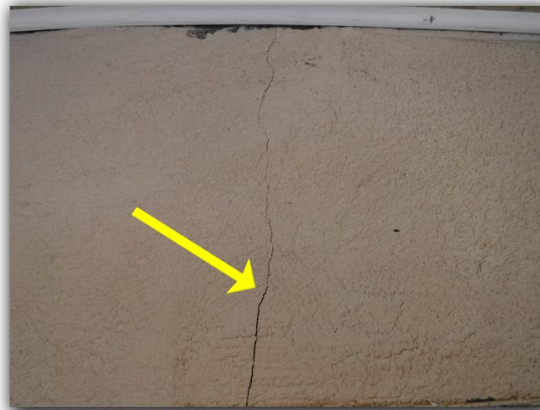
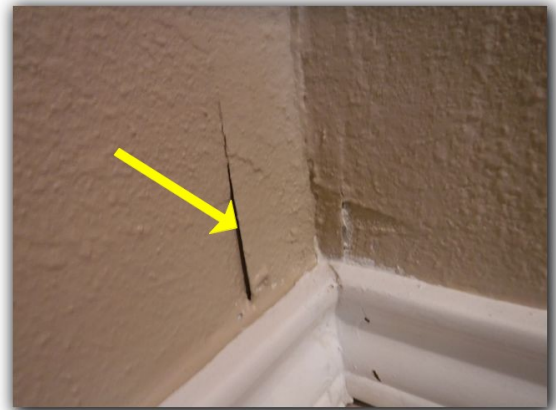
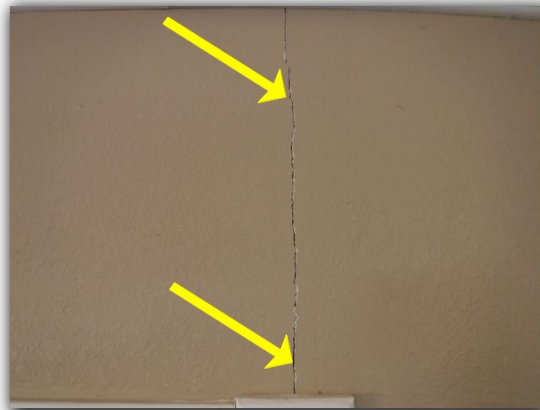
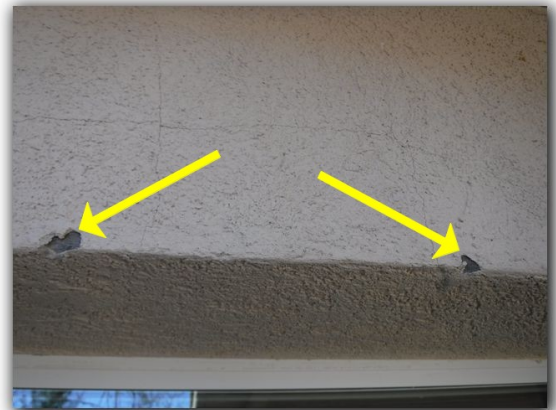
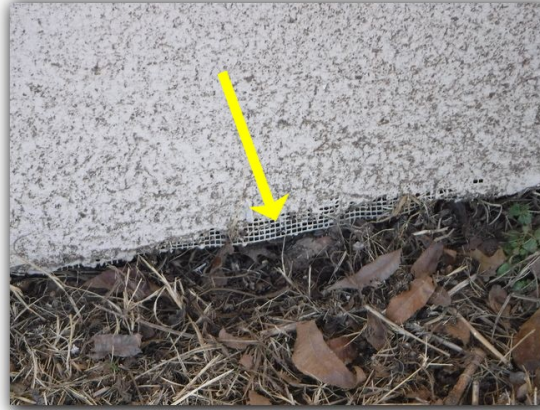
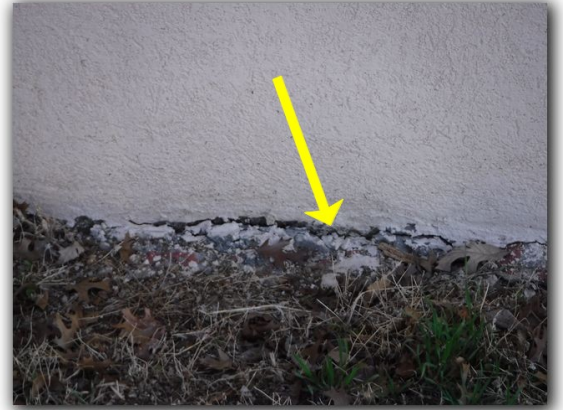
- The exterior stucco type veneer/cladding has inadequate clearance from the finished grade (ground). Most manufacturers require a minimum of 4- to 6-inches of clearance from the finished grade (ground).
- Cracking of the stucco type veneer/cladding was observed on the north side of the structure. This condition should be further evaluated and corrected as necessary.
- Some deterioration and/or damage to the stucco type veneer/cladding was observed on the west side of the structure.

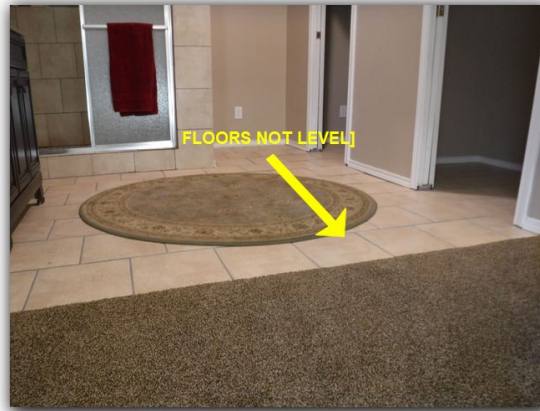
- **Note:** The floors were observed to be out-of-level in some areas of the house.

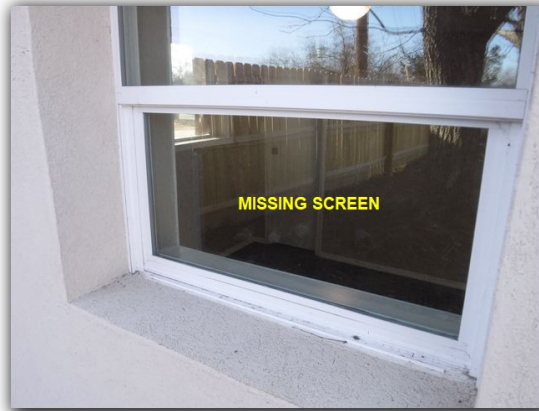
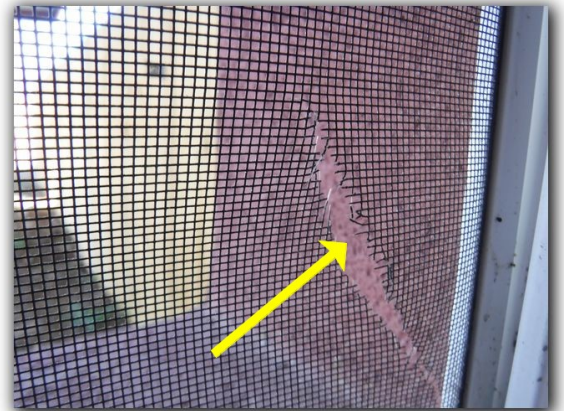
- One or more of the window screens were observed to be damaged.
- One or more of the window screens were observed to be missing.

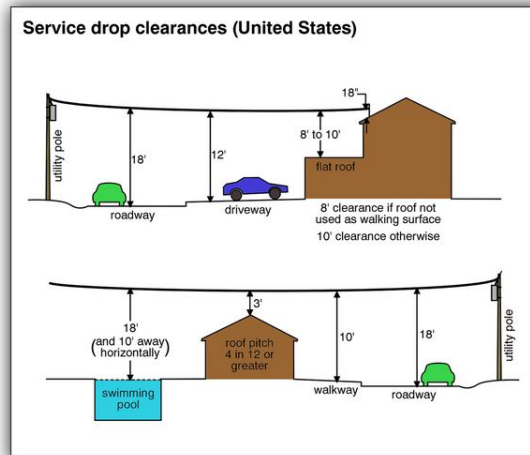
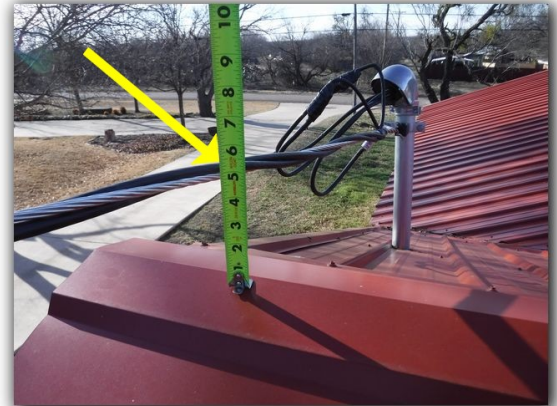
- The electrical service wires hang to low over the roof structure. The electrical service wires from the service pole to the structure should clear all roof structure components by a minimum of 3-feet.

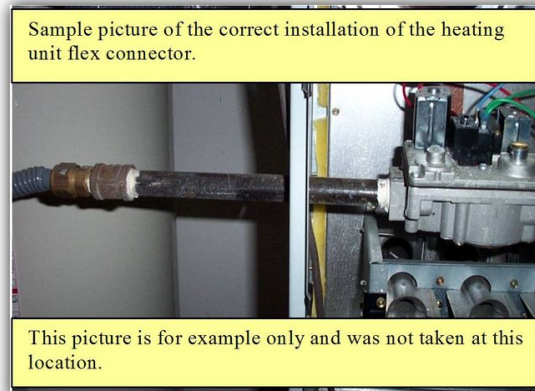
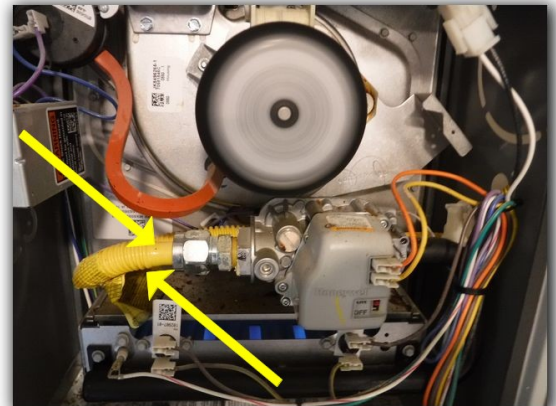
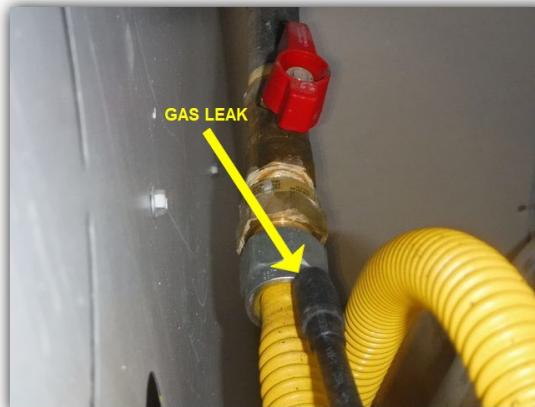
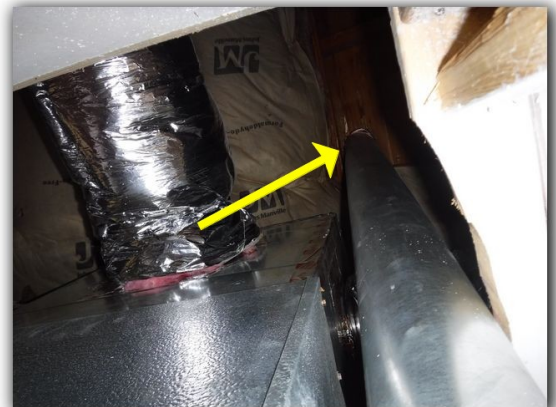
- The gas supply flex connector was observed to be passing through the heating unit cabinet. Under current mechanical installation standards, this is no longer an accepted practice. Only rigid black gas pipe is allowed to pass through the heating unit cabinet.
- The heating unit flue (vent pipe) has inadequate clearance from combustible materials. Double walled vent pipes should have at least 1-inch of clearance and single walled vent pipes should have at least 6-inches of clearance from combustible material.
- There was a gas leak detected at or around the gas flex connector. The inspector used a gas leak detector to locate the leak.

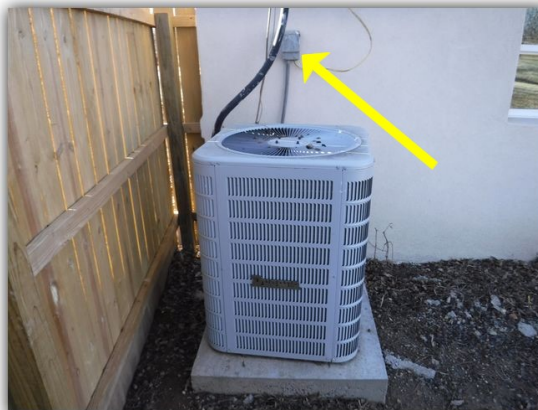
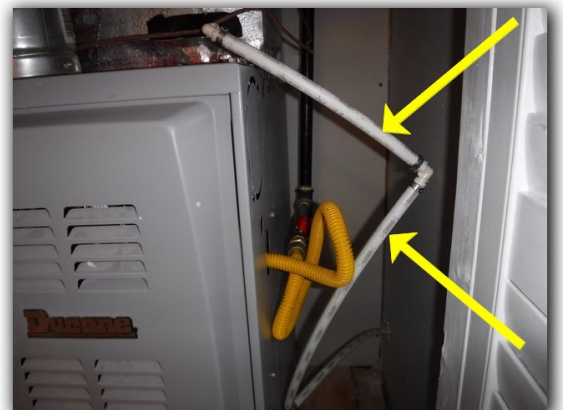
- The electrical service disconnect is installed behind the outside condenser/coil. This does not meet the clearance requirements of the National Electrical Code or the International Residential Code and should be corrected as necessary.
- Improper material is being used for the condensate drain line at this time. The condensate drain line should be made of an approved material (i.e. PVC or Ridged Insulated Copper) and be a minimum of 3/4 inch in diameter.
- **Note:** The primary condensate drain line is terminated next to the exterior foundation perimeter beam. It is recommended that the drain line terminate further away from the foundation beam or to an approved waste system.

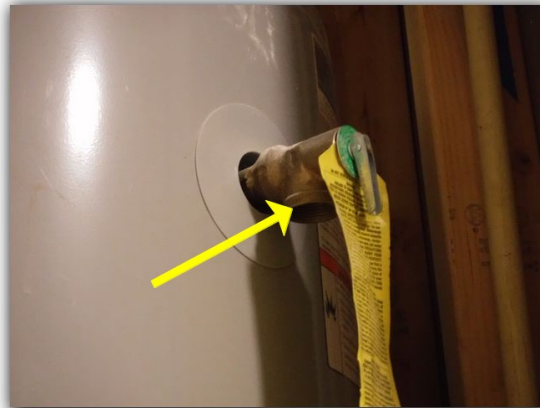
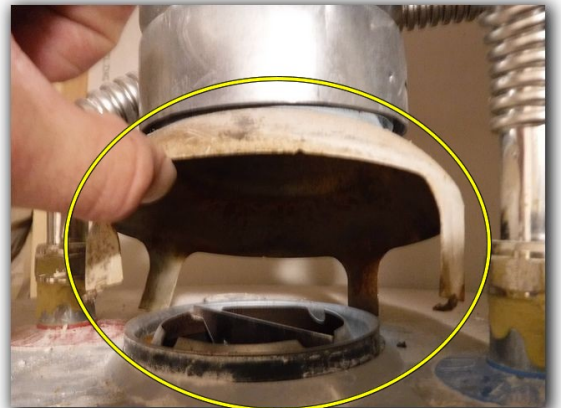
- The vent pipe is not properly mounted at the top of the water heater. This configuration will emit Carbon Monoxide into the heater compartment, which is a known safety hazard.

- The water heater vent pipe is separated in the closet. This configuration will emit Carbon Monoxide into the closet area, which is a known safety hazard.

- There is no temperature and pressure relief valve (TPR) discharge pipe in place at the time of this inspection. For safety reasons, it is recommended that a TPR valve discharge pipe be installed. Under current building standards, the discharge pipe should run downward to the exterior of the structure, turn downward, and terminate within 6-inches of the ground.

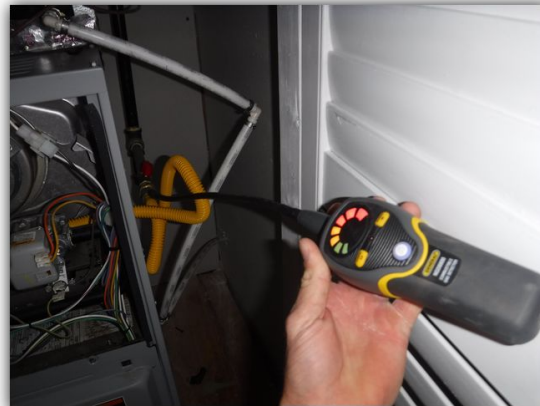
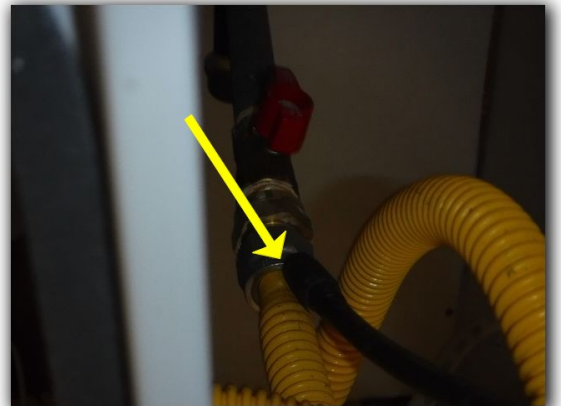
Movement was detected in the gas gauge at the time of the gas check. This indicates a gas leak is present and needs to be investigated and repaired as necessary by a Qualified Licensed Plumber. The observation made to support the rendering of this opinion are listed but not limited to the following:

- There was a gas leak detected at the heating (HVAC) equipment. The inspector used a gas leak detector to locate the leak. This condition needs to be corrected for reason of safety.

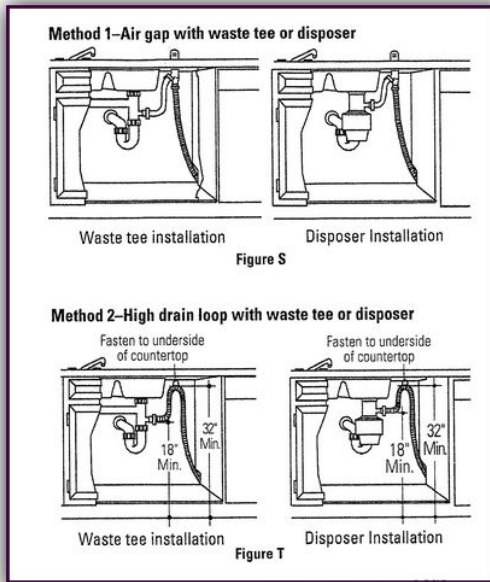
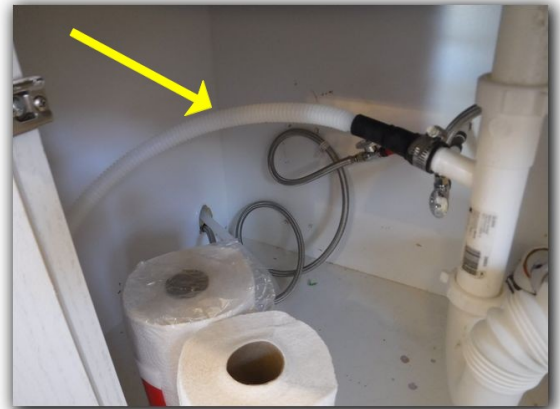
- The dishwasher drain hose is not properly installed to prevent back flow or anti-siphoning. It is recommended that an air gap device or high drain loop be installed in the drain line which can usually be accomplished without any expense as in Method-2 below.
