PROPERTY INSPECTION REPORT

Concerning: 13 Mission Hills, Abilene, TX 79606
(Address or Other Identification of Inspected Property)

By: Felipe Cruz, Lic #22478 / NAWT #13743ITC 03/12/2018
(Name and License Number of Inspector) (Date)

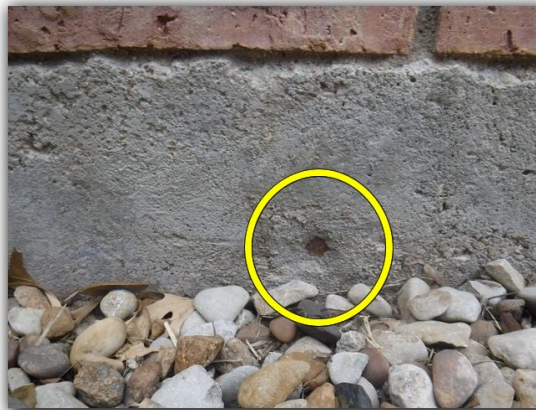
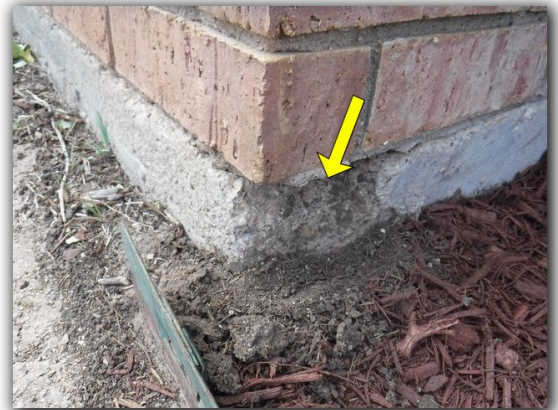
- One or more of the foundation perimeter beam corners were observed to be sheared off (corner pop). This is a common condition in slab on grade foundations. This condition does not adversely affect the performance of the foundation. However, in some cases, some cosmetic improvements may be necessary.
- The foundation rebar is visible at the edge of the foundation beam and needs to be properly covered on the east side of the structure.

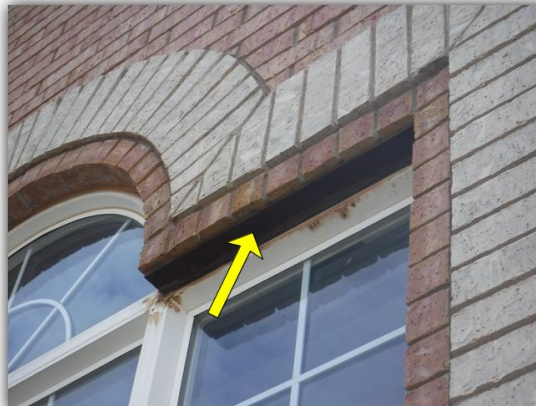
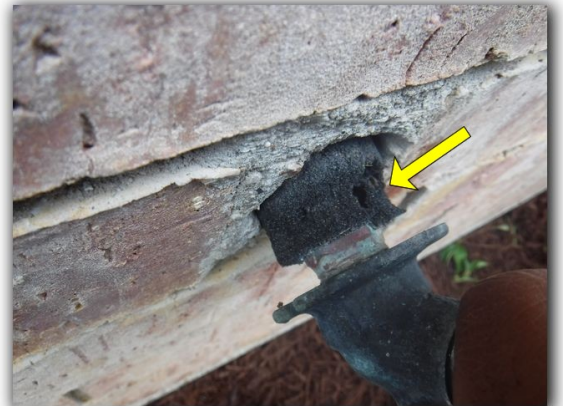
- The area between the exterior veneer and the exterior water hose bibbs (faucets) need to be properly sealed.
- **Note:** Typical minor mortar and/or brick cracks were observed in the exterior veneer on the east side of the structure.
- The steel lintels over the exterior doors and windows should be painted.

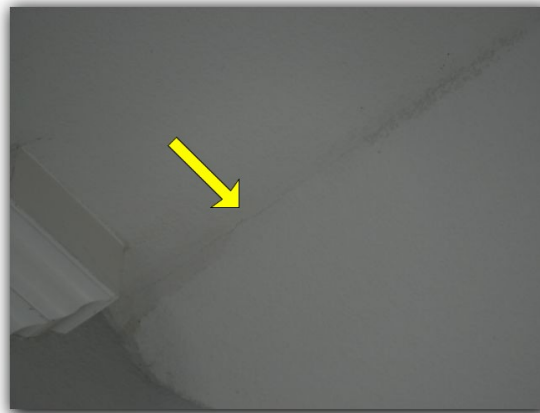
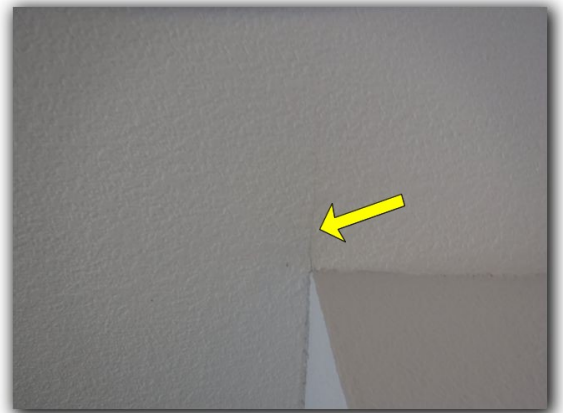
- Typical ceiling joint cracks were observed in the living room.

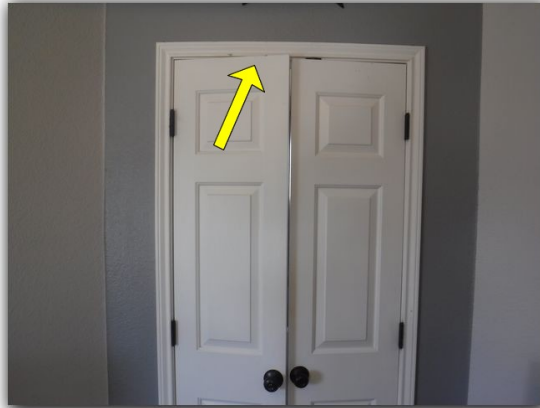
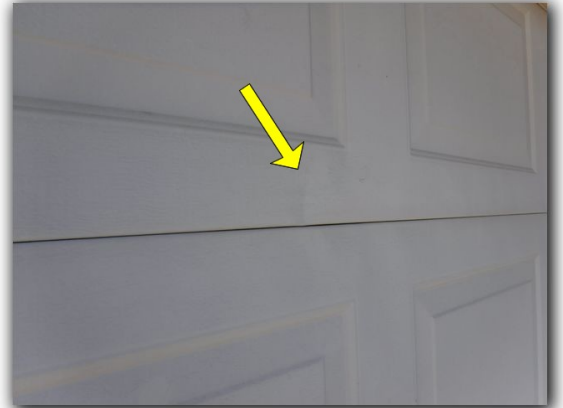
- The door(s) are not latching properly and/or sticking in master bathroom. Recommend minor adjustments to the hinges and/or striker plates.

- Minor damage was observed at the overhead garage doors.

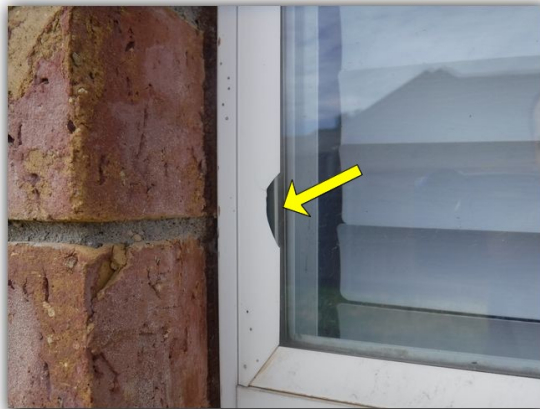
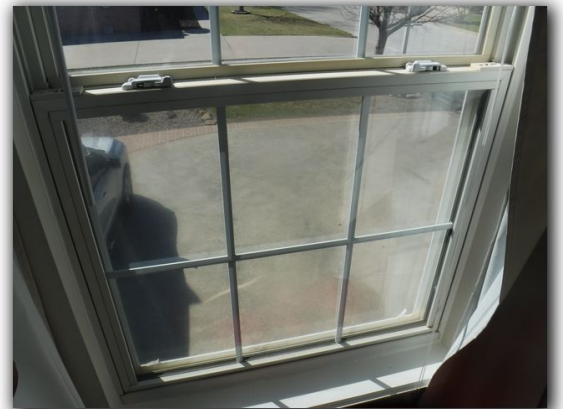
- The window glass plastic sealing strip damaged and/or missing at one or more of the windows and improvements are recommended.
- The window guide was observed to be damaged and the window will not stay in the open position in the upstairs front middle bedroom.

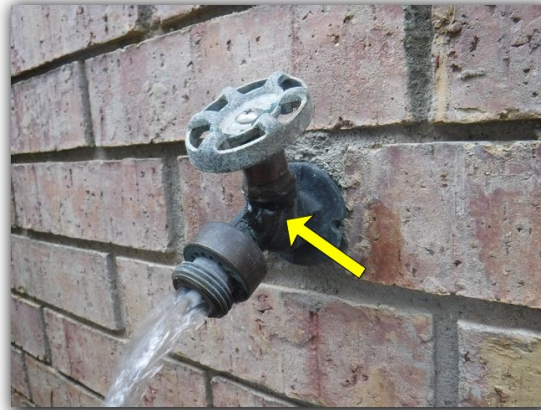
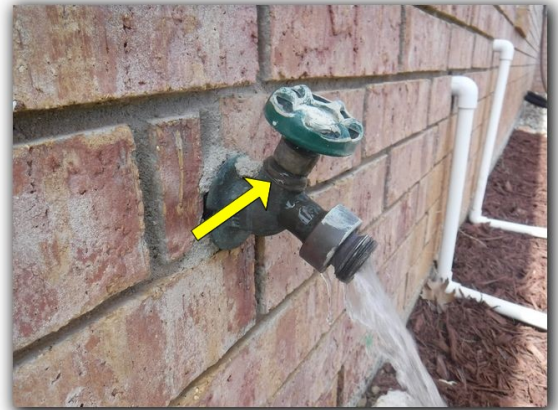
- The exterior water hose bibb (faucet) is leaking at the handle when operated on the east and south sides of the structure.

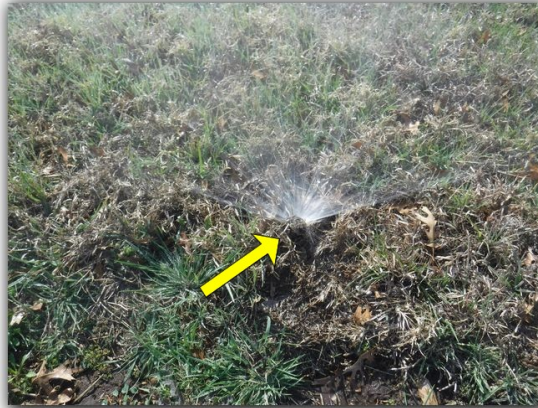
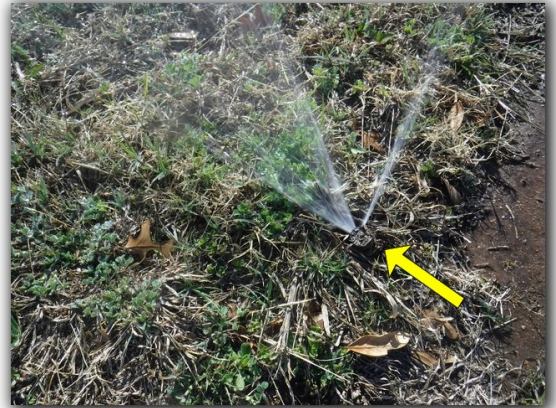
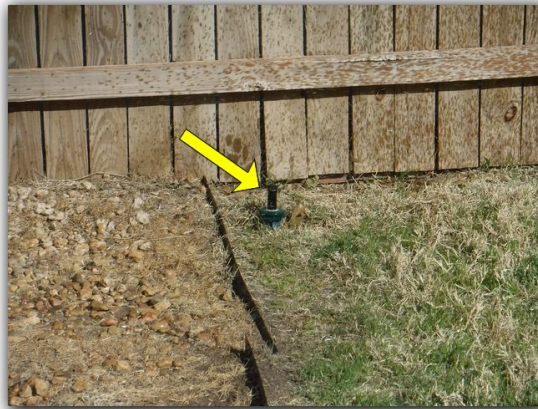
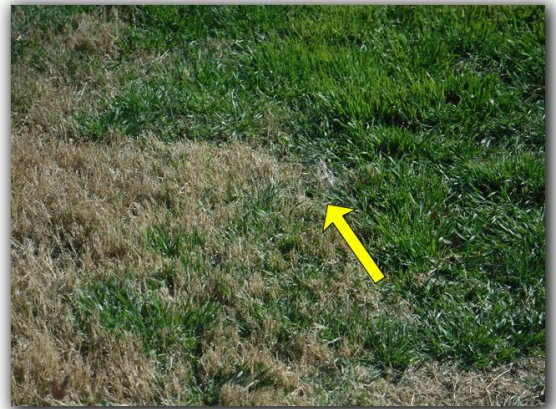
- **Additional Observations and/or Comments:**
- I was unable to locate a moisture (rain / freeze) sensor device for the sprinkler system. This is an “*as-built*” condition, but *Per TREC standards of practice we are required to report this condition as a deficiency.*

- I was unable to locate an anti-siphon device or back-flow prevention device for the sprinkler water supply. An anti-siphon or back-flow prevention device is needed to help protect the systems water source from contamination. The homeowner should be consulted on the location of this device. If there is no anti-siphon or back-flow prevention device in place, one should be installed.

- One or more of the sprinkler heads do not pop-up high enough to disperse water properly in station(s); **2, 5.**
- One or more of the sprinkler heads do not disperse water in stations(s); **5.**

- Sprinkler station(s) **3, 8, 10, 11** did not respond when tested in the manual setting. The cause and remedy should be further evaluated and corrected as necessary.
