**Rob Baker**  
**133 S View Trail**  
**Abilene, TX 79602**

**October 6, 2020**

## PROPERTY INSPECTION REPORT

**By:** Felipe Cruz, Lic #22478 / NAWT #13743ITC 10/06/2020  
(Name and License Number of Inspector) (Date)

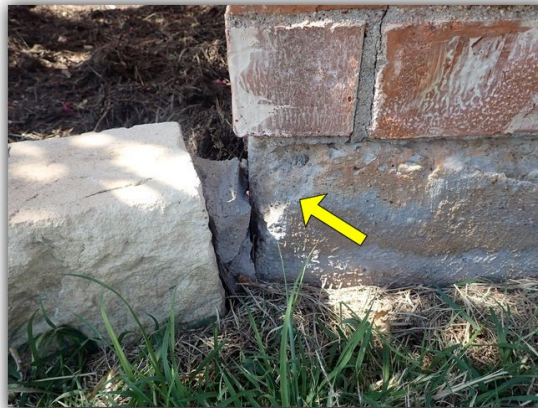
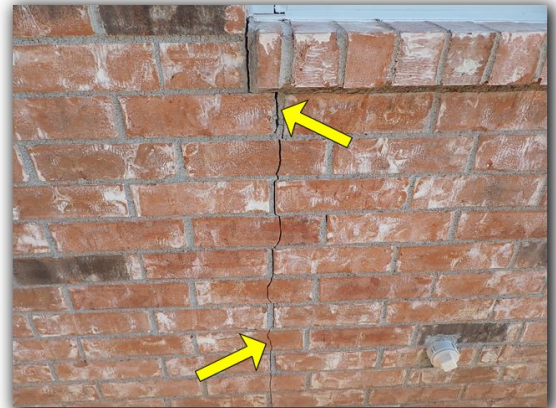
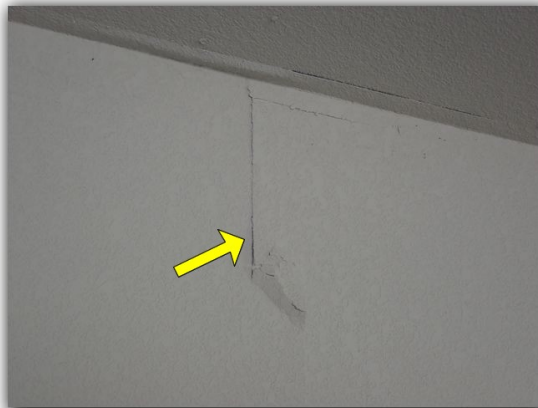
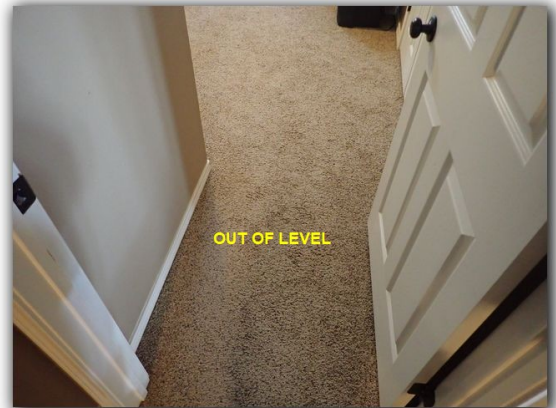
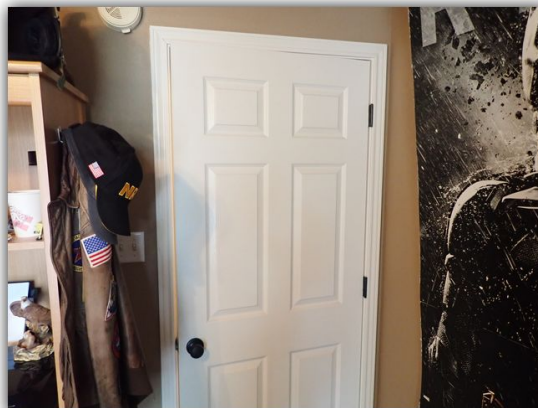
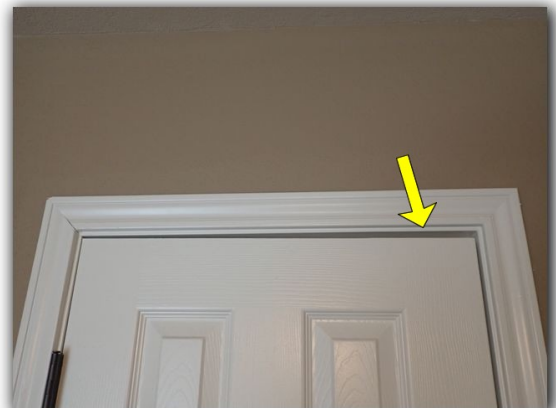
- Misalignment of interior doors due to foundation movement.
- Interior door(s) stick and/or not closing due to foundation movement.
- Floor slopes and/or unlevelness were observed.

- Interior sheet rock cracks and/or stress indicators.
- Deflection cracks were observed in the exterior veneer.

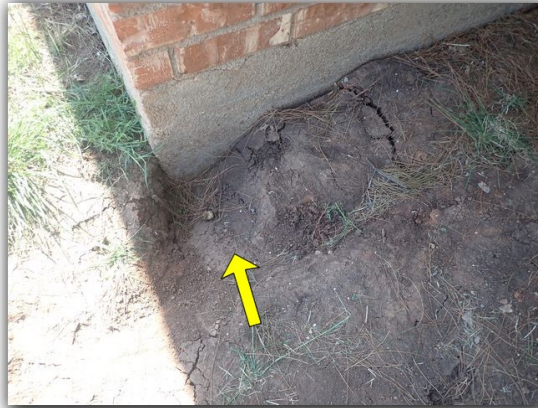
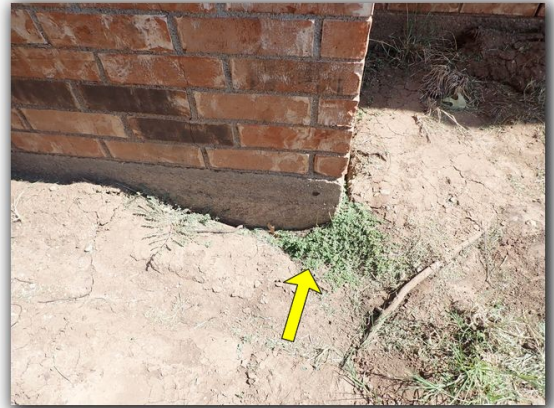
- Fill dirt is needed around the structure. The low spots in the finished grade (ground) adjacent to the foundation perimeter wall need to be filled in to help prevent water from standing and/or ponding next to the foundation area.
- **Note:** No gutters have been installed on this property. Gutters are recommended for proper water drainage away from the structure's foundation.

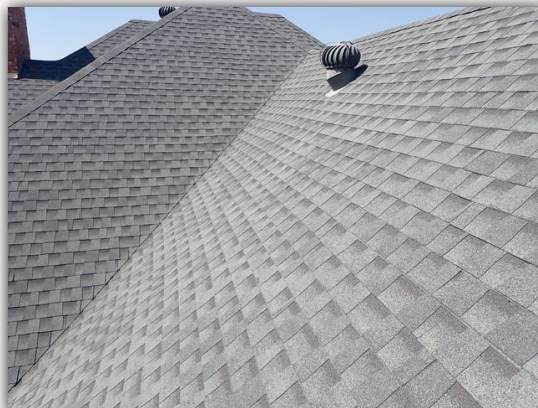
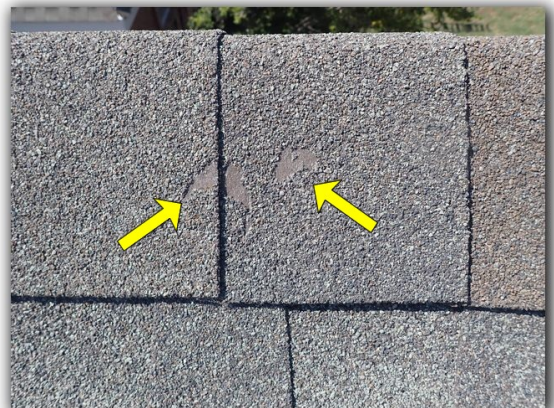
- One or more of the ridge cap shingles were observed to have some minor damaged at the garage area.
- **Note:** This inspection does not imply insurability or warrantability of the roof covering. We have heard of other clients insurance being canceled within a period of time after after the insurance company inspector inspects the roof, which will generally occur after closing. It is recommended you ask your insurance agent about any limitations or reductions of coverage that may occur, especially if it's an older roof covering with some normal wear. Furthermore, when D (D=Deficient) is marked it is recommended that all of the roofing material and its components be fully evaluated by a Qualified Roofing Specialist, prior to the expiration of any time limitations such as option or warranty periods.

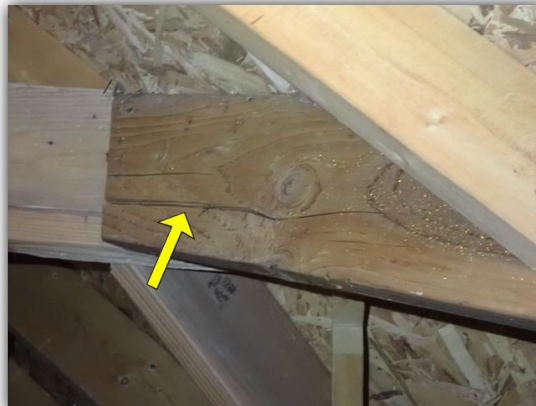
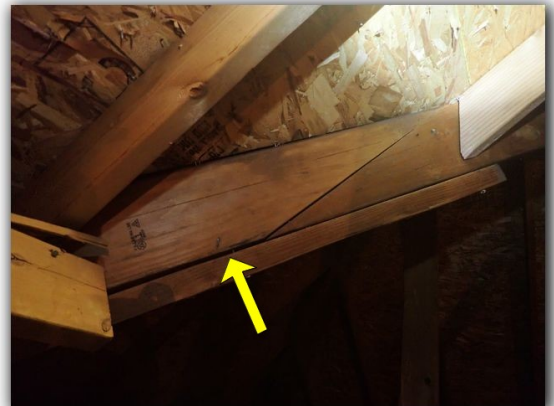
- Split valley board was observed in the attic over living room area(s).
- One or more of the roof structure rafters were observed to be pulling away and/or cut too short from the top ridge board.
- Some separation in the diagonal splice of the hip board was observed over the living room area(s). The diagonal splice in the hip board needs to be properly supported.

- The attic ladder does not close completely. The cause and remedy should be further evaluated and corrected as necessary.

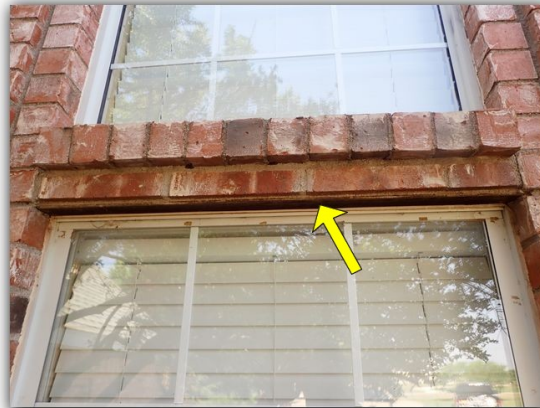
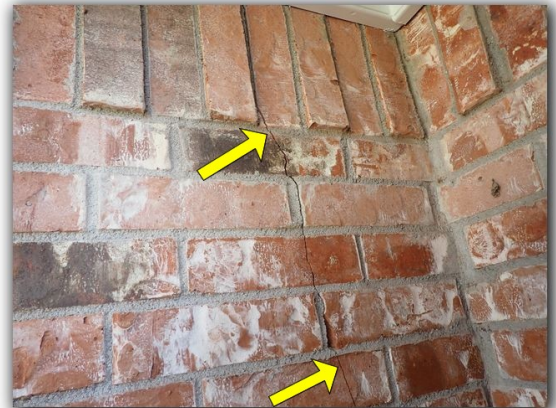
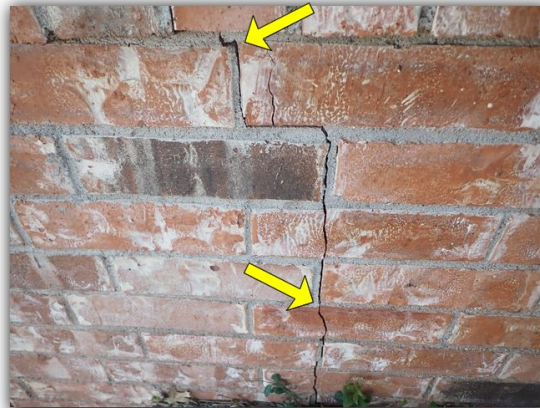
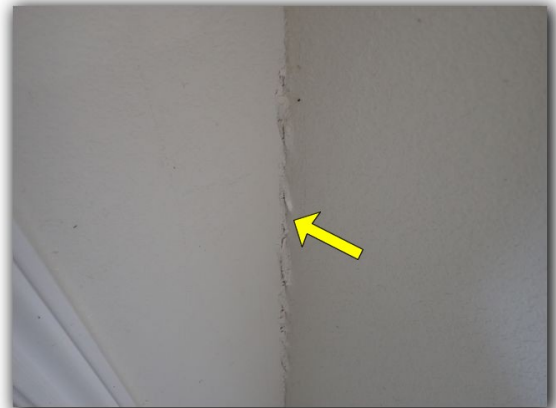
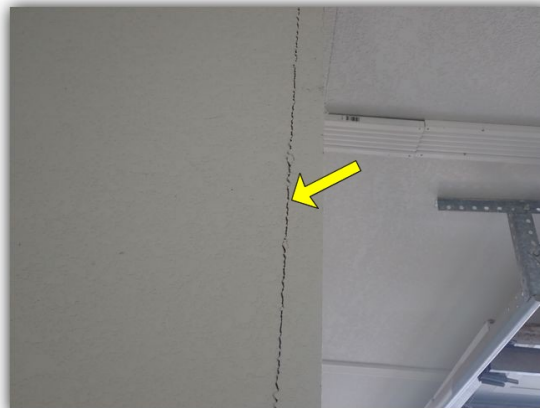
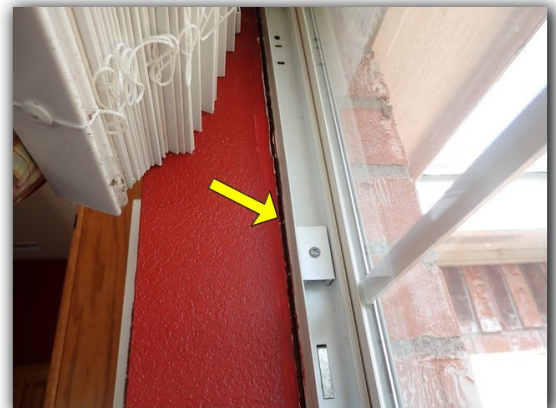
- **Note:** There is evidence of painting and patching to the interior finish and prior interior finish repairs. This condition could limit the Inspectors visual observations and ability to render accurate opinions as to the performance of the structure.
- Interior wall stress and/or joint cracks were observed in the various locations throughout the house.
- The tape lines are pulling and/or twisting in the wall intersections in the garage
- master bathroom closet. This condition is sometimes related to adverse foundation performance and should be further evaluated.
- Recommend sealant material improvements for the area between the interior walls and window frames.

- **Note:** Typical minor mortar and/or brick cracks were observed in the exterior veneer on the north, east, west and south sides of the structure.
- The steel lintels over the exterior doors and windows should be painted.

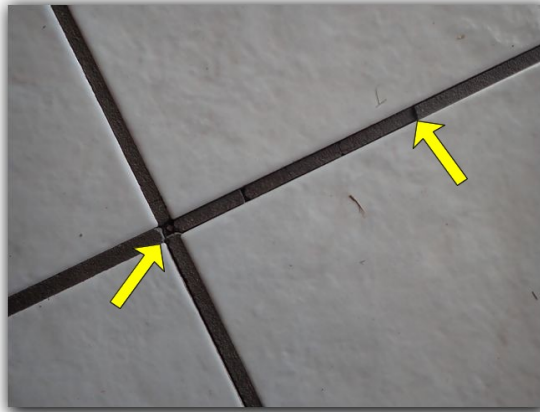
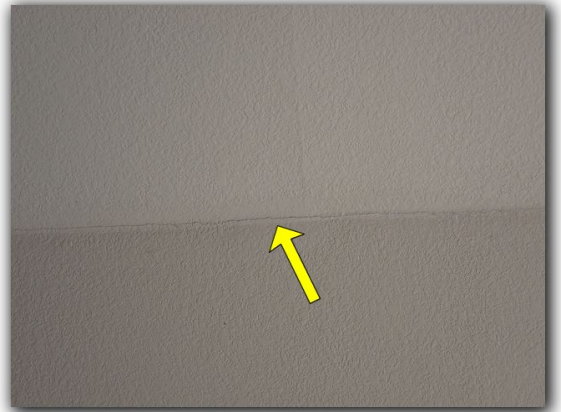
- Typical ceiling joint cracks were observed in the kitchen.

- The floors were observed to be out-of-level in some areas of the house.
- The floor tile grout was observed to be cracked and/or damaged in breakfast area.

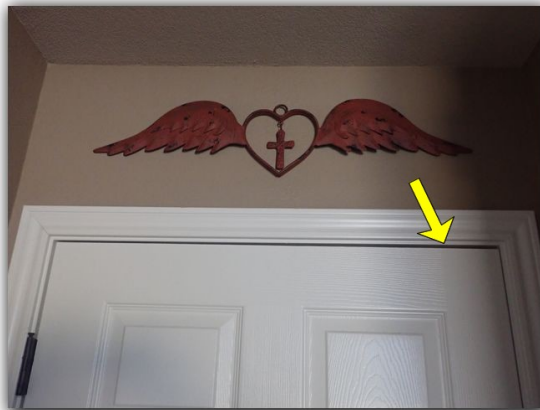
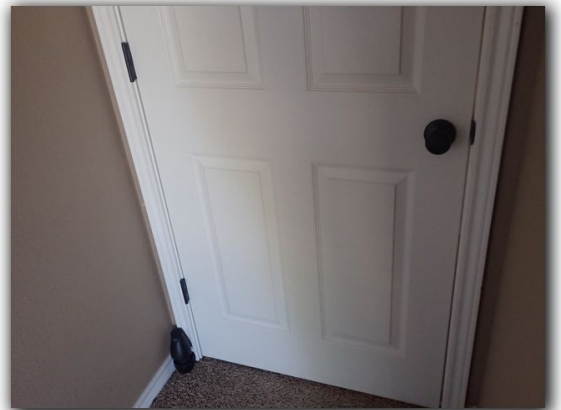
- The door(s) are not latching properly and/or sticking in front corner bedroom, side middle bedroom. Recommend minor adjustments to the hinges and/or striker plates.
- Some of the interior doors are out of square and have been shaven at the top to help them fit the opening. This may be due to adverse foundation performance.

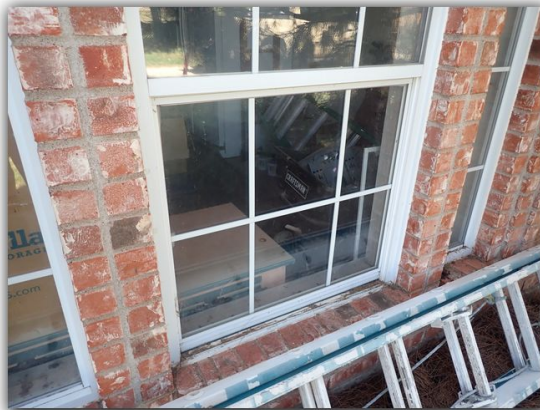
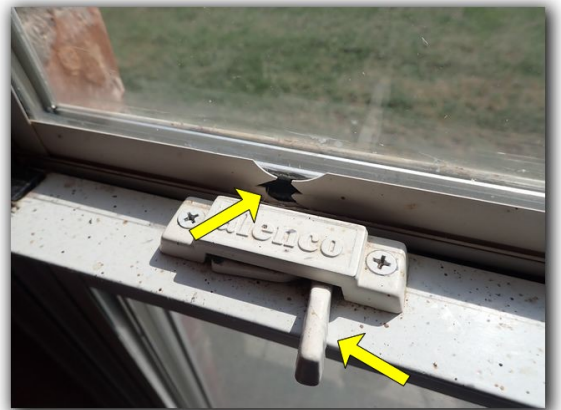
- **Note:** I was unable to inspect the operation of some of the windows due to window treatments, personal effects, large, heavy or fragile storage and/or furniture.
- The window lock(s) do not appear to be latching properly in the breakfast area.
- The window glass plastic sealing strip damaged and/or missing at one or more of the windows and improvements are recommended.

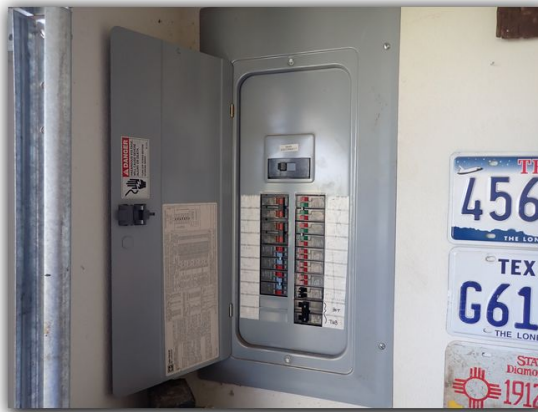
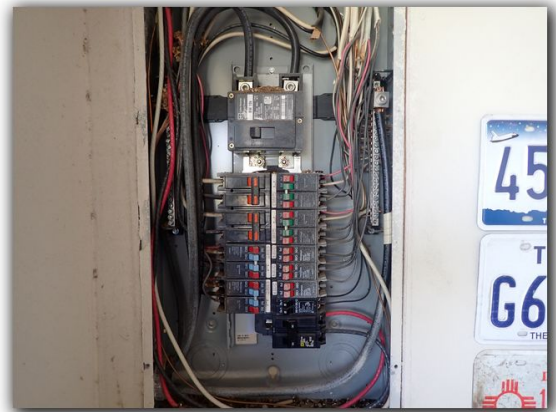
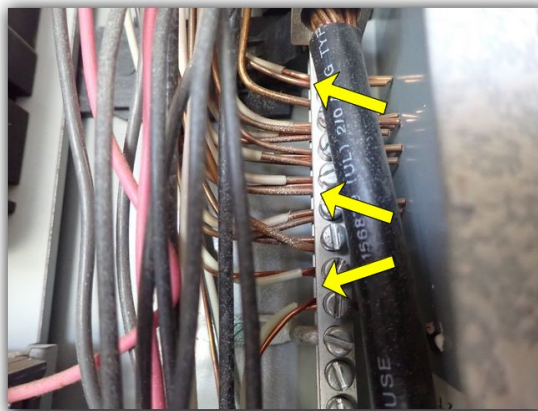
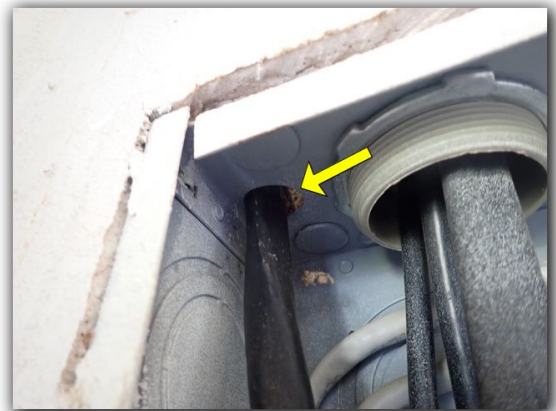
- The wires entering the electrical cabinet are not properly secured or protected from the sharp edges of the cabinet.
- One or more of the neutral wires are incorrectly connected under a single screw on the grounding/neutral bus bar. Under current installation standards, the ground and neutral wires should be under separate screws with no more than one neutral wire per screw.

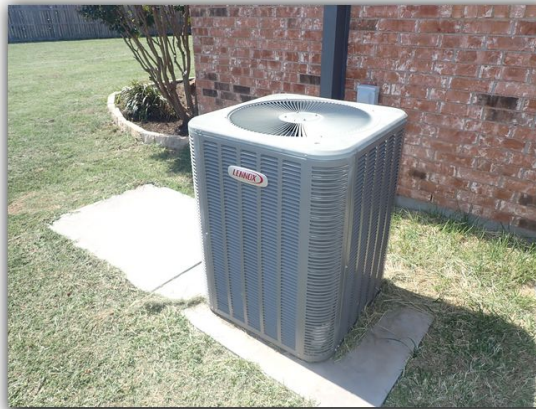
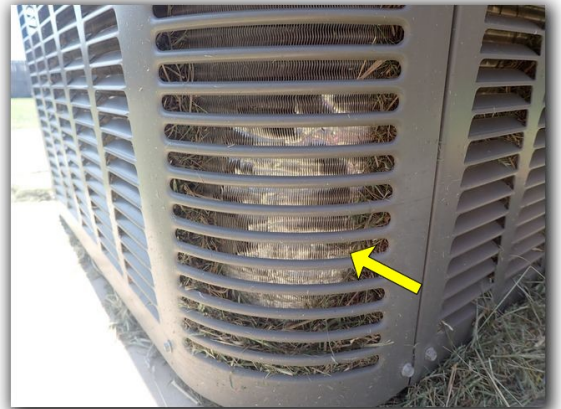
- The fins of the outdoor portion of the air conditioning system were observed to be have some minor damaged. This condition can reduce the efficiency of the system.
- The outdoor unit of the air conditioning system is noisy. The cause and remedy should be further evaluated and corrected as necessary.

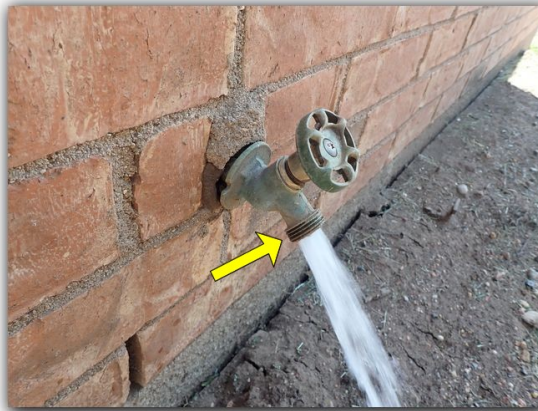
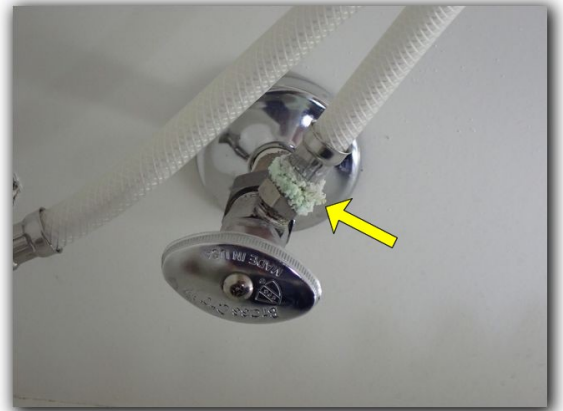
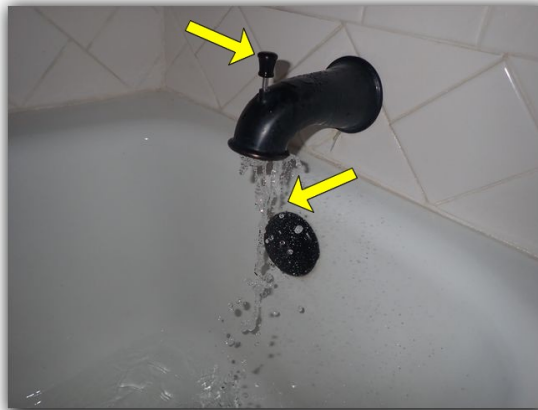
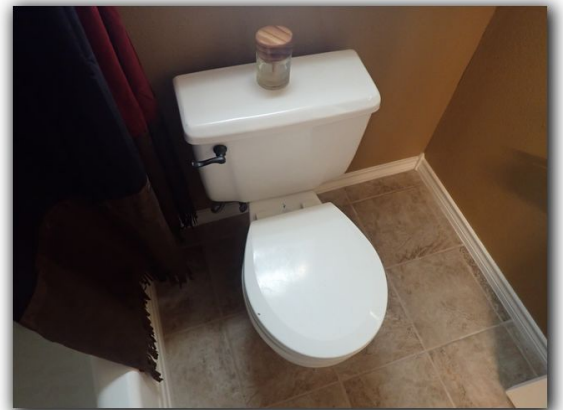
- **Note:** Some corrosion was observed at one and/or both of the water supply shutoff valves.

- The commode is loose at the floor mount.

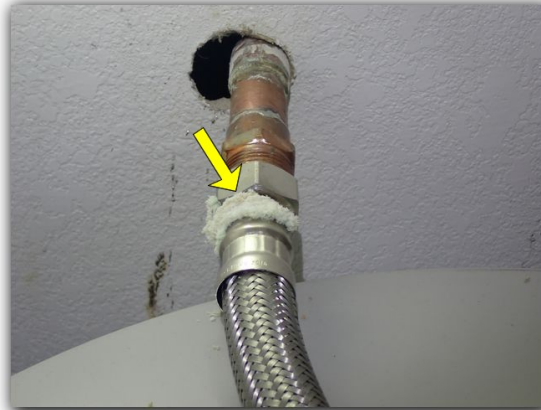
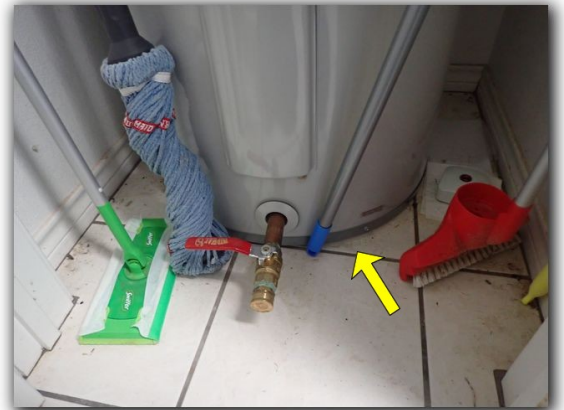
- There is no pan installed under the water heater. It is suggested that the correct sized pan and associated drain pipe system be installed per current installation requirements; at least the next time the water heater is replaced.
- Some corrosion was observed at the water supply connections at the top of the water heater.

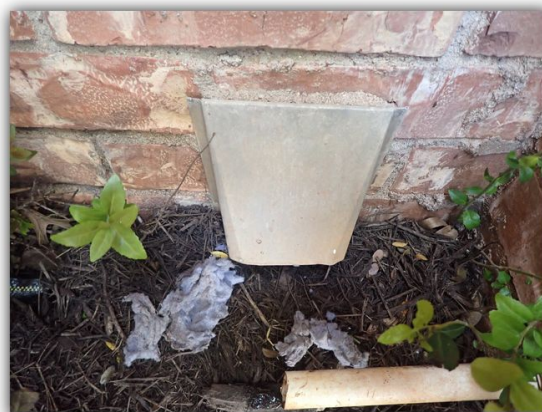
- The dryer exhaust duct (vent pipe) is dirty and needs to be cleaned.
