## PROPERTY INSPECTION REPORT

**Concerning:** 123 Main Street, Abilene, TX 8675309  
(Address or Other Identification of Inspected Property)

**By:** David Renner, Lic #20502 / NAWT #12181ITC 01/03/2018  
(Name and License Number of Inspector) (Date)

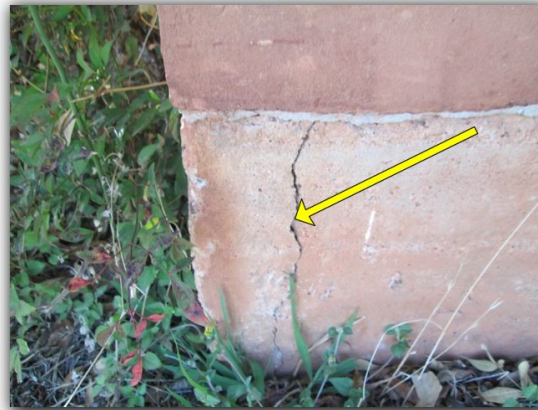
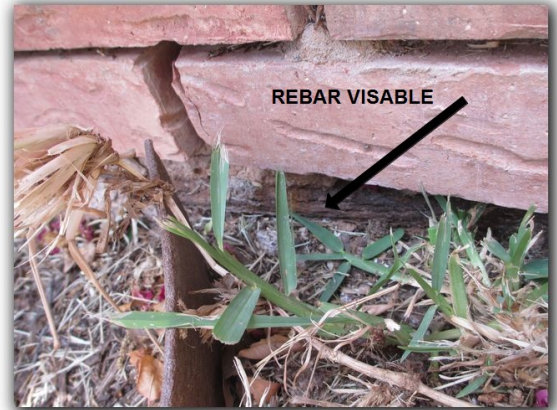
- The foundation rebar is visible at the edge of the foundation beam and needs to be properly covered on the south side of the structure.
- One or more of the foundation perimeter beam corners were observed to be sheared off (corner pop). This is a common condition in slab on grade foundations. This condition does not adversely affect the performance of the foundation. However, in some cases, some cosmetic improvements may be necessary.

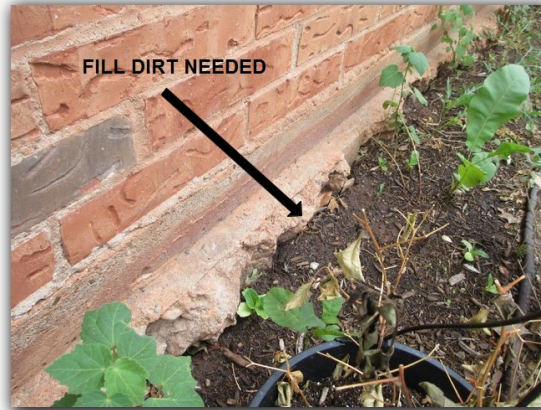
- Ground erosion was observed on the west side of the structure. Fill dirt is needed against the foundation perimeter wall where the soil line is to low to help support the foundation footer properly.

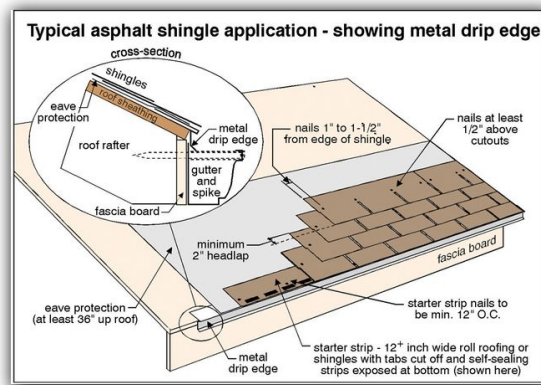
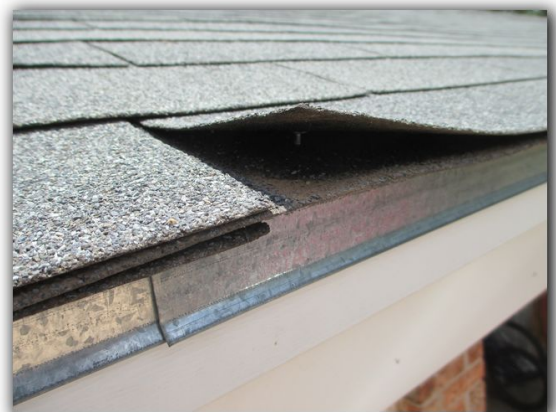
- The starter strip of the roofing material was not properly installed per the manufacture installation requirements. The starter course shingle should consist of a strip shingle with the tabs cut off with the self-sealing strip at the lower bottom edge. This will help prevent wind damage or lifting of the shingles in high winds.
- **Note:** The tree and shrub branches should be trimmed away from the roofing material at all times.

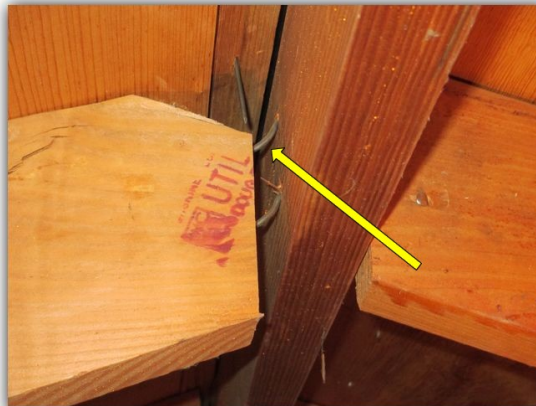
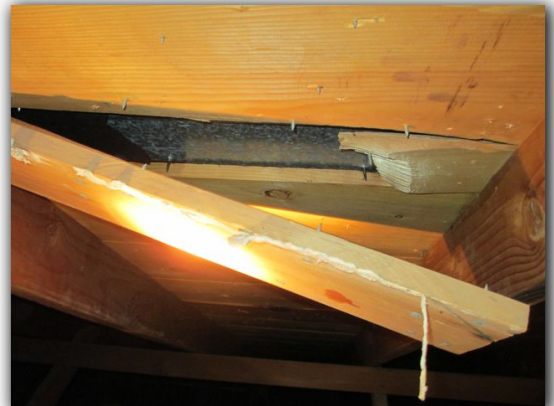
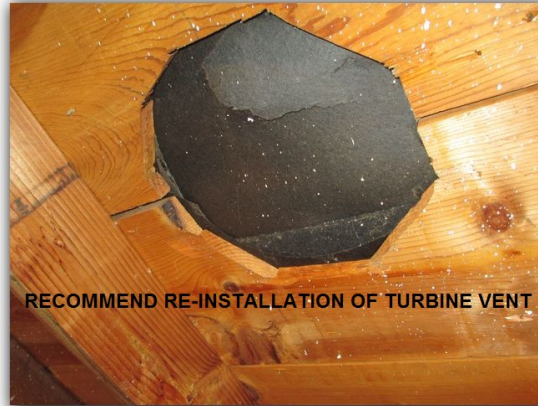
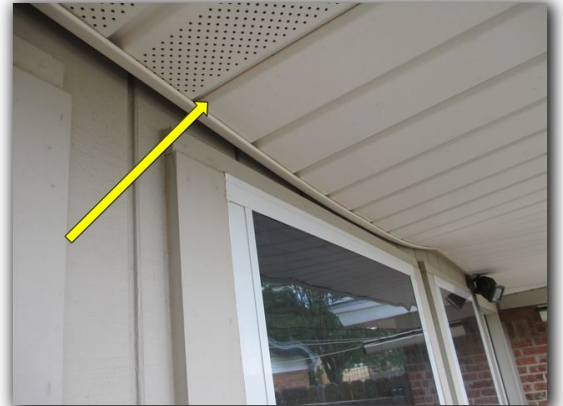
- One or more of the roof structure rafters were observed to be pulling away from the top ridge board and should be further investigated and corrected as necessary.
- The soffit material is sagging and/or pulling loose on the north side of the roof structure.

- The roof structure attic space ventilation appears to be marginal at the time of this inspection. It is recommended to increase the amount of lower and upper ventilation to help prevent heat buildup in the attic space area.

- The attic floor insulation needs to be redistributed in one or more locations.

- Some roof sheathing (decking) deterioration and/or damage was observed in one or more locations.

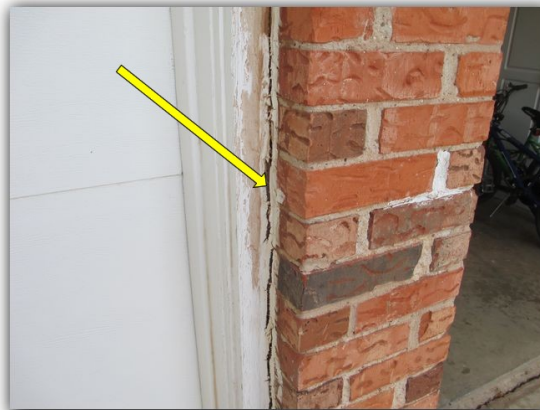
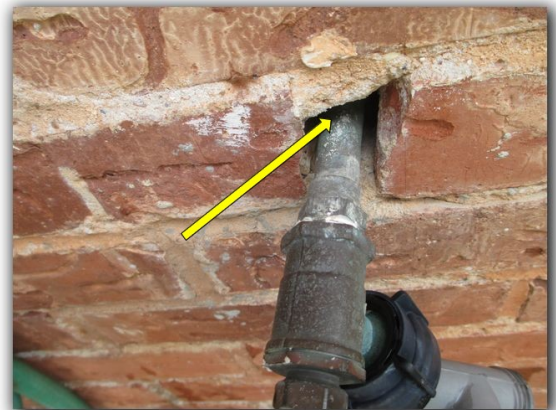
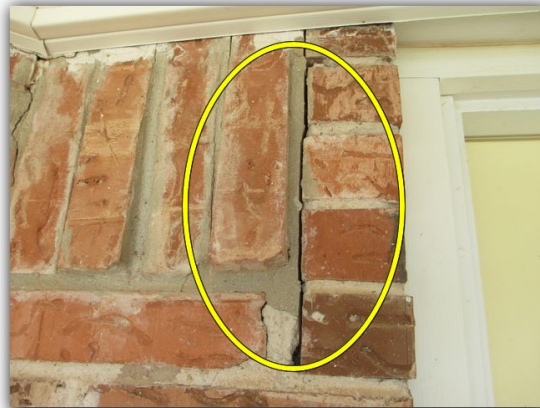
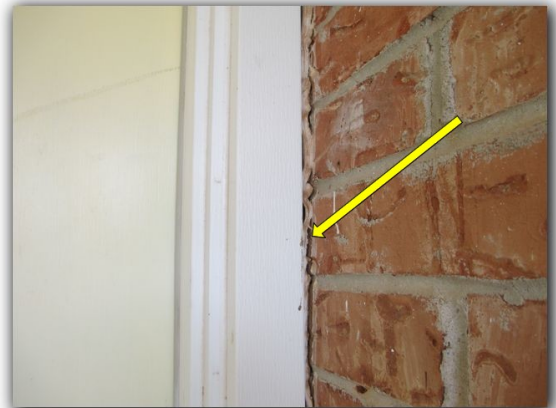
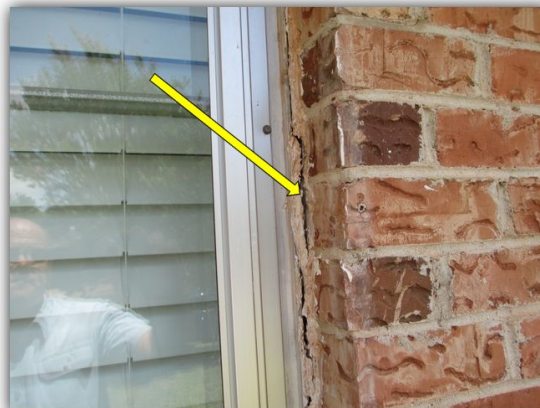
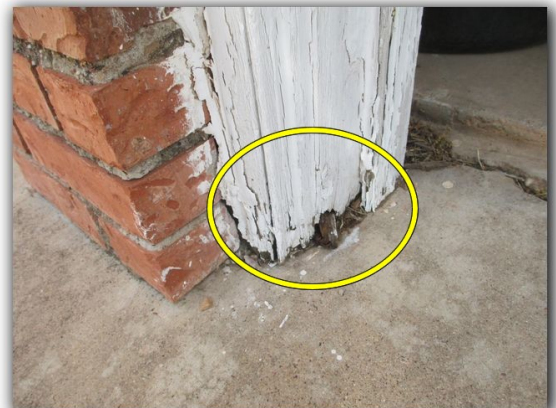
- Interior wall stress cracks were observed in the master bedroom, southwest corner bedroom, southwest corner bedroom closet, southeast corner bedroom, southeast corner bedroom closet, living room.
- Interior wall joint cracks were observed in the master bedroom, southwest corner bedroom, southeast corner bedroom.
- Wall surface damage was observed in the southwest corner bedroom, master bedroom.
- **Note:** There is evidence of painting and patching to the interior finish and prior interior finish repairs. This condition could limit the Inspectors visual observations and ability to render accurate opinions as to the performance of the structure.

- Mortar improvements are recommended for the exterior masonry veneer on the north, east, west and south sides of the structure.
- Caulking improvements are recommended for the area between the exterior veneer and the window frames, garage door trim boards and exterior door frames. It is recommended to use elastomeric caulking.
- The area between the exterior veneer and the exterior water hose bibbs (faucets) need to be properly sealed.
- The area between the exterior veneer and the dryer vent termination needs to be properly sealed.
- The garage door trim has some deterioration and/or damage at the bottom.

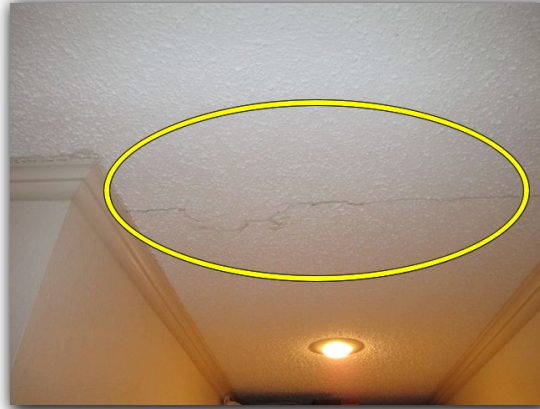
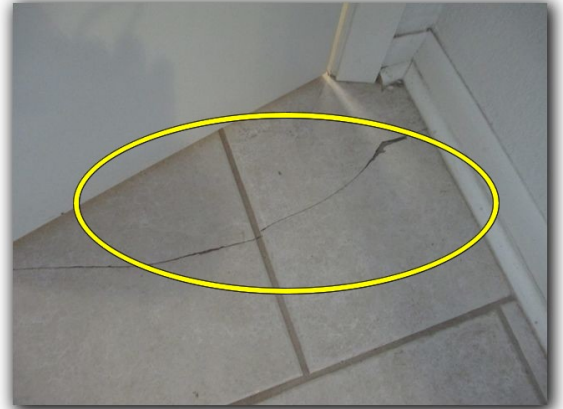
- **Note:** There is evidence of painting and patching to the interior finish and prior interior finish repairs. This condition could limit the Inspectors visual observations and ability to render accurate opinions as to the performance of the structure.
- Ceiling joint cracks were observed in the master bedroom.

- The floor tile(s) were observed to be cracked and/or damaged in family room, various locations throughout the house.

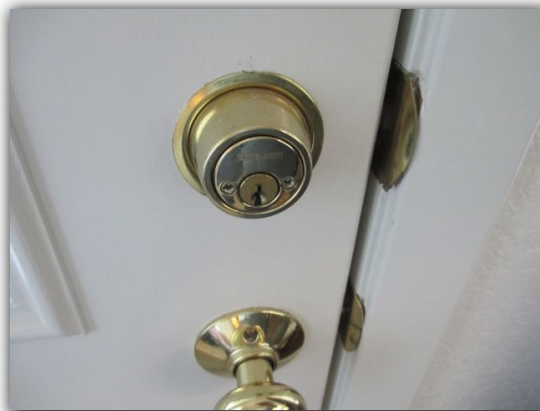
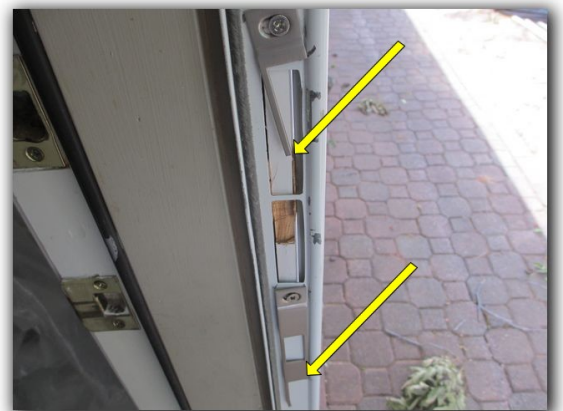
- Weather-stripping improvements are recommended for the exterior doors.
- Double cylinder locks were observed on one or more of the exterior exit (egress) doors. All exterior egress doors should be readily operable from the side from which egress is to be made without the use of a key or special knowledge or effort.
- The door hardware is damaged and/or is not functioning properly to the backyard storm door.

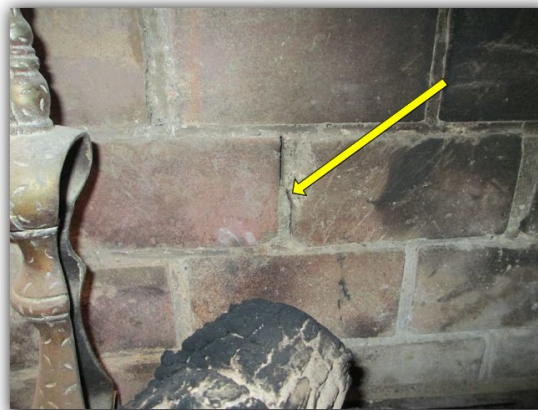
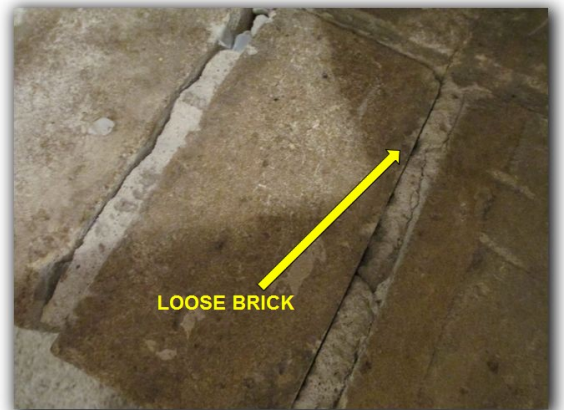
- Firebox brick mortar needs to be improved.
- The brick hearth extension brick is loose and the mortar needs to be improved.

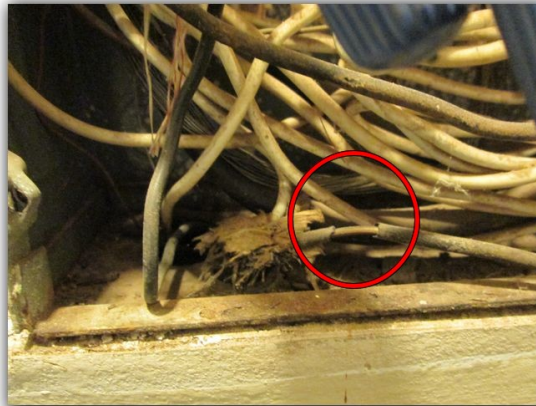
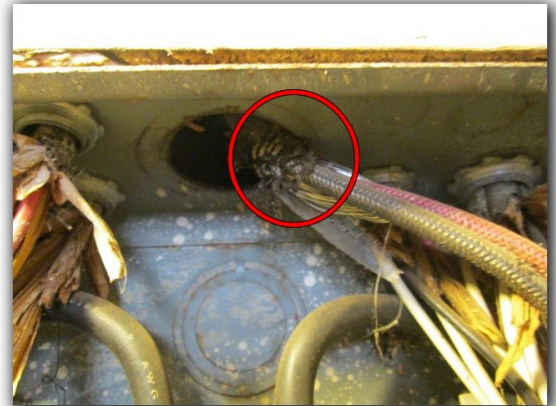
- There was no main disconnect observed in the panel box. This may be an “as-built” condition but Per TREC standards of practice we are required to report this condition as a deficiency.
- The wires entering the electrical cabinet are not properly secured or protected from the sharp edges of the cabinet.
- Bare wire observed in panel box and should be corrected as necessary.

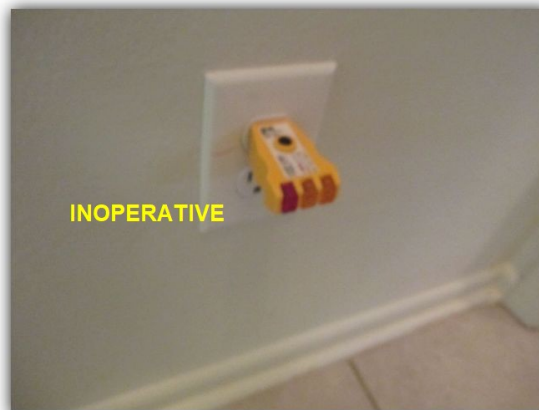
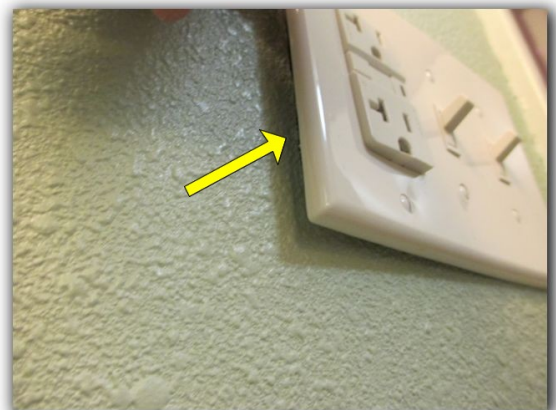
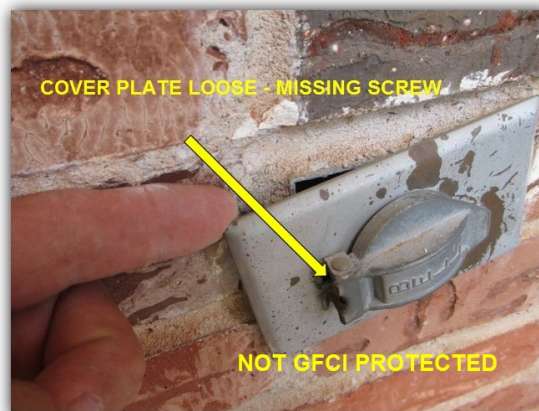
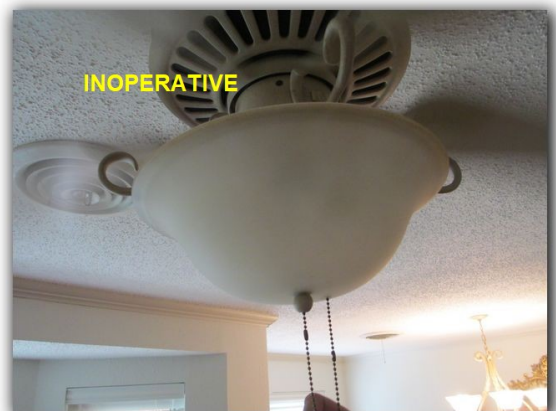
- Not all of the garage receptacles appear to be connected to a ground fault circuit interrupter (GFCI) device. Under current electrical standards, all of the garage receptacles should have GFCI protection. The new National Electrical (NEC) Code no longer has an exception for “non-appliance dedicated”.

- The exterior receptacles do not appear to be connected to a ground fault circuit interrupter (GFCI) device. Under current electrical standards, all of the exterior receptacles should have GFCI protection.

- One or more of the receptacles were observed to be loose at the wall mount in the front entrance area.
- One or more of the receptacles appears to be inoperative. This receptacle(s) and circuit should be investigated and corrected as necessary. Receptacle(s) were located in the bedroom hallway.

- The switch is loose at the wall mount in the hall bathroom.

- The ceiling fan fixture appears to be inoperative in the living room.

- There are not enough smoke alarms located in the home. Under current building standards, there should be a smoke alarm located in each sleeping room, outside each separate sleeping area in the immediate vicinity of the sleeping rooms, and on each additional story of the dwelling.
- **Note:** It is recommended to replace the batteries in all of the smoke detectors once a year for reasons of safety.

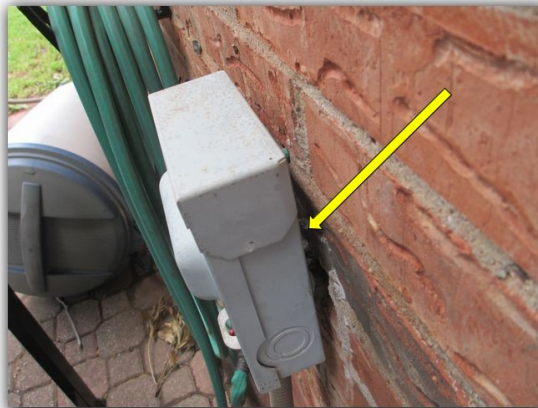
- The outside condenser/coil service disconnect box has pulled loose from the exterior wall and should be re-secured.

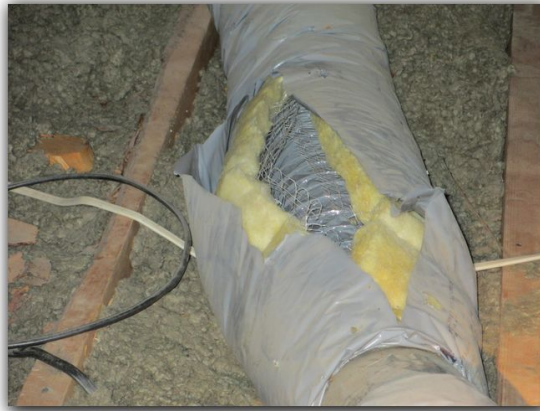
- Some of the ductwork insulation in the attic area is separated and should be repaired.
- **Note:** The covering on the ductwork that is in place has been known to deteriorate with direct and/or indirect UV light. This item should be closely monitored and corrected as necessary.

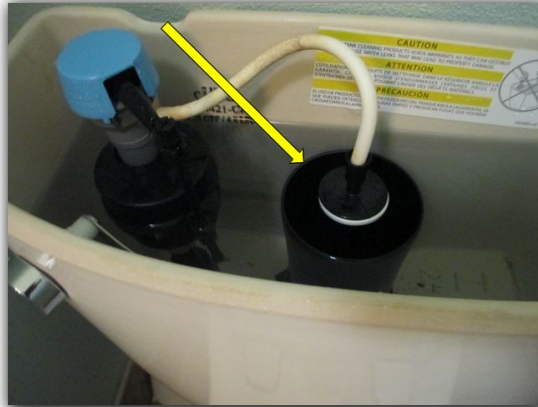
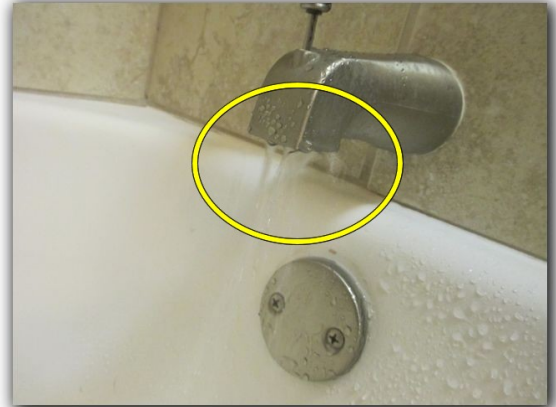
- The commode is loose at the floor mount.
- The commode tank overflow tube should be adjusted so to be at least 1-inch lower than the ballcock assembly (tank valve) head seal. The lack of this air-gap could cause a cross connection and should be corrected as necessary.

- The bathtub shower head diverter is not functioning properly.

- Cracked, deteriorated and/or missing shower stall grout and/or caulking should be repaired or replaced as necessary.

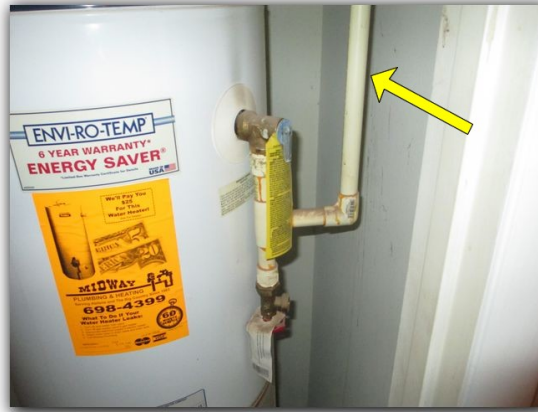
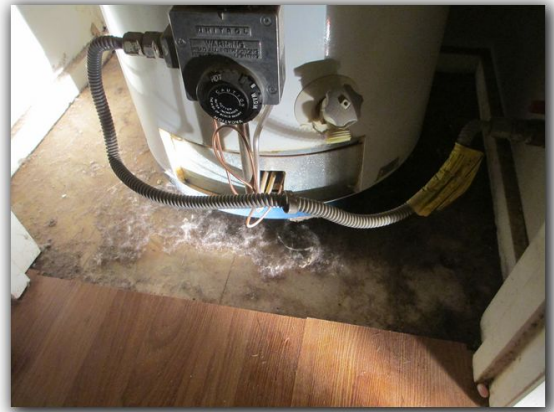
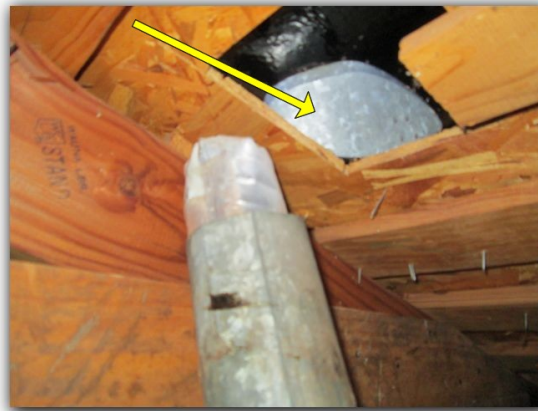
- The water heater vent pipe is separated in the attic. This configuration will emit Carbon Monoxide into the attic area, which is a known safety hazard.
- Some corrosion was observed on the water supply shutoff valve.
- There is no pan installed under the water heater.
- The water heater burner is dirty. The burner should be cleaned and adjusted.
- The temperature and pressure relief (TPR) valve discharge pipe is running in an upwards direction in one or more locations. The TPR discharge pipe should run gravitationally downwards at all points.

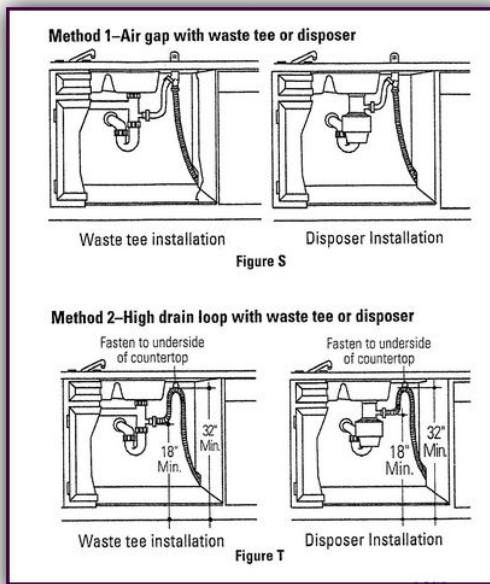
- The dishwasher drain hose is not properly installed to prevent back flow or anti-siphoning. It is recommended that an air gap device or high drain loop be installed in the drain line which can usually be accomplished without any expense as in Method-2 below.

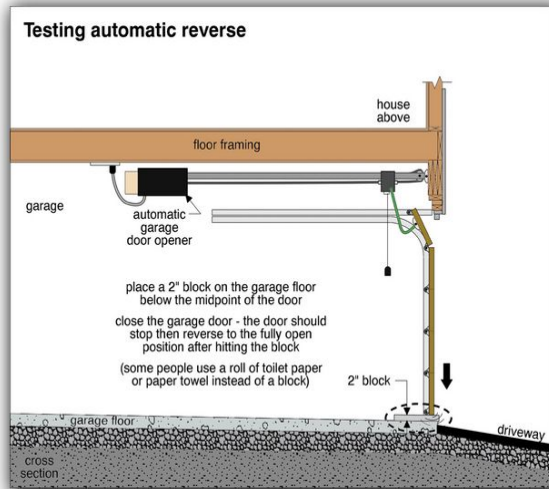
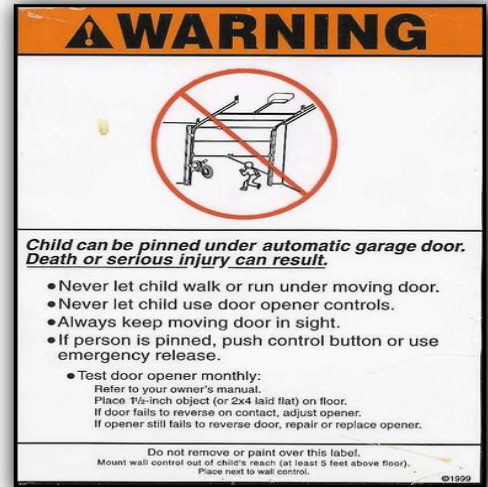
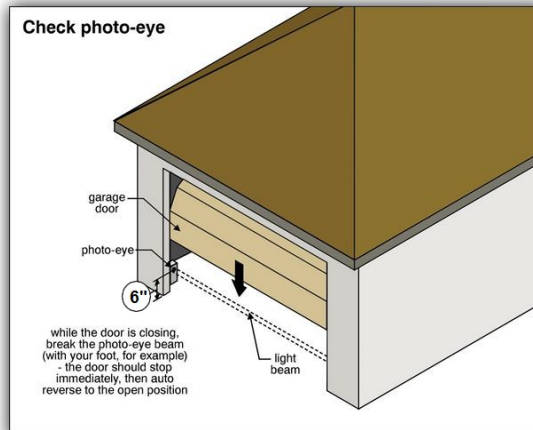
- The garage door reverse sensors are not properly installed. The garage door reverse sensors should be installed within 6-inches of the garage floor.
- The garage door opener ***DID NOT*** automatically reverse under reasonable resistance when closing. Improvement may be as simple as adjusting the sensitivity control on the opener.
