PROPERTY INSPECTION REPORT

Concerning: 4510 Vista Del Sol, Abilene, TX 79606
(Address or Other Identification of Inspected Property)

By: David Renner, Lic #20502 / NAWT #12181ITC 01/23/2018
(Name and License Number of Inspector) (Date)

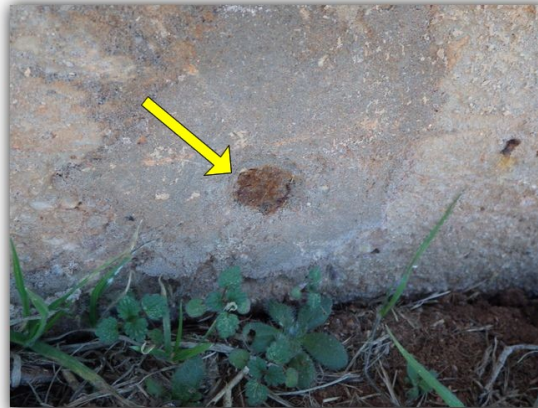
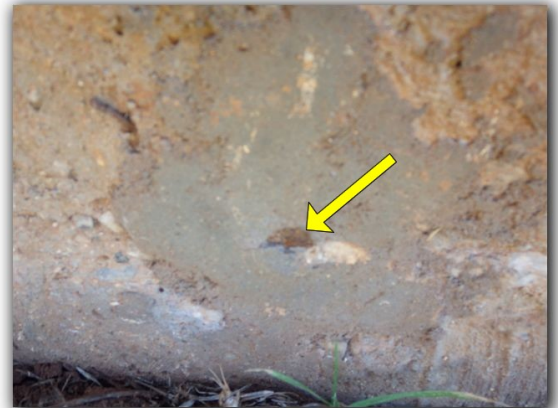
- One or more of the post tension cable ends are exposed and need to be properly sealed on the north side of the structure.

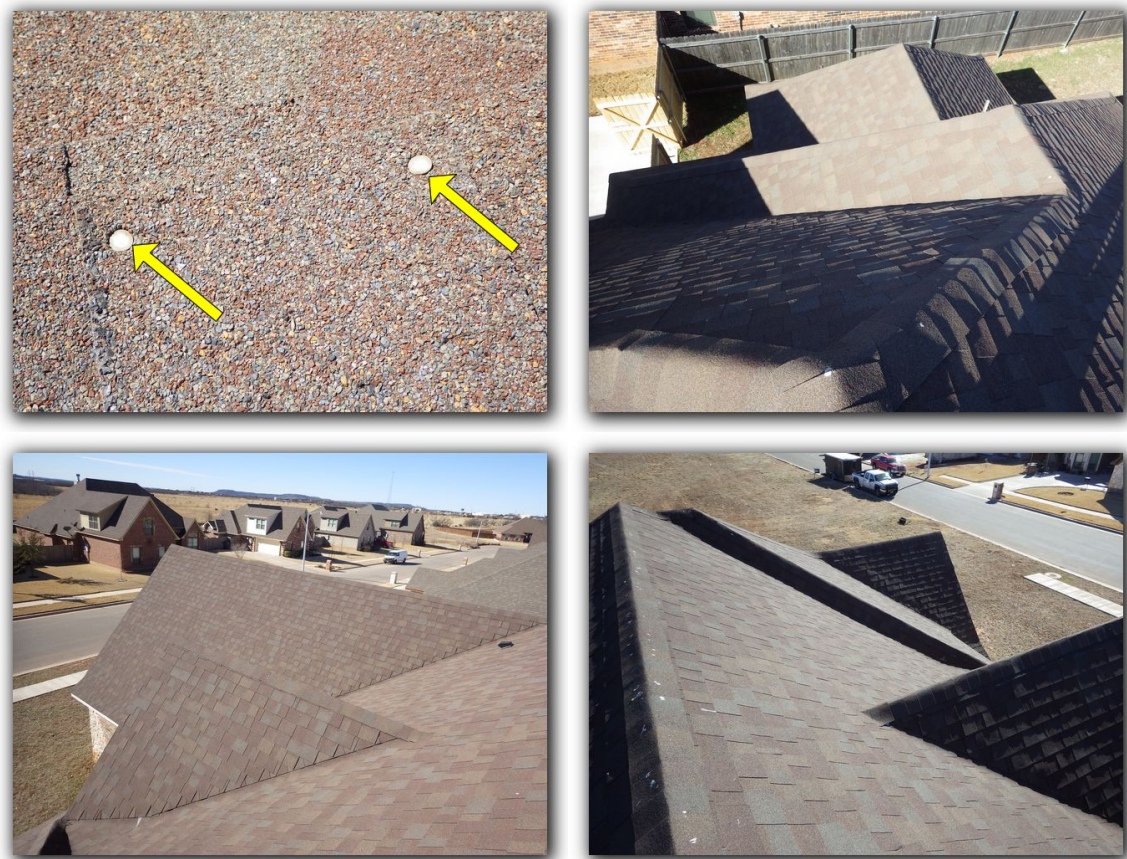
- Note:** Roof fasteners (nails and/or staples) were observed to be exposed and should be properly sealed at the ridge caps and flashing areas.

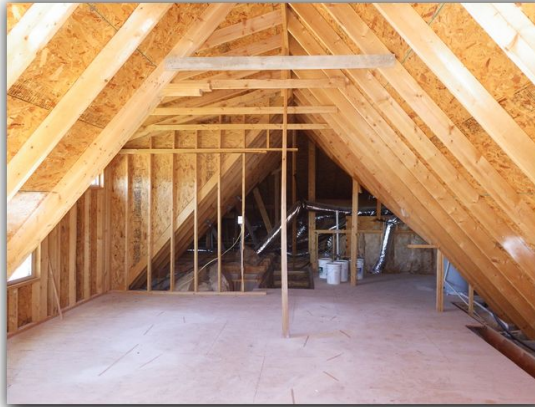
Attic Insulation

All components were found to be performing and in satisfactory condition on the day of the inspection.

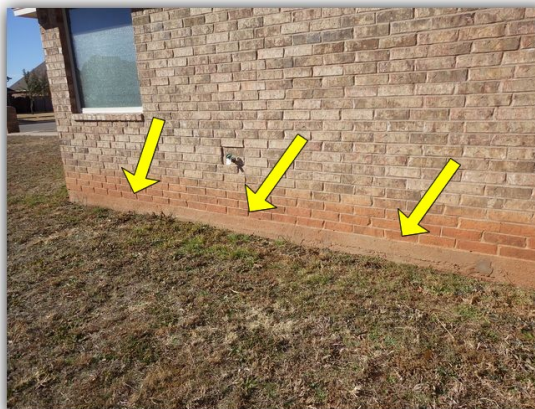
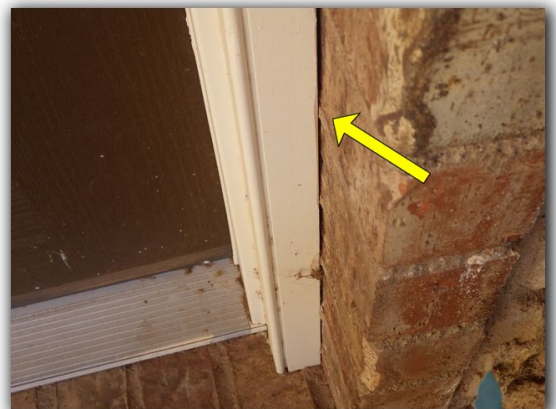
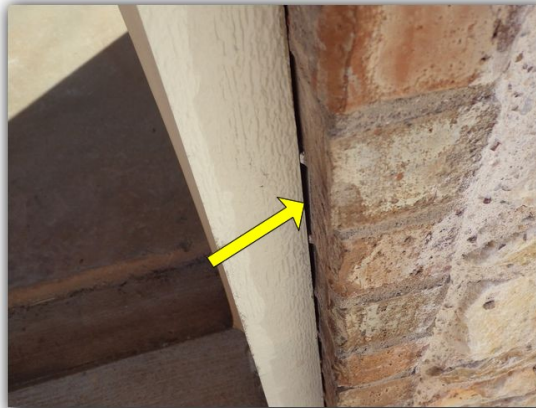
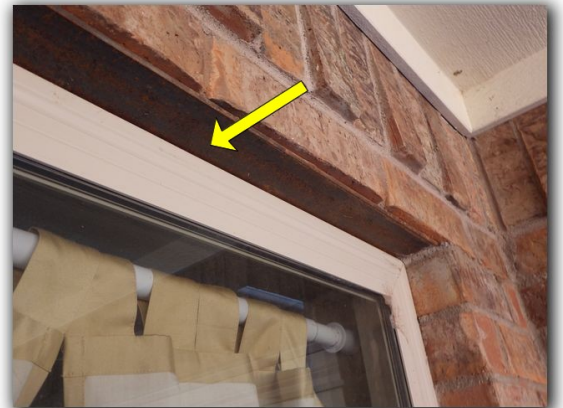
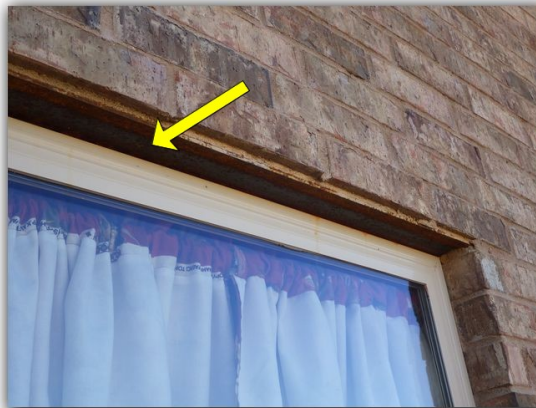
- Caulking is needed for the area between the exterior veneer and the exterior door frames, window frames and garage door trim boards.
- The steel lintels over the exterior doors and windows should be painted.
- There are not enough weep-holes in the lower course of masonry veneer on the north, east, west and south sides of the structure. Under current building standards, there should be weep-holes in the lower course of the masonry veneer, no more than 33" apart, to help drain water from the interior of the wall voids.

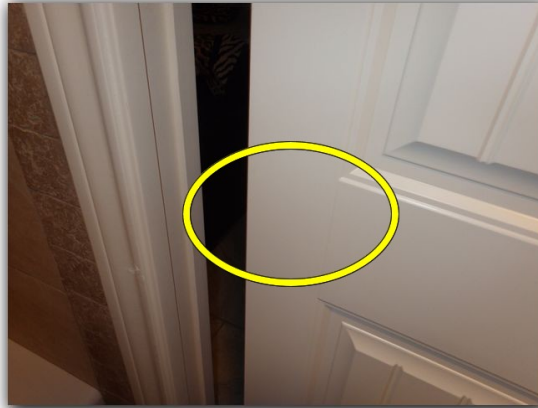
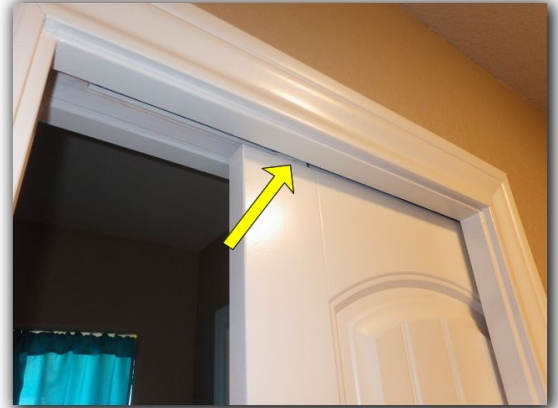
- The door hardware is missing to the Jack and Jill bathroom.
- The pocket door does not appear to be functioning properly (sticking) to the Jack and Jill bathroom.

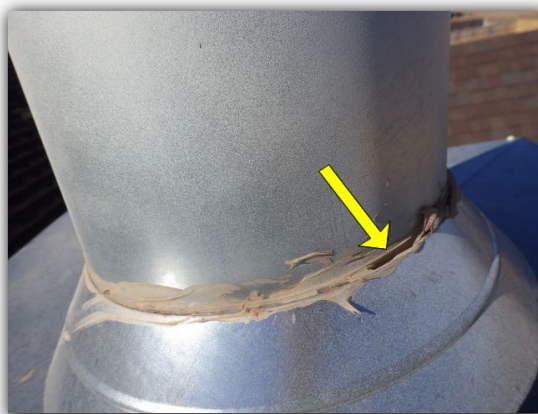
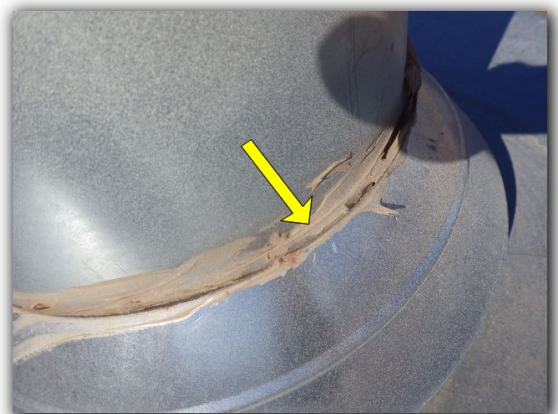
- The roof level flue storm collar needs to be resealed to help prevent water intrusion into the structure.

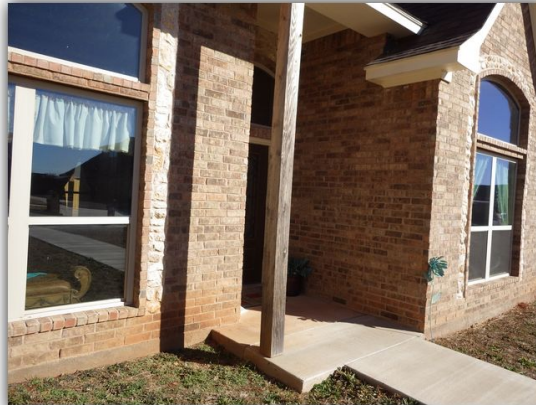
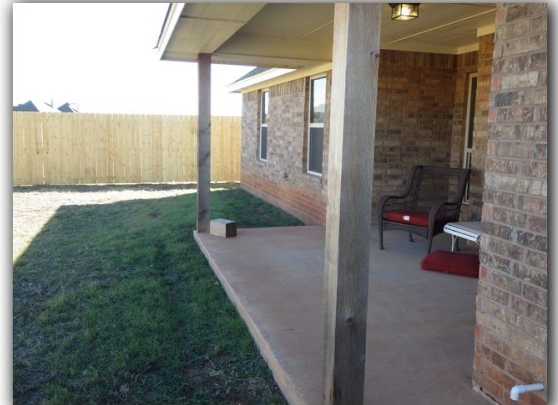
- **Note:** It is recommended to maintain the exposed wood support posts by treating with a water repellent on a regular basis.

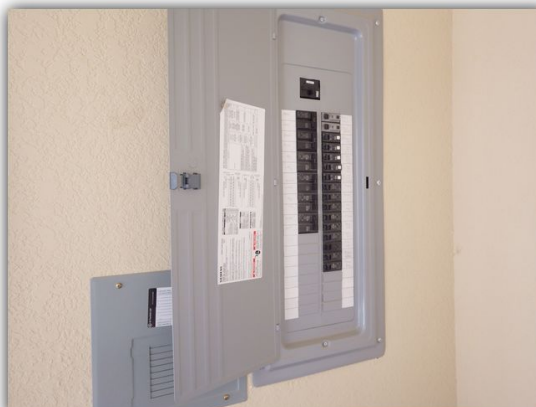
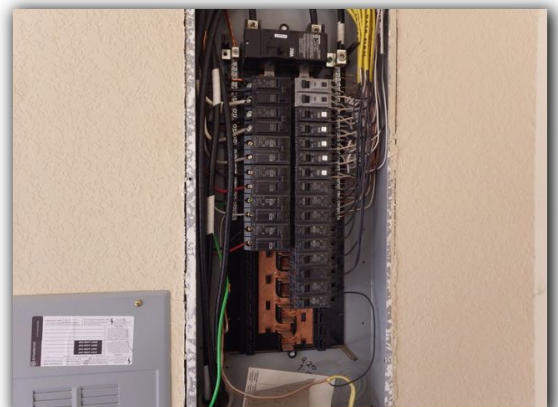
All components were found to be performing and in satisfactory condition on the day of the inspection.

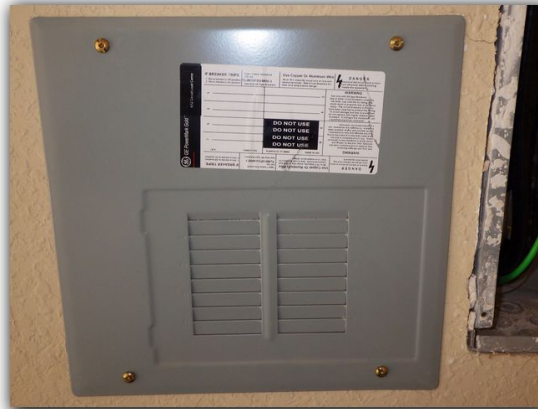
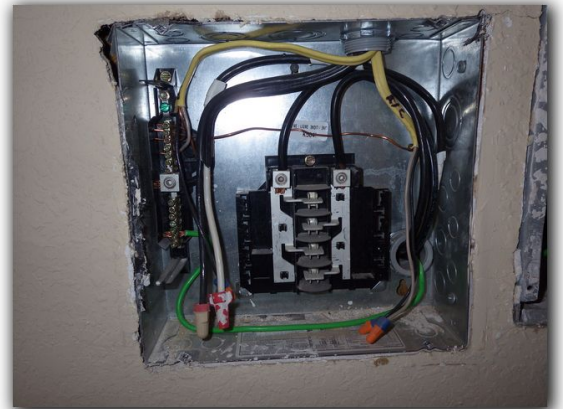
- The panel is not in use at this time.

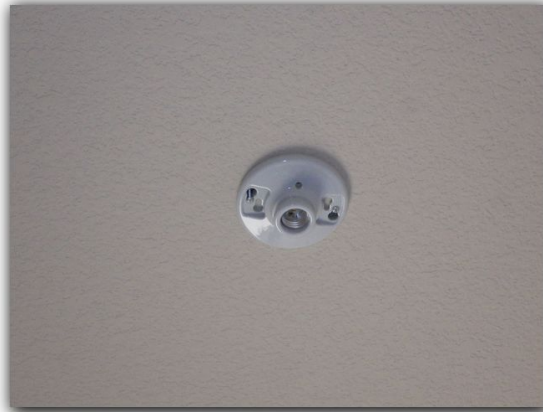
- One or more of the light fixtures appear to be inoperative in the master bedroom. This may be due to a bad bulb or some other unknown condition. This condition should be further evaluated and corrected as necessary.

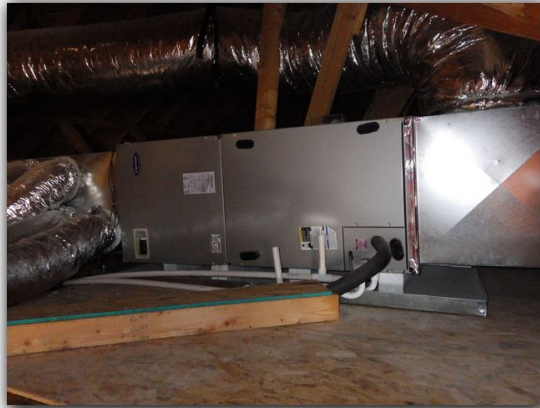
This component appears to be performing adequately at the time of this inspection. It is achieving an operation, function, or configuration consistent with accepted industry practices for its age.

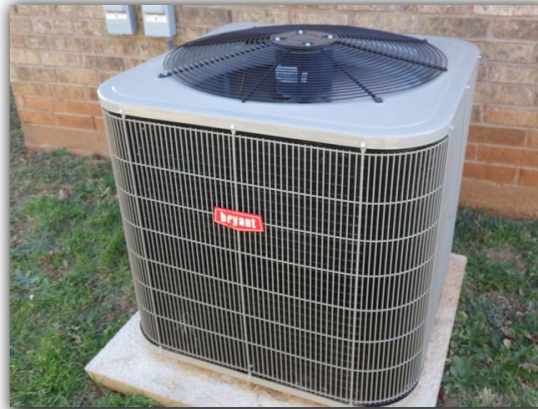
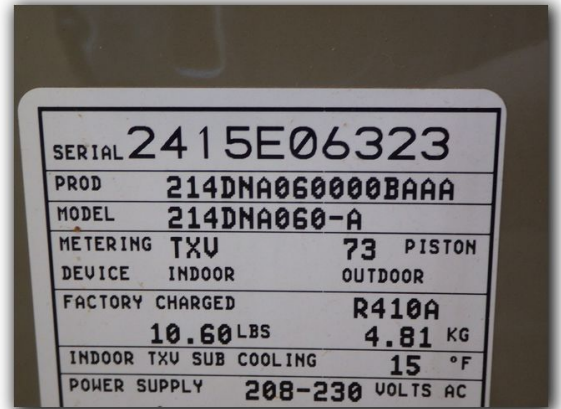
Notice: Temperature differential readings are a fundamental standard for testing the proper operation of the cooling system. The normal acceptable range is considered approximately **between 15 to 23 degrees F.** total difference between the return air and supply air. Unusual conditions such as excessive humidity, low outdoor temperatures, and restricted airflow may indicate abnormal operation even through the equipment is functioning basically as designed and occasionally may indicate normal operation in spite of an equipment malfunction.

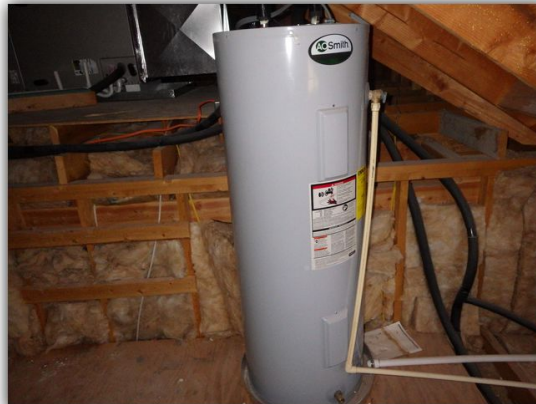
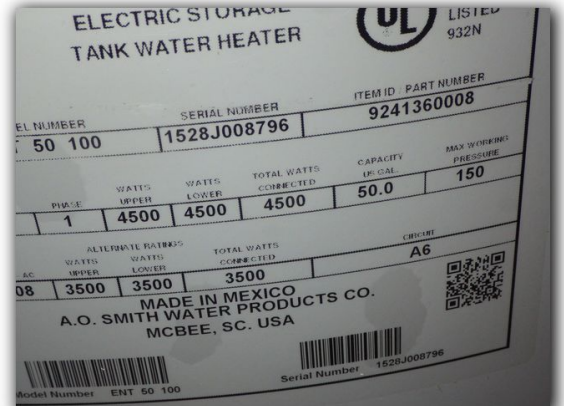
This component appears to be performing adequately at the time of this inspection. It is achieving an operation, function, or configuration consistent with accepted industry practices for its age.

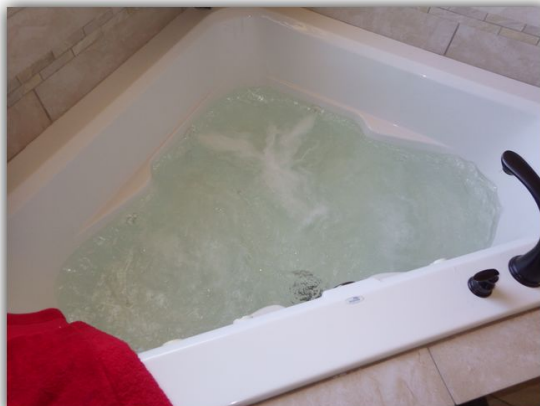
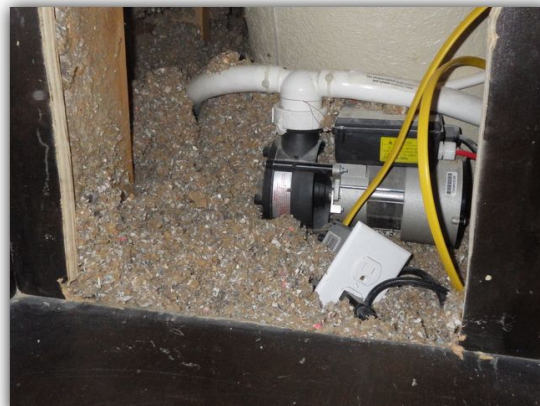
- **Note:** It is recommended to remove the insulation from contact with the pump to help prevent overheating of the pump/motor.

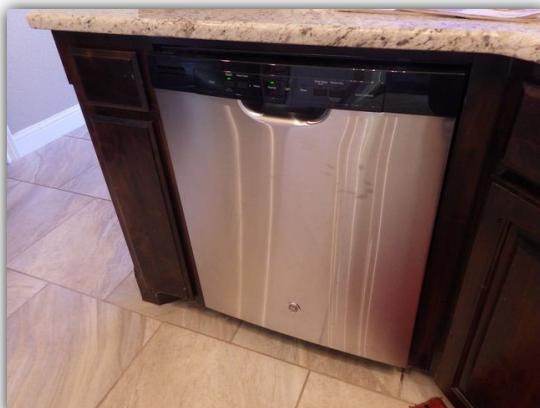
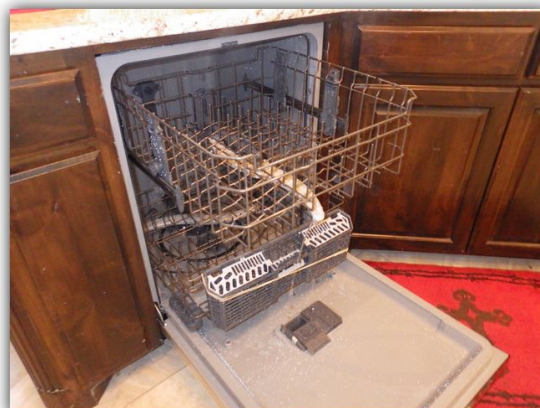
Brand Name: General Electric – GE

This component appears to be performing adequately at the time of this inspection.

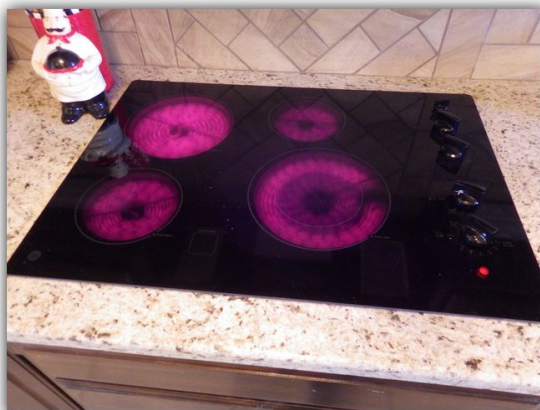
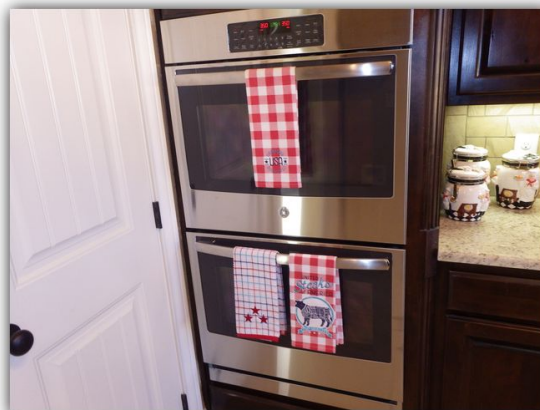
Upper/Lower Built-in Oven Brand Name: General Electric – GE

The oven was set to 350 degrees. When tested, at least 30 minutes later, the temperature rose to 355 degrees and held that temperature. A +/- of 25 degrees is considered acceptable.

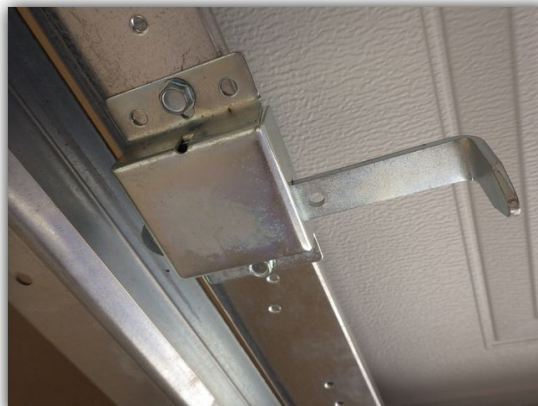
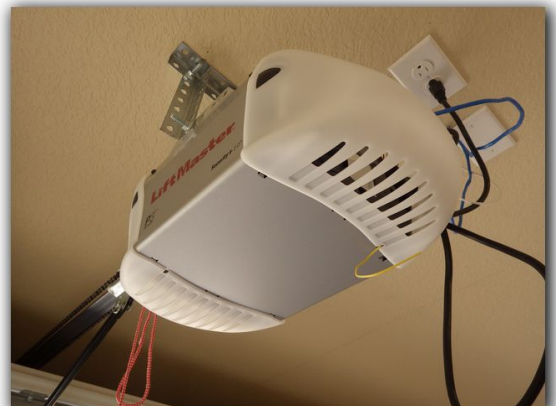
- When an automatic garage door opener is in use, the manual lock should be disabled or removed.
- The lights on the door opener are missing.
