PROPERTY INSPECTION REPORT

Concerning: 5157 Yellowstone Trail, Abilene, TX 79602
(Address or Other Identification of Inspected Property)

By: Felipe Cruz, Lic #22478 / NAWT #13743ITC 06/12/2020
(Name and License Number of Inspector) (Date)

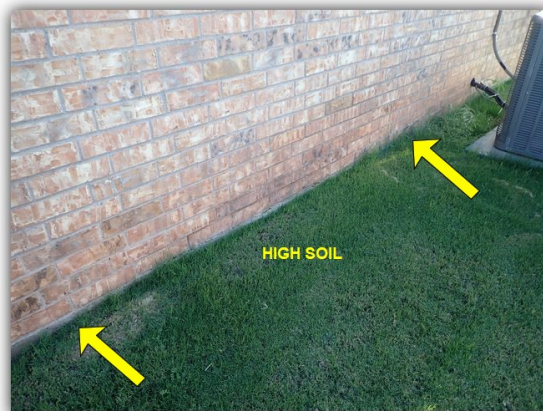
- The soil line is too high on the south side of the structure. Under current building standards there should be at least 4-inches of foundation visible below masonry veneer and 6-inches of foundation visible below wood type veneer.

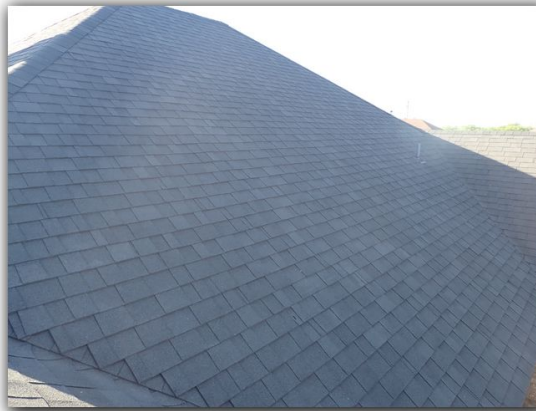
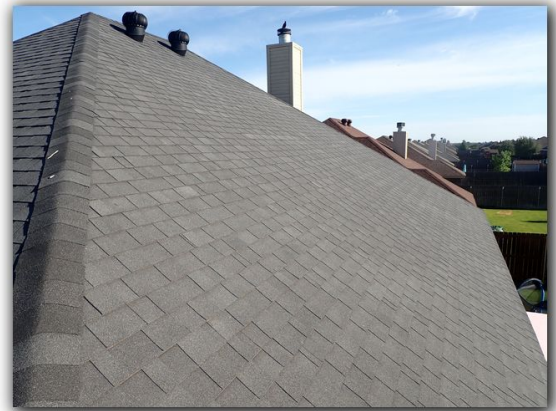
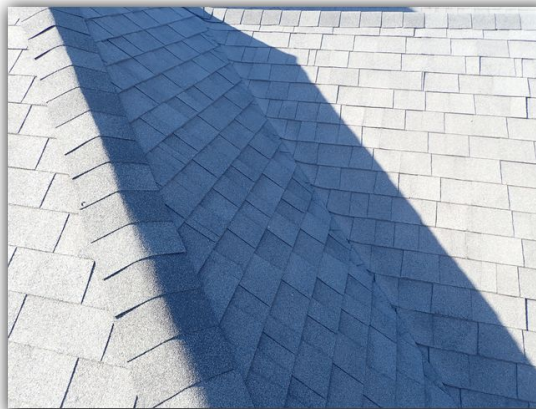
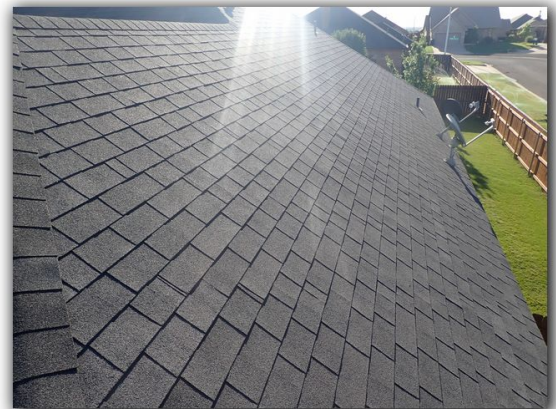
All components were found to be performing and in satisfactory condition on the day of the inspection.

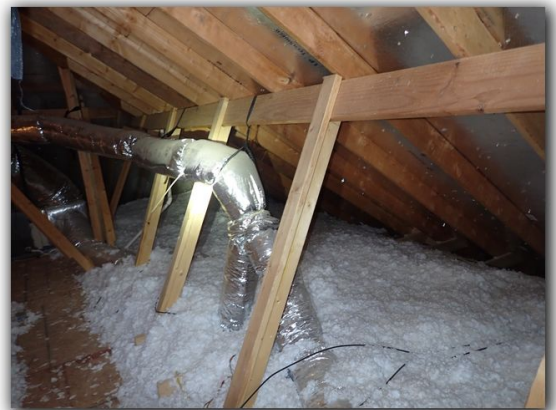
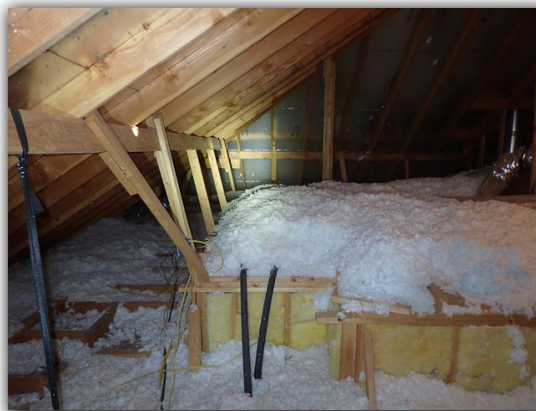
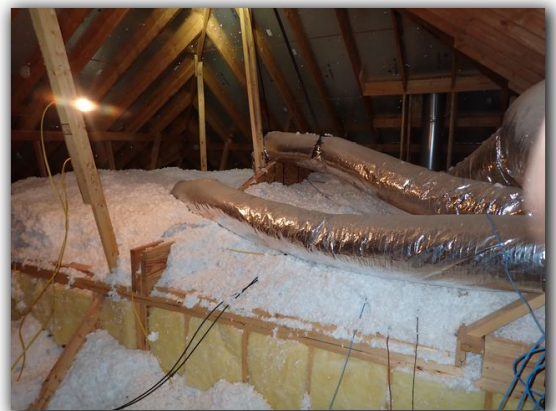
Approximate Average Depth of Insulation: 13+”

All components were found to be performing and in satisfactory condition on the day of the inspection.

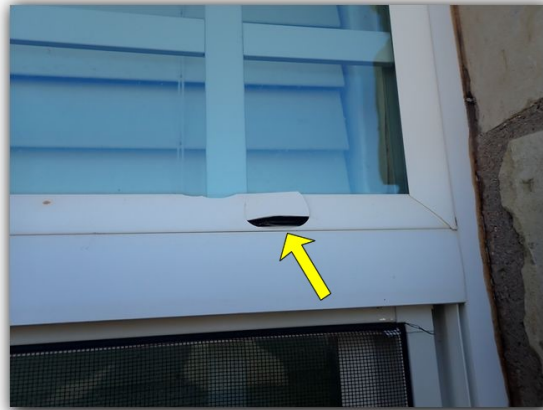
- **Note:** I was unable to inspect the operation of some of the windows due to window treatments, personal effects, large, heavy or fragile storage and/or furniture.
- The window glass plastic sealing strip damaged and/or missing at one or more of the windows and improvements are recommended.

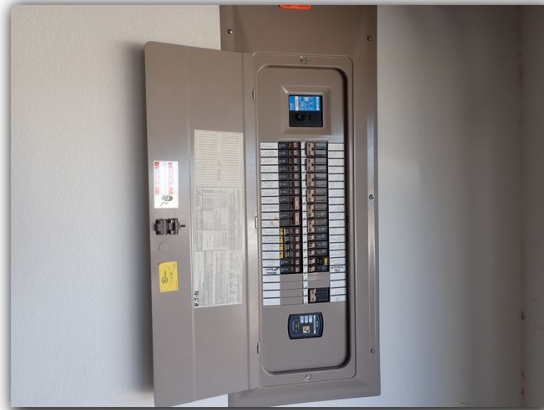
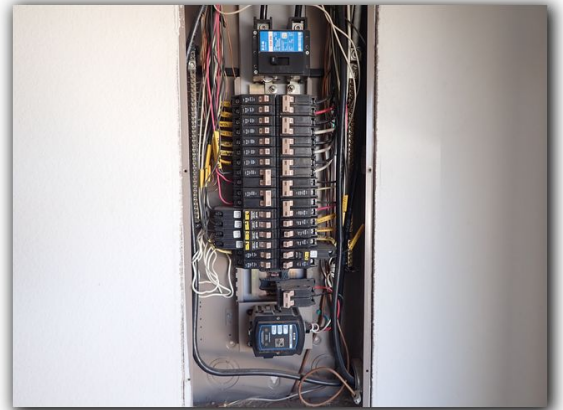
Box Rating and/or Main Disconnect Rating: 200 amps

Cabinet Manufacturer: EATON

All components were found to be performing and in satisfactory condition on the day of the inspection.

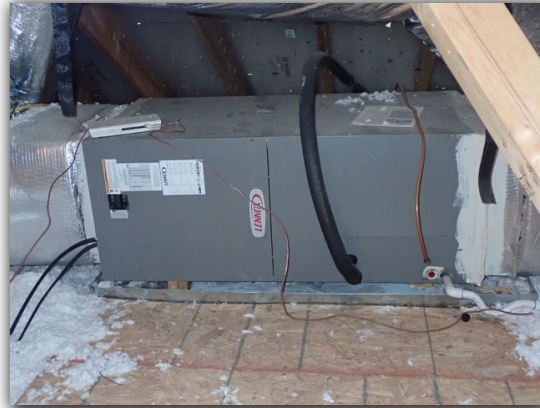
This component appears to be performing adequately at the time of this inspection. It is achieving an operation, function, or configuration consistent with accepted industry practices for its age.

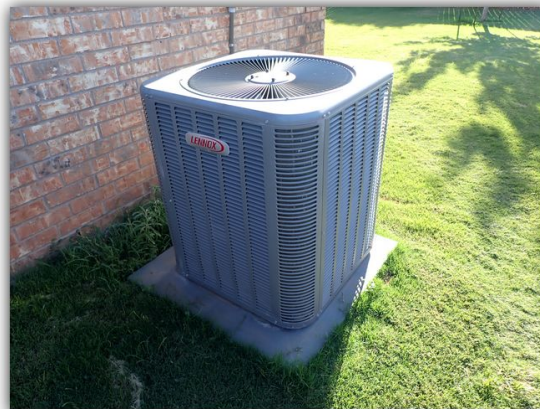
Today's Temperature Differential (Delta-T): **15 Degrees**

This component appears to be performing adequately at the time of this inspection. It is achieving an operation, function, or configuration consistent with accepted industry practices for its age.

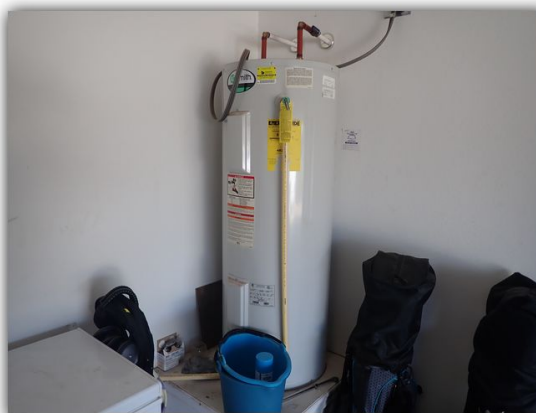
Capacity: **50 Gallons**

This component appears to be performing adequately at the time of this inspection. It is achieving an operation, function, or configuration consistent with accepted industry practices for its age.

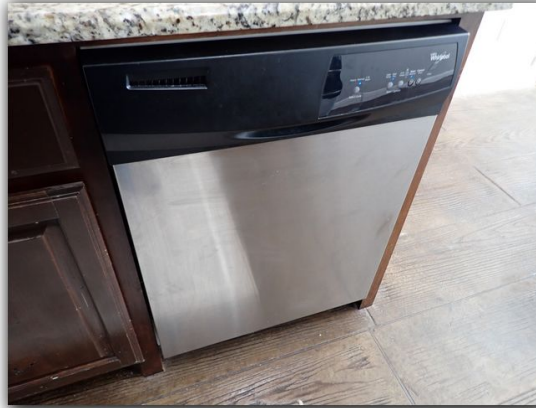
- Some rusting of the dishwasher interior components was observed.

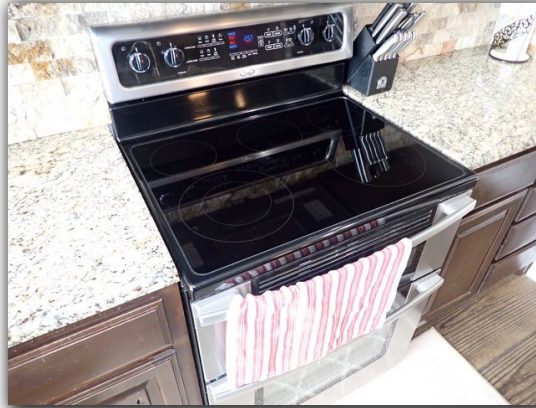
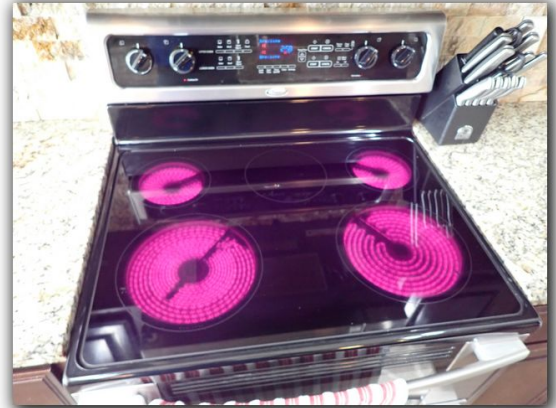
The oven was set to 350 degrees. When tested, at least 30 minutes later, the temperature rose to 345 degrees and held that temperature. A +/- of 25 degrees is considered acceptable.
