**Home Inspection
7412 Tuscany Dr
Abilene, TX 79606**

December 1, 2022

PROPERTY INSPECTION REPORT FORM

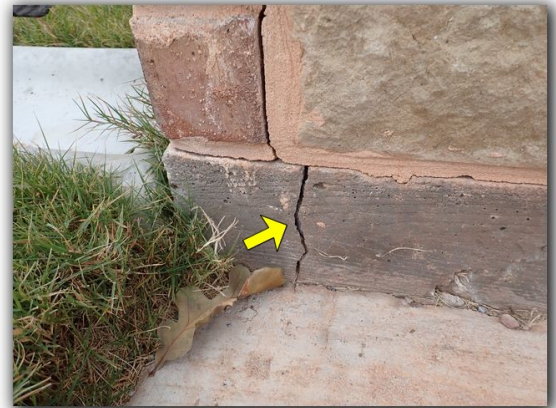
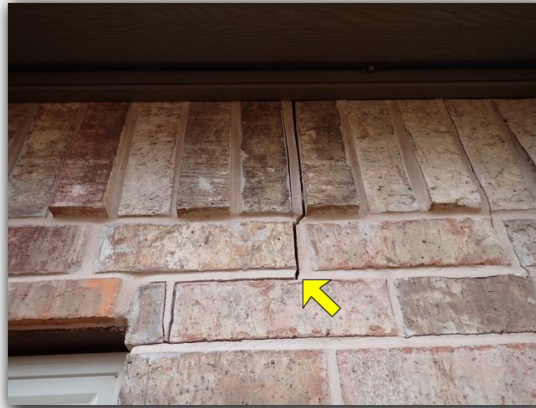
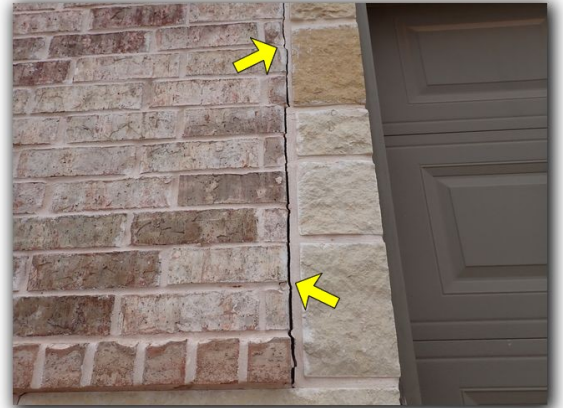
- One or more of the foundation perimeter beam corners were observed to be sheared off (corner pop). This is a common condition in slab on grade foundations. This condition does not adversely affect the performance of the foundation. However, in some cases, some cosmetic improvements may be necessary.
- Stress cracks were observed in the exterior veneer.
- Stress crack(s) were observed in the exterior foundation perimeter beam.

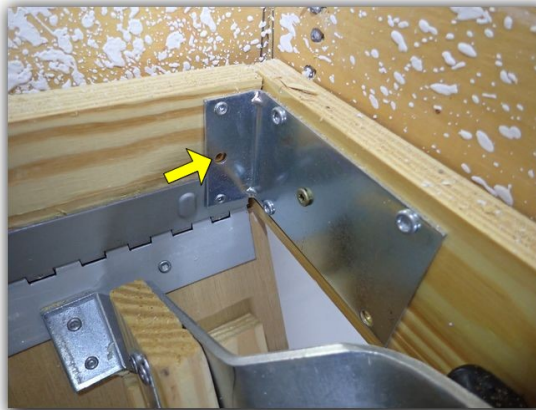
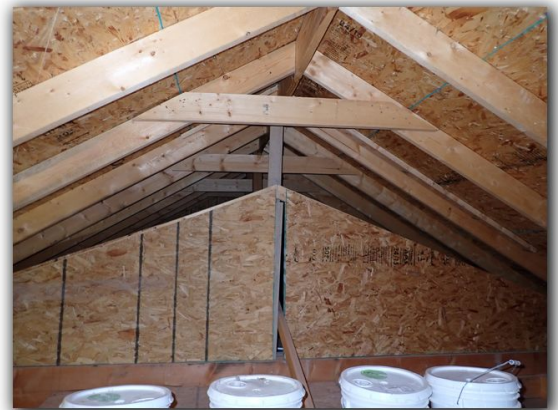
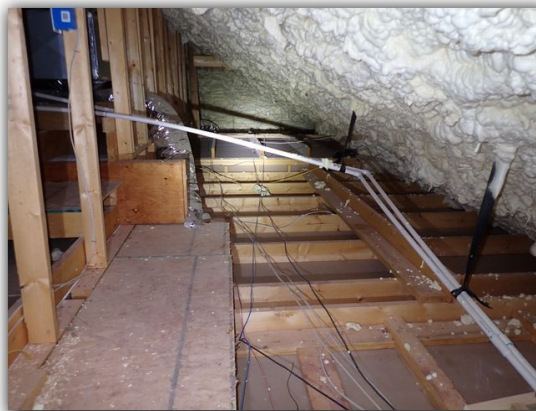
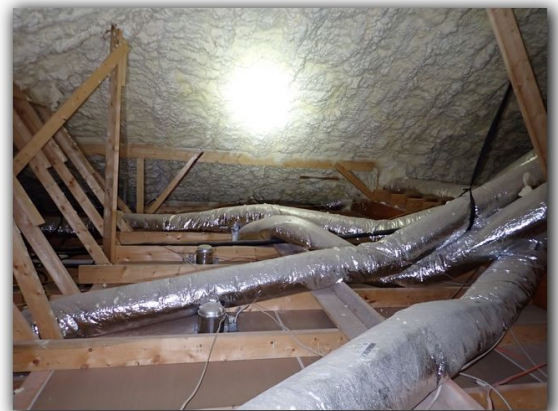
- One or more of the attic ladder fasteners were observed to be missing.

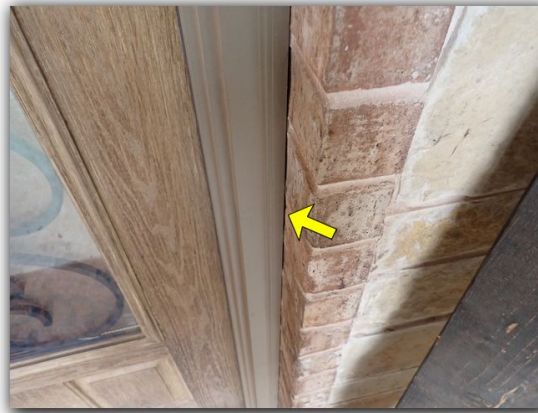
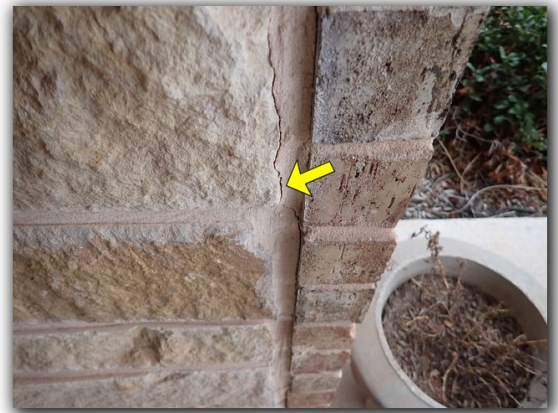
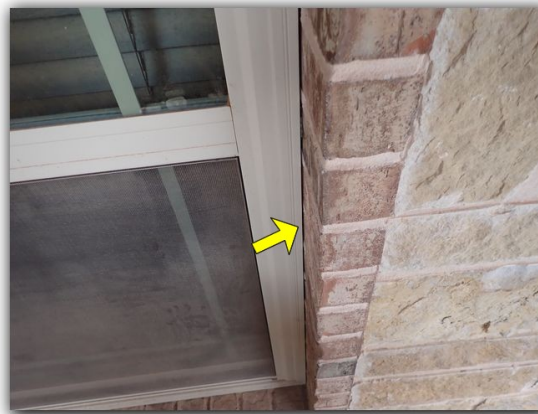
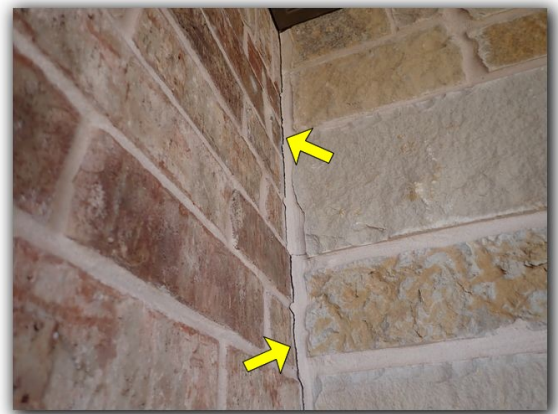
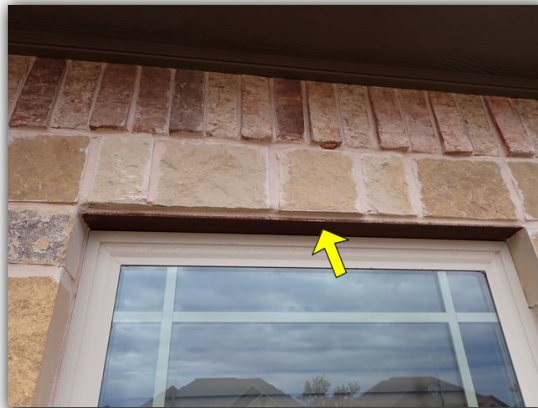
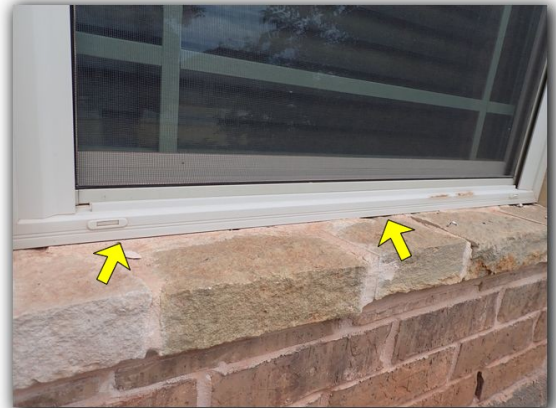
- Interior wall stress cracks were observed in the garage.

- Caulking improvements are recommended for the area between the exterior veneer and the exterior door frames, window frames and garage door trim boards.
- The area between the exterior veneer and the outside HVAC condenser/coils refrigerant lines needs to be properly sealed.
- Mortar improvements are recommended for the exterior masonry veneer on the north, east, west and south sides of the structure.
- The steel lintels over the exterior doors and windows should be painted.

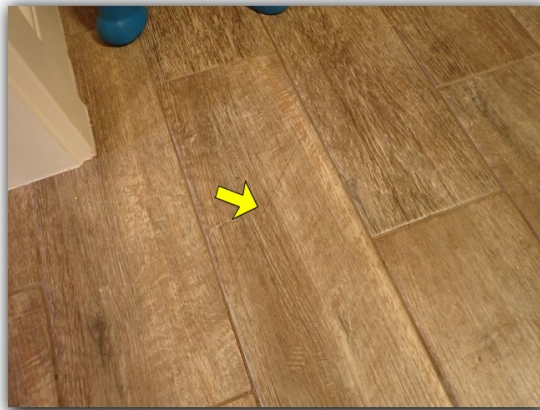
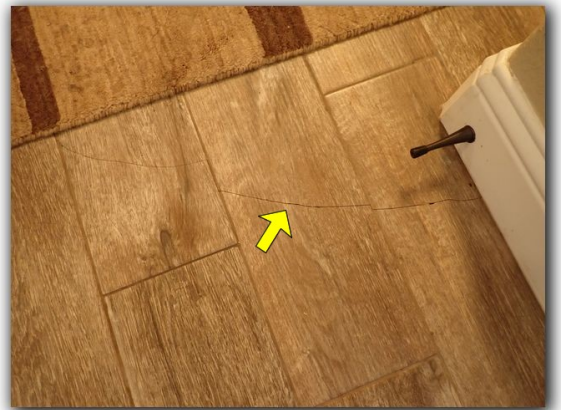
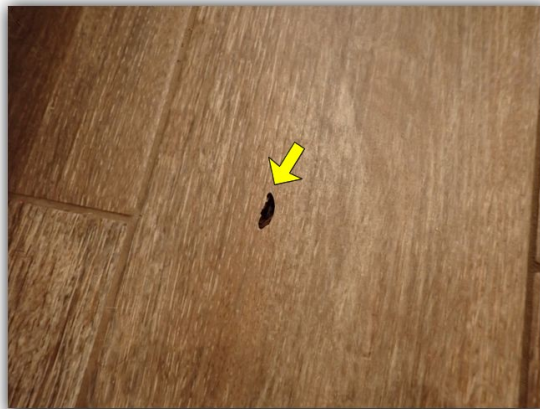
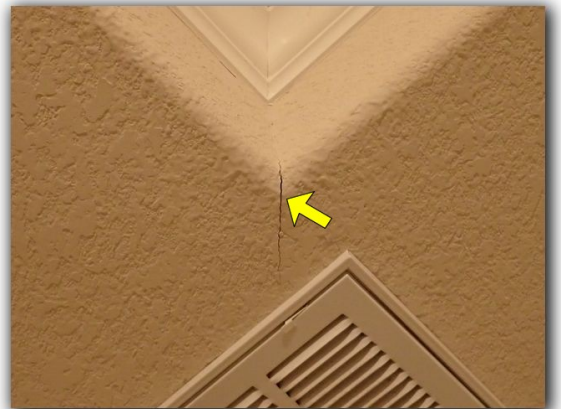
- Ceiling stress cracks were observed in the master bedroom.

- The floor tile(s) were observed to be cracked and/or damaged in various locations throughout the house.

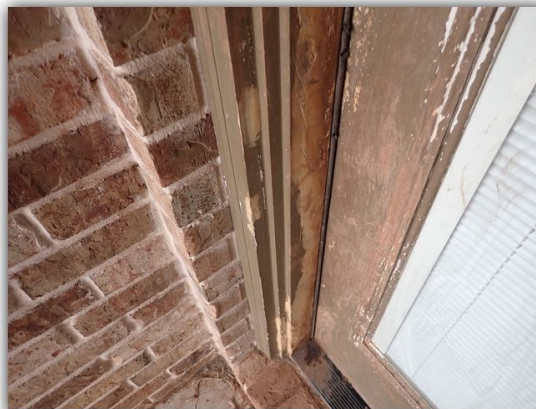
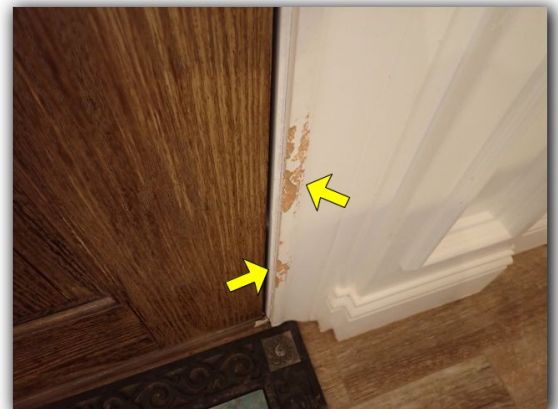
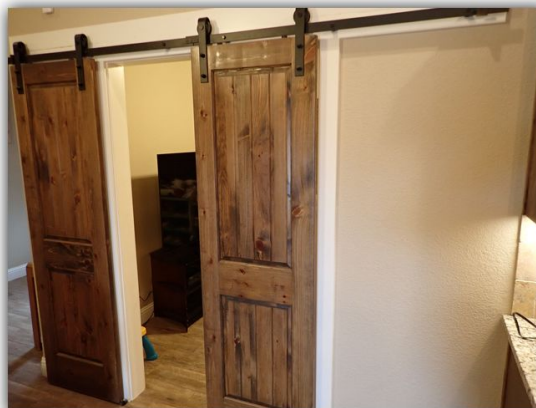
- One of the barn doors does not stay in open position.
- The door(s) are not latching properly and/or sticking in master bathroom. Recommend minor adjustments to the hinges and/or striker plates.
- The door has some surface damage to the master bathroom.

- The exterior door trim has some deterioration and/or damage to the front entry door(s).
- **Note:** Prior repairs were observed at the back porch entry door frame.

- The garage entry door is not equipped with a self-closing device. This is an “as-built” condition per local building standards but we are required to mark it as deficient per the TREC standards of practice.

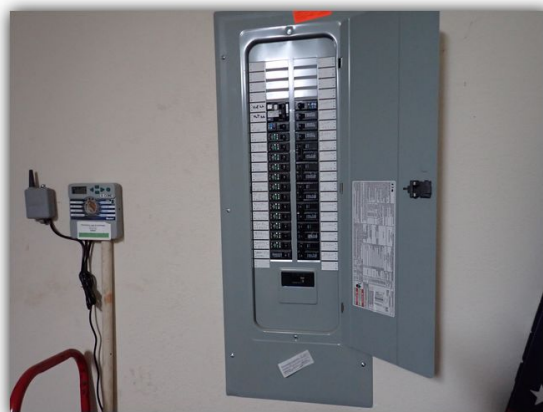
All components were found to be performing and in satisfactory condition on the day of the inspection.

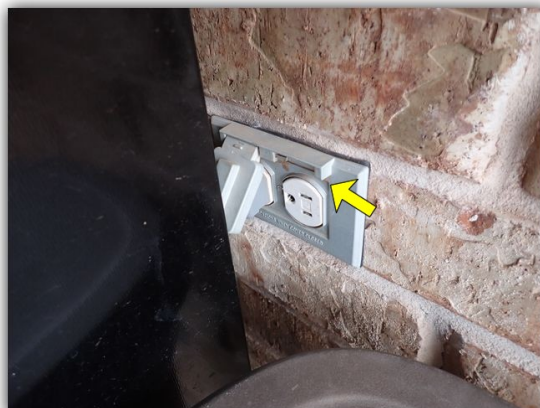
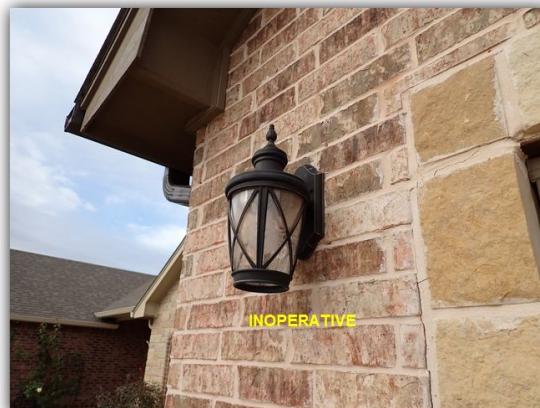
Doorbell / Chime

All components were found to be performing and in satisfactory condition on the day of the inspection.

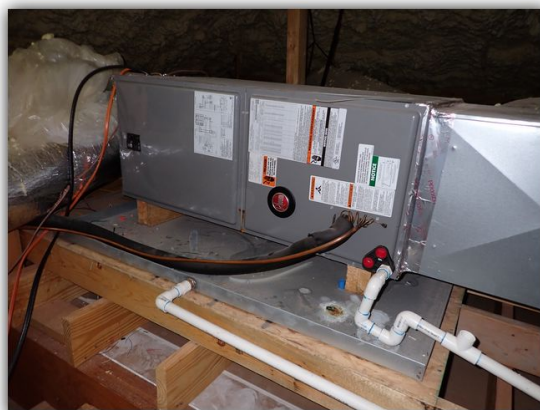
This component appears to be performing adequately at the time of this inspection. It is achieving an operation, function, or configuration consistent with accepted industry practices for its age.

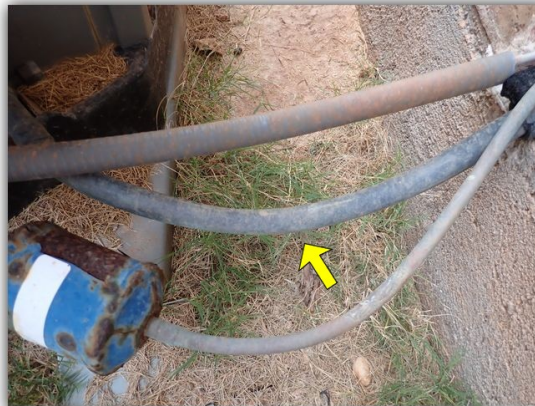
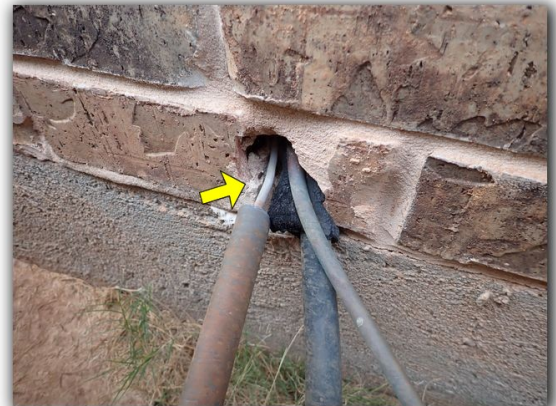
- Damaged, deteriorated and/or missing insulation on the refrigerant lines should be repaired or replaced at the outside condenser. This is typically an inexpensive item which can easily be obtained at home improvement stores.
- The electrical wire conduit has pulled loose at the outside condenser housing and/or service disconnect.

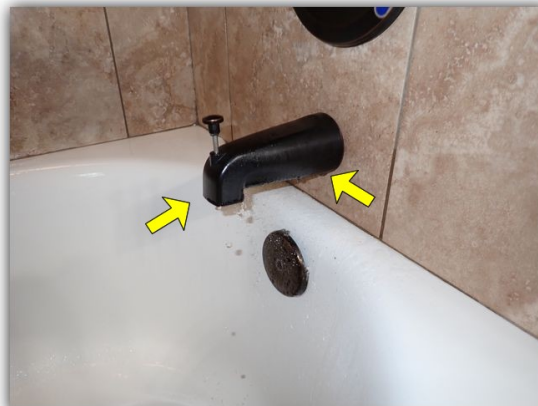
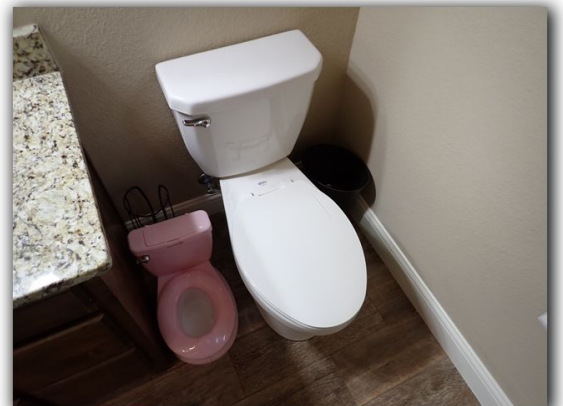
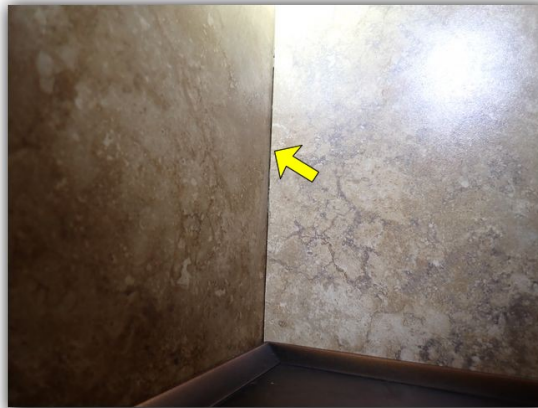
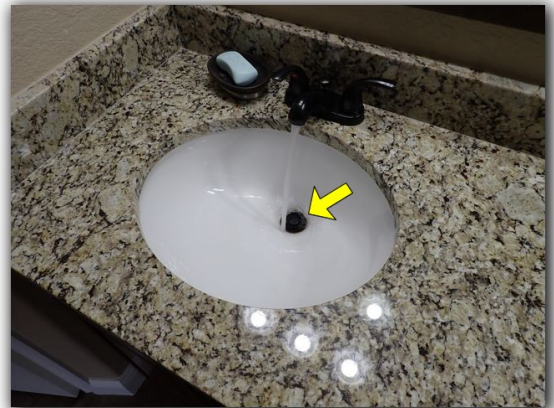
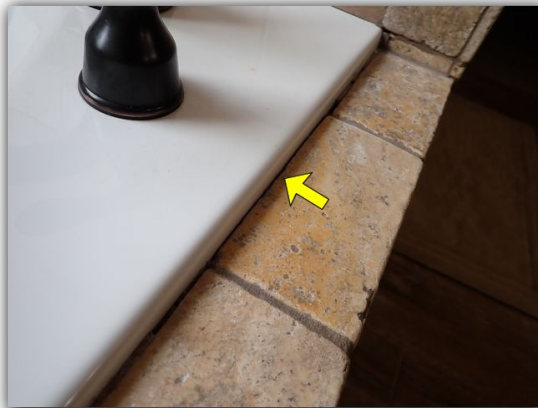
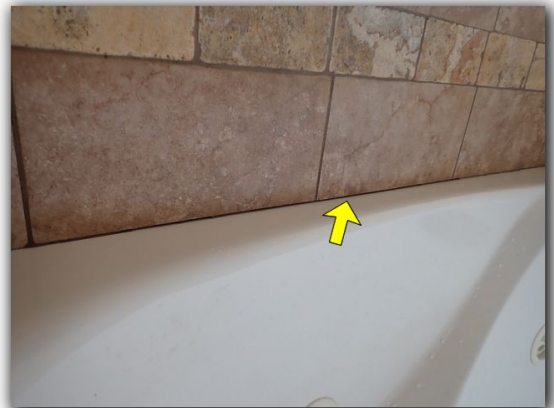
- The sprayer does not appear to be working properly.

- The bathtub shower head diverter is not functioning properly and leaks when operated.

- The commode is loose at the floor mount.

- The stopper does not appear to be functioning properly.

- Cracked, deteriorated and/or missing bathtub enclosure grout and/or caulking should be repaired or replaced as necessary.

- Cracked, deteriorated and/or missing shower stall grout and/or caulking should be repaired or replaced as necessary.
- The shower handle is not functioning properly.

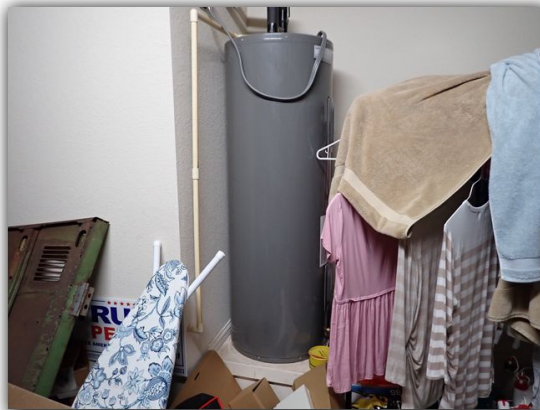
- Some corrosion was observed at the water supply connections at the top of the water heater.

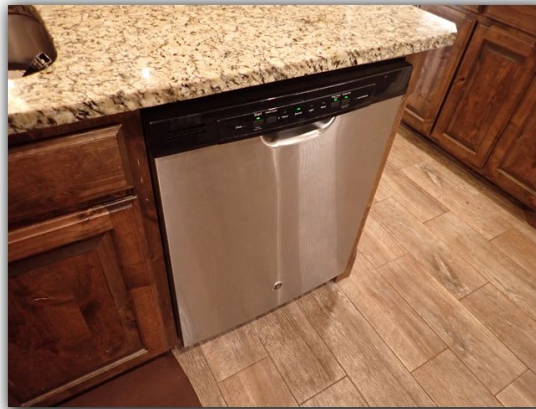
Brand Name: General Electric – GE

This component appears to be performing adequately at the time of this inspection.

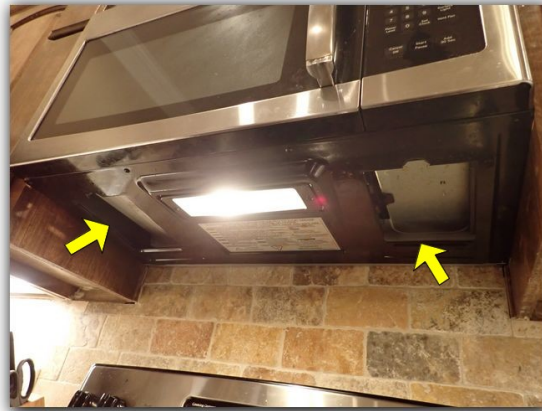
- The range exhaust vent filter is missing.

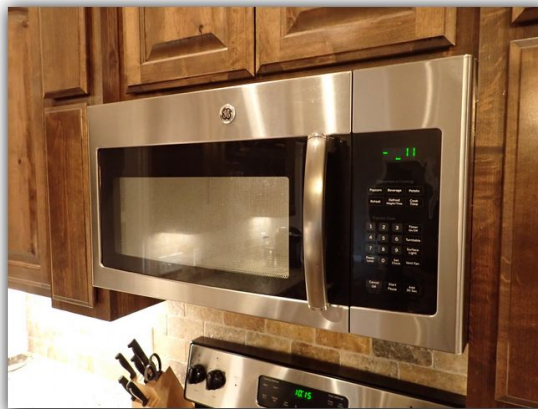
E. Microwave Ovens

Brand Name: General Electric – GE

This component appears to be performing adequately at the time of this inspection.

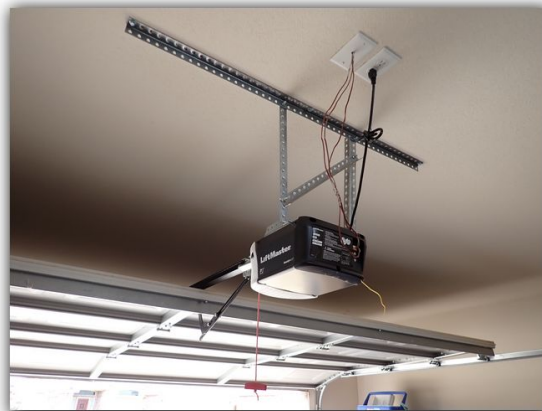
G. Garage Door Operators

This component appears to be performing adequately at the time of this inspection.
