PROPERTY INSPECTION REPORT

Prepared For: Jared & Melissa Boduch
(Name of Client)

Concerning: 5410 Cinderella Ln, Abilene, TX 79602
(Address or Other Identification of Inspected Property)

By: Felipe Cruz, Lic #22478 / NAWT #13743ITC 05/20/2019
(Name and License Number of Inspector) (Date)

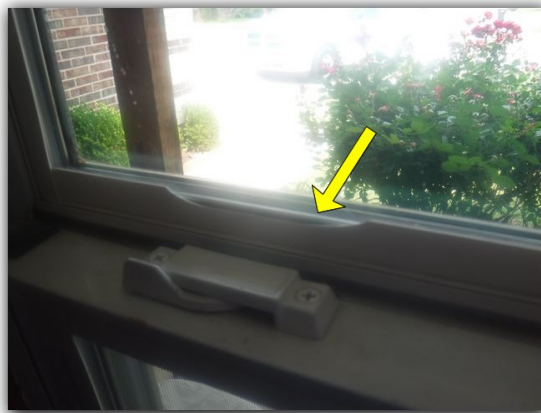
- The window glass plastic sealing strip damaged and/or missing at one or more of the windows and improvements are recommended.

- The window glass plastic sealing strip damaged and/or missing at one or more of the windows and improvements are recommended.

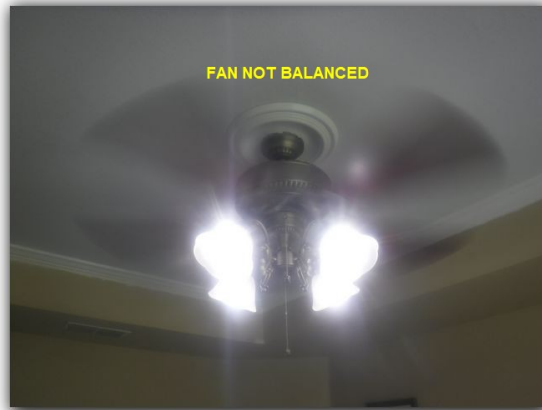
- The ceiling fan is not balanced properly and wobbles when operated in the master bedroom.

- The ceiling fan is not balanced properly and wobbles when operated in the master bedroom.

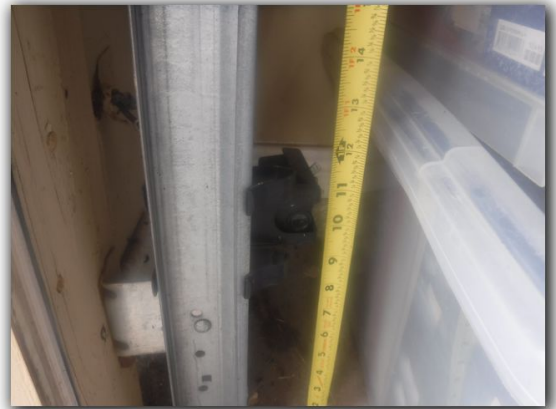
- The garage door reverse sensors are not properly installed. The garage door reverse sensors should be installed within 6-inches of the garage floor.

- The garage door reverse sensors are not properly installed. The garage door reverse sensors should be installed within 6-inches of the garage floor.
