## PROPERTY INSPECTION REPORT

**Prepared For:** James & Beatriz Freeman  
(Name of Client)

**Concerning:** 258 Sugarloaf Ave, Abilene, TX 79602  
(Address or Other Identification of Inspected Property)

**By:** River Dillard, Lic #22970 01/26/2018  
(Name and License Number of Inspector) (Date)

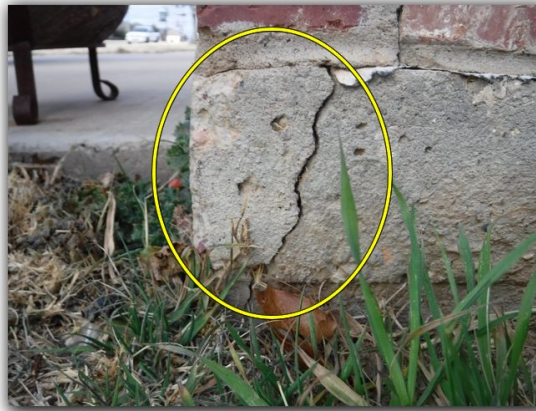
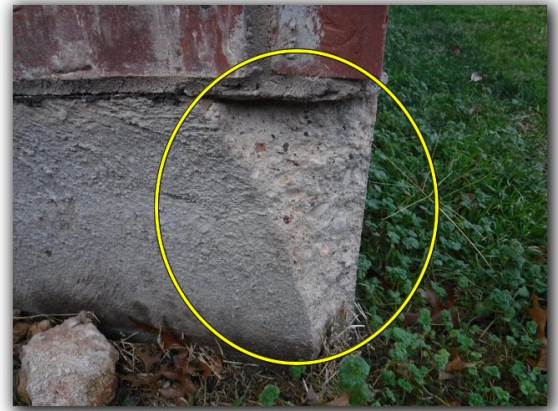
- One or more of the foundation perimeter beam corners were observed to be sheared off (corner pop). This is a common condition in slab on grade foundations. This condition does not adversely affect the performance of the foundation. However, in some cases, some cosmetic improvements may be necessary.

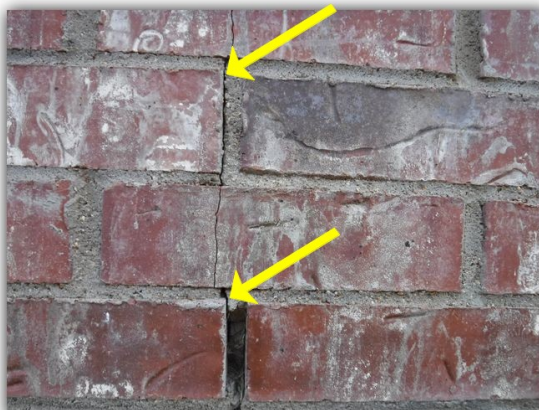
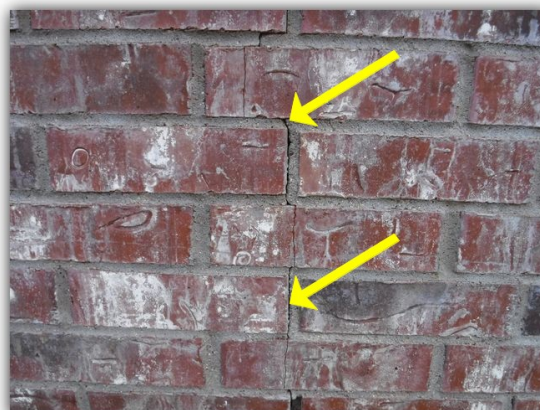
- **Note:** Typical minor mortar and/or brick cracks were observed in the exterior veneer on the west side of the structure.

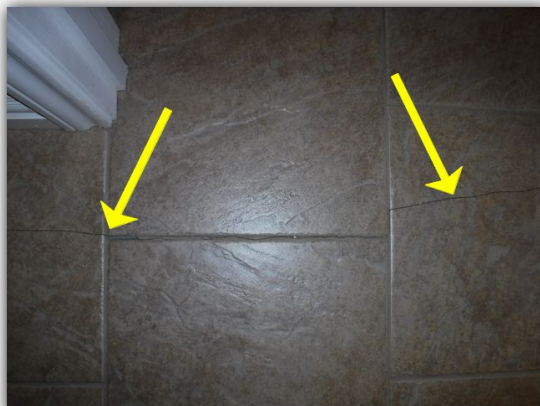
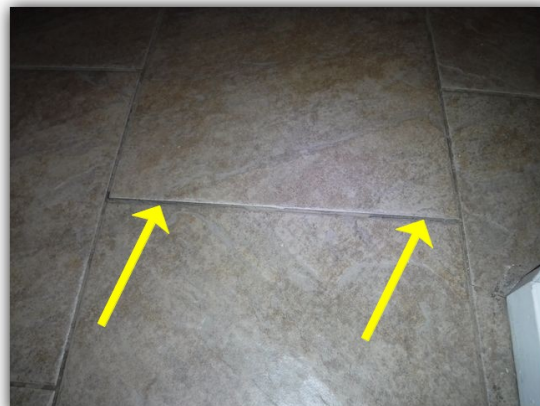
- The floor tile(s) were observed to be cracked and/or damaged in front entrance area, laundry room.

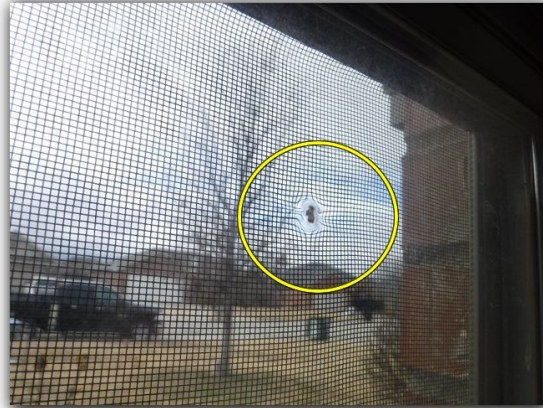
- Cracked and/or broken window glass was observed in the front corner bedroom.

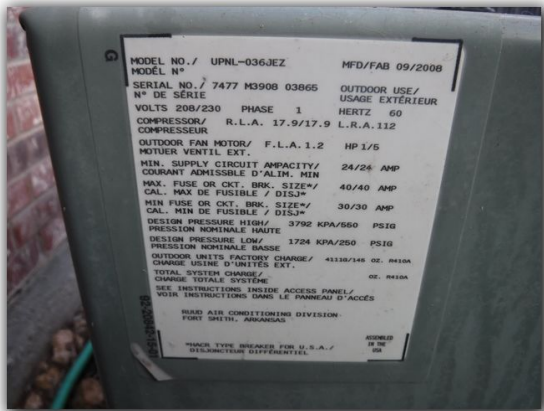
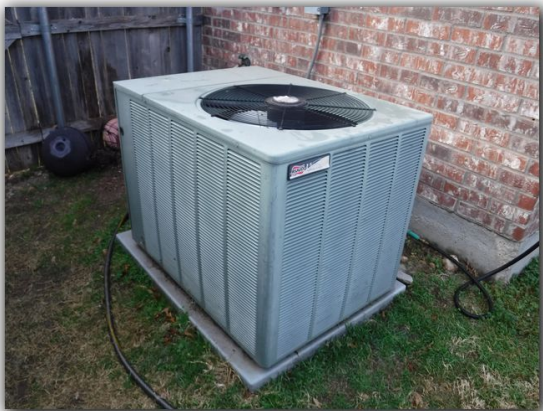
Comments:  
This component appears to be performing adequately at the time of this inspection. It is achieving an operation, function, or configuration consistent with accepted industry practices for its age.

**Notice:** Temperature differential readings are a fundamental standard for testing the proper operation of the cooling system. The normal acceptable range is considered approximately **between 15 to 23 degrees F.** total difference between the return air and supply air. Unusual conditions such as excessive humidity, low outdoor temperatures, and restricted airflow may indicate abnormal operation even through the equipment is functioning basically as designed and occasionally may indicate normal operation in spite of an equipment malfunction.

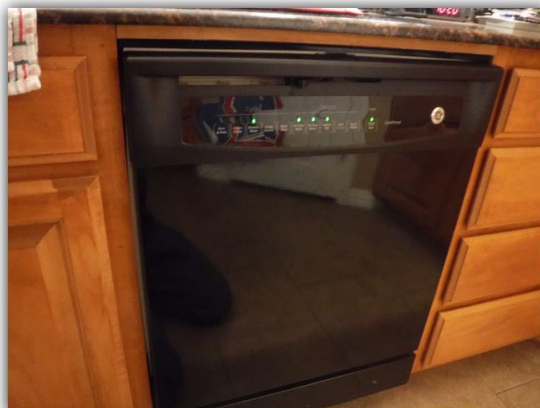
**Brand Name:** General Electric – GE

This component appears to be performing adequately at the time of this inspection.

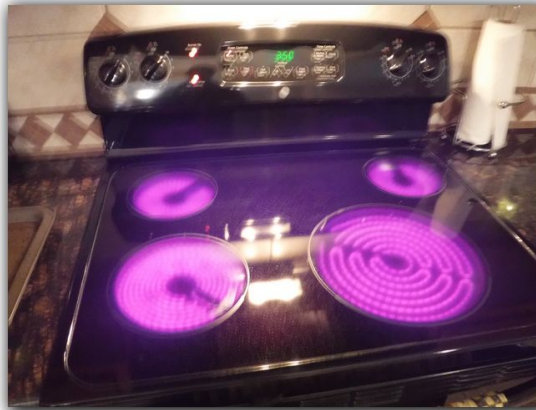
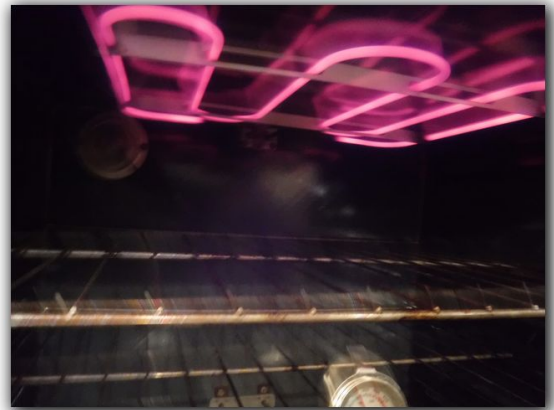
- The range can be easily tipped over and should be equipped with an anti-tip device, for safety.

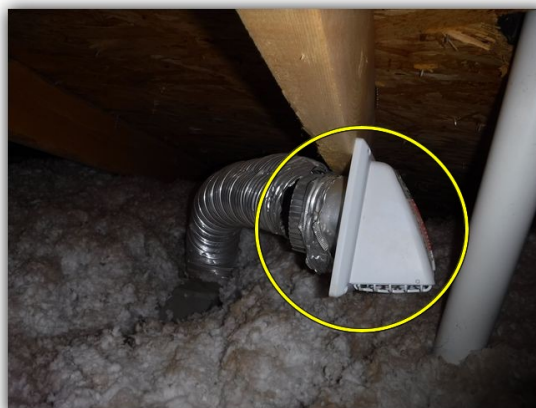
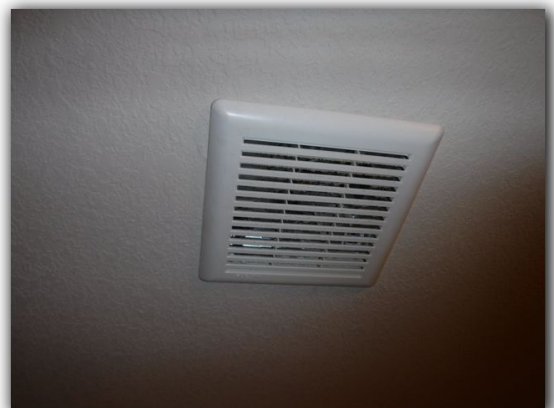
- **Note:** The bathroom exhaust vents were observed to be venting into the attic area and not to the exterior of the structure. This is an “as-built” condition per local building codes but we are required to mark it as deficient per the TREC standards of practice.
