PROPERTY INSPECTION REPORT

Concerning: 307 Paisano Dr, Clyde, TX 79510
(Address or Other Identification of Inspected Property)

By: River Dillard, Lic #22970 01/31/2018
(Name and License Number of Inspector) (Date)

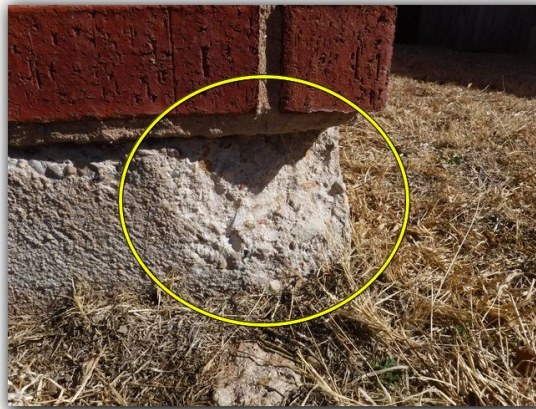
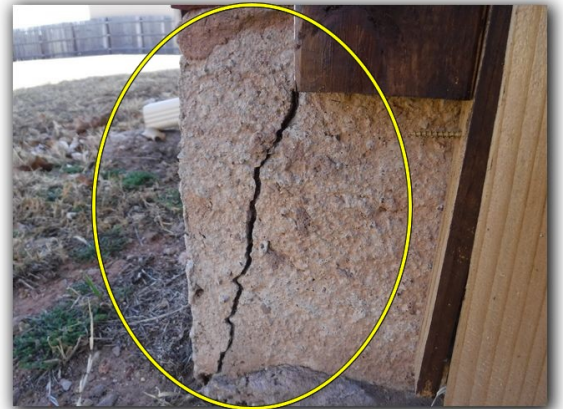
- One or more of the foundation perimeter beam corners were observed to be sheared off (corner pop). This is a common condition in slab on grade foundations. This condition does not adversely affect the performance of the foundation. However, in some cases, some cosmetic improvements may be necessary.

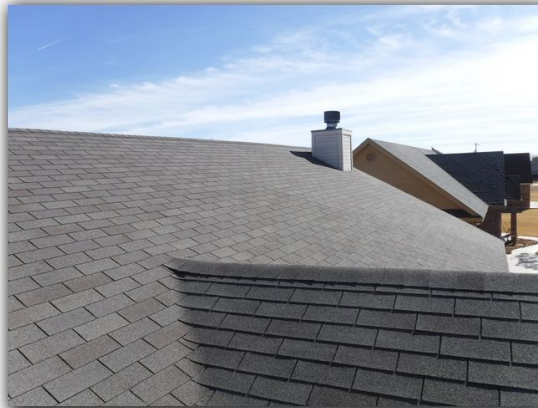
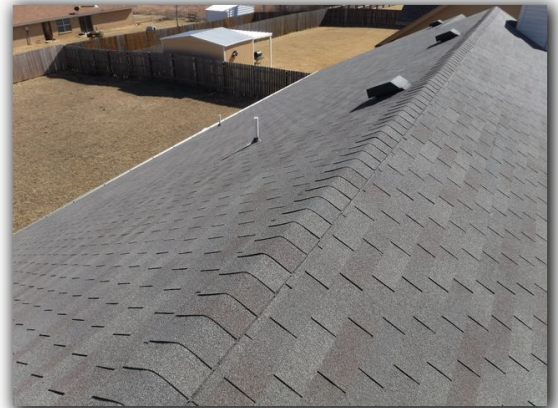
- **Note:** Roof fasteners (nails and/or staples) were observed to be exposed and should be properly sealed at the ridge caps and flashing areas.

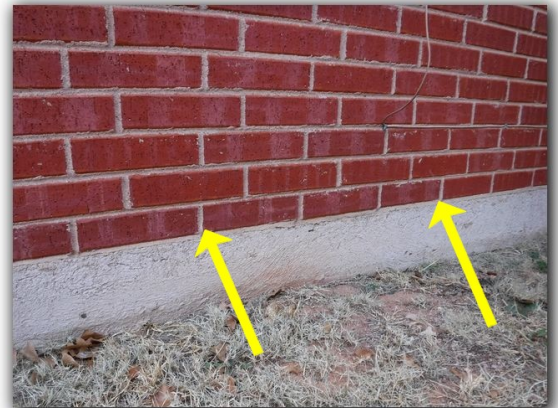
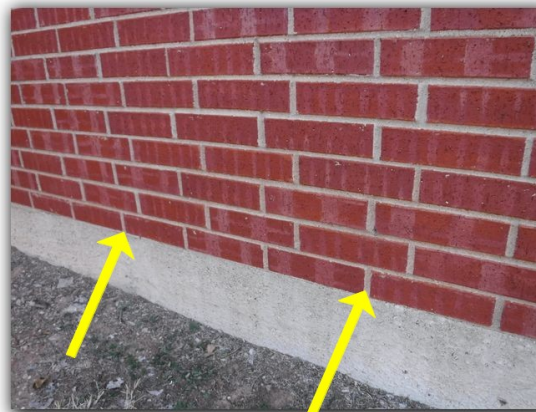
- There were no weepholes observed in the lower course of the masonry veneer on the north, east, west and south sides of the structure. Under current building standards, there should be weepholes in the lower course of the masonry veneer, no more than 33" apart, to help drain water from the interior of the wall voids.

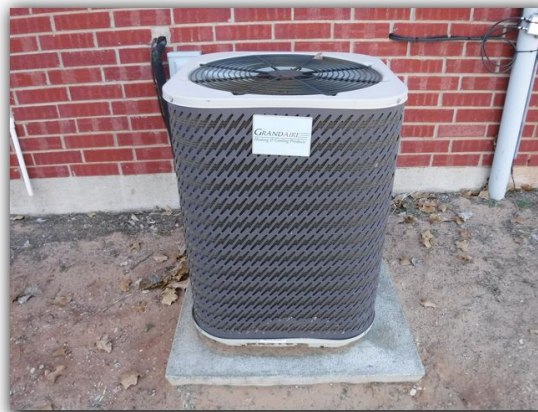
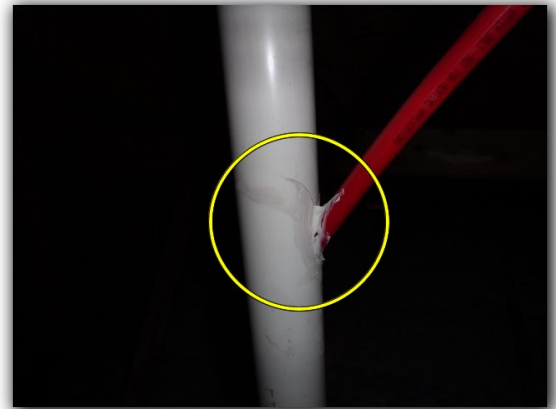
- The primary condensate drain line is improperly terminating into a plumbing vent stack.

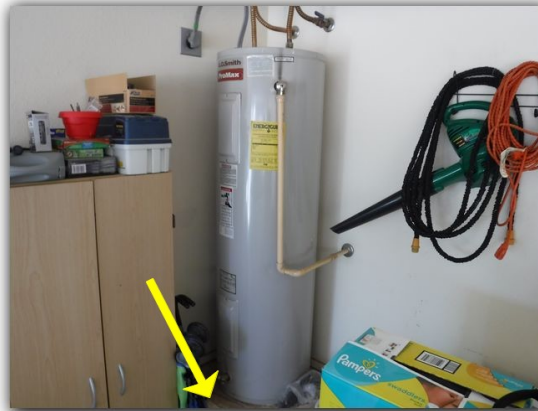
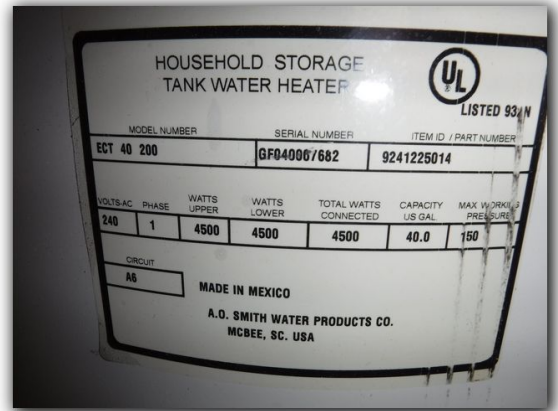
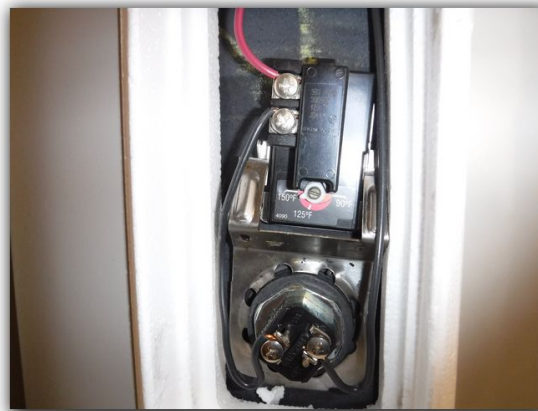
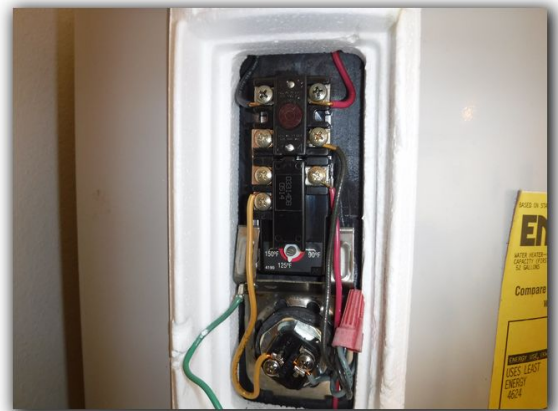
- There is no pan installed under the water heater. It is suggested that the correct sized pan and associated drain pipe system be installed per current installation requirements; at least the next time the water heater is replaced.

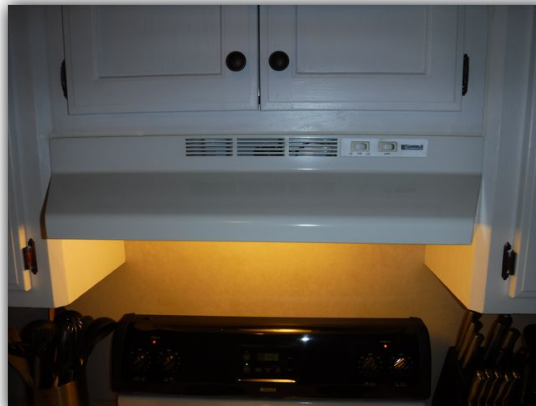
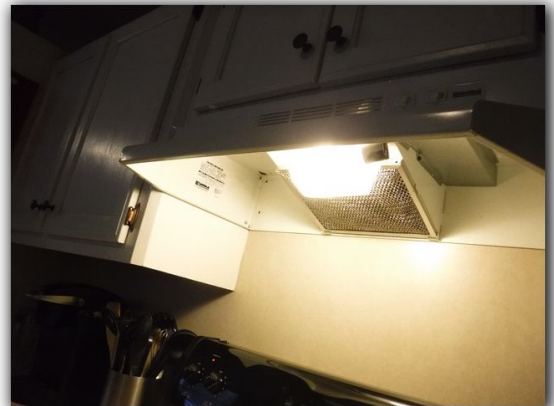
- The range can be easily tipped over and should be equipped with an anti-tip device, for safety.

An **Anti-Tip bracket** is supplied with instructions for installation in a variety of locations. The instructions include all necessary information to complete the installation. Read the **Safety Instructions** and the instructions that fit your situation before beginning installation.

- Range must be secured by **Anti-Tip bracket** supplied.
- If the Anti-Tip device supplied with the range does not fit this application, use the universal Anti-Tip device WB2X7909.
- See instructions to install (supplied with bracket).
- Unless properly installed, the range could be tipped by stepping or sitting on the door. Injury may result from spilled hot liquids or from the range itself.
