PROPERTY INSPECTION REPORT

Concerning: 273 Cedar Lake Dr, Abilene, TX 79606
(Address or Other Identification of Inspected Property)

By: David Renner, Lic #20502 / NAWT #12181ITC 01/05/2018
(Name and License Number of Inspector) (Date)

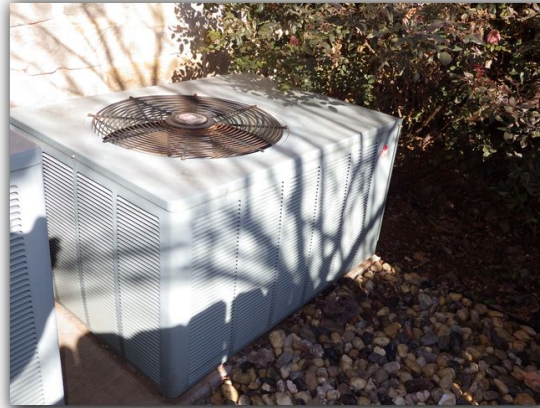
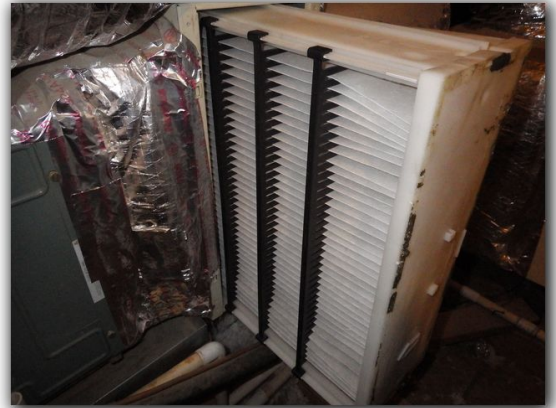
Notice: Temperature differential readings are a fundamental standard for testing the proper operation of the cooling system. The normal acceptable range is considered approximately **between 15 to 23 degrees F.** total difference between the return air and supply air. Unusual conditions such as excessive humidity, low outdoor temperatures, and restricted airflow may indicate abnormal operation even through the equipment is functioning basically as designed and occasionally may indicate normal operation in spite of an equipment malfunction.

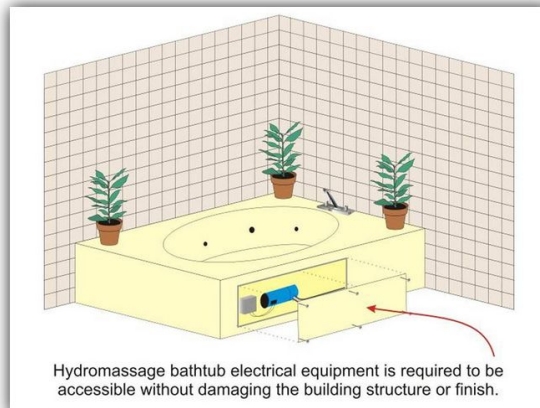
- I was unable to locate a ground fault circuit interrupter (GFCI) receptacle or breaker for the hydro-massage therapy equipment. The homeowner should be consulted on the location of this GFCI device. If there is no GFCI device installed on the hydro-massage therapy equipment circuit, a GFCI receptacle or breaker should be installed for reasons of safety.
- The access to the hydro-massage therapy equipment motor is not readily accessible and inspection of the equipment lines and motor could not be performed. This does not meet current installation standards.

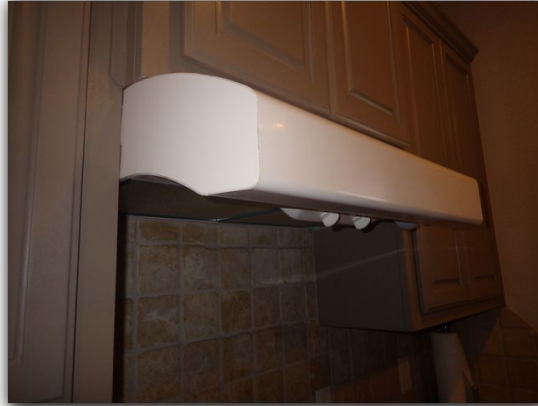
- The range exhaust appears to terminate into the wall. Vented range exhaust should terminate to the exterior of the structure.

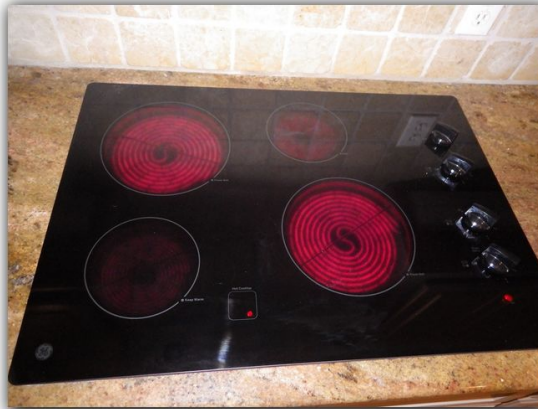
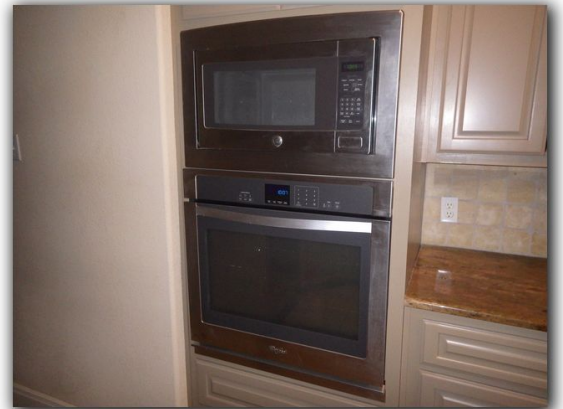
The oven was set to 350 degrees. When tested, at least 30 minutes later, the temperature rose to 355 degrees and held that temperature. A +/- of 25 degrees is considered acceptable.

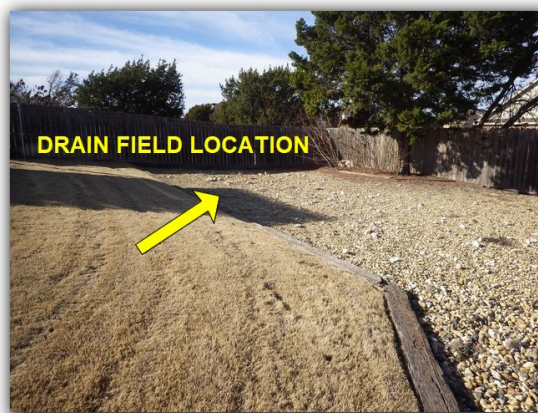
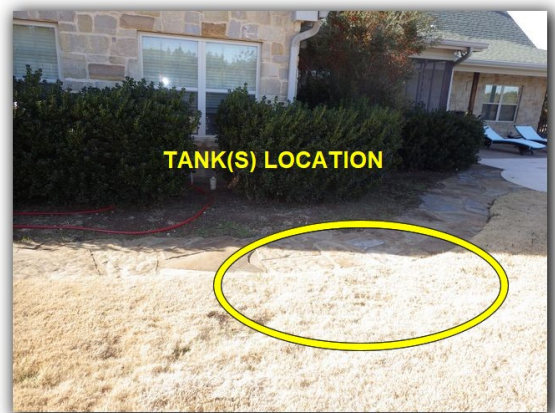
Operation Opinion: Acceptable – Good to Fair Condition

The private sewage disposal (septic) system and related components appear to be operating at an acceptable level at the time of this inspection. There was no visible evidence of deficiencies in accessible components, stopped main drains and no unusual septic olfactory odors. The water was allowed to run for approximately 20 minutes at all of the water fixtures with drains and there was no visible evidence of deficiencies with functional drain flow. Approximately 80 to 100 gallons of water was added to the system. The inspection included a general visual survey of the probable tank and absorption system areas (surface and perimeter) at the beginning, during and the end of the operational test and there was no visible evidence surfacing water in the drain field.
