## PROPERTY INSPECTION REPORT

**Concerning:** 2864 S 7th St, Abilene, TX 79605  
(Address or Other Identification of Inspected Property)

**By:** David Renner, Lic #20502 / NAWT #12181ITC 02/02/2018  
(Name and License Number of Inspector) (Date)

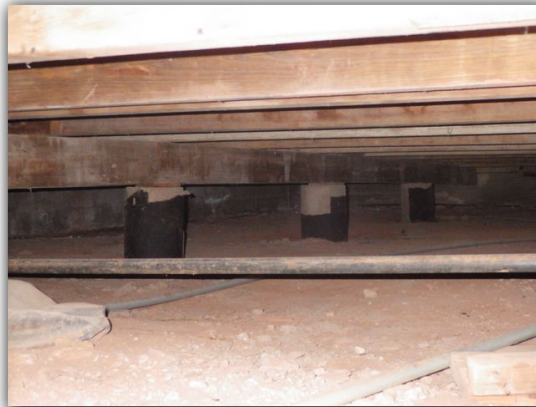
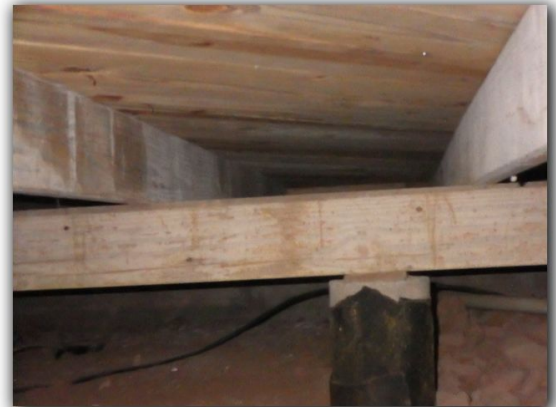
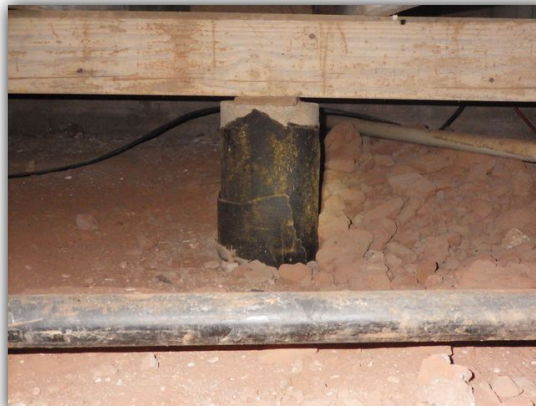
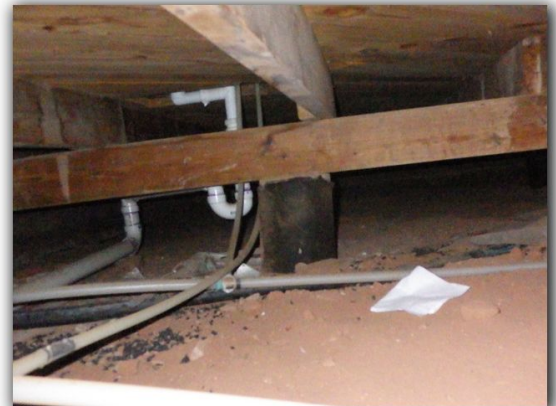
- **Note:** Proper drainage and moisture control is needed with all foundation types. Due to the expansive nature of the load bearing soils in the area it is important to direct water away from the foundation at all locations and that the soil moisture content be maintained at a constant level around the structure. Improper drainage and moisture control may contribute to greater than normal foundation movement.

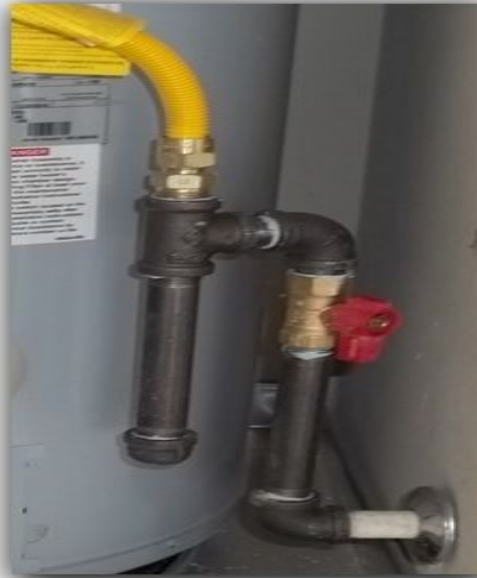
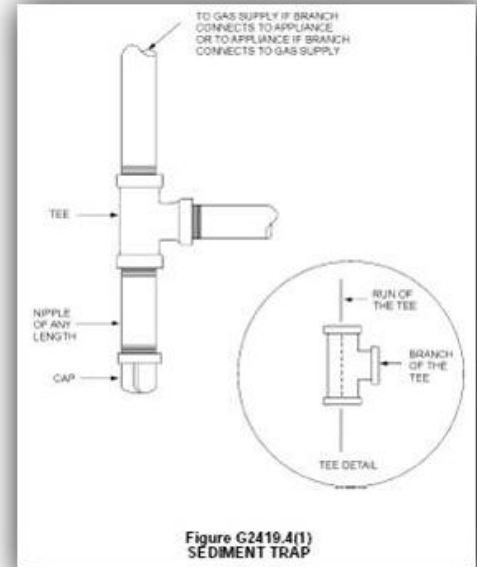
Samples of correct sediment trap installations
