February 6, 2018

PROPERTY INSPECTION REPORT

Concerning: 209 Stardust Trail, Tuscola, TX 79562
(Address or Other Identification of Inspected Property)

By: David Renner, Lic #20502 / NAWT #12181ITC 02/06/2018
(Name and License Number of Inspector) (Date)

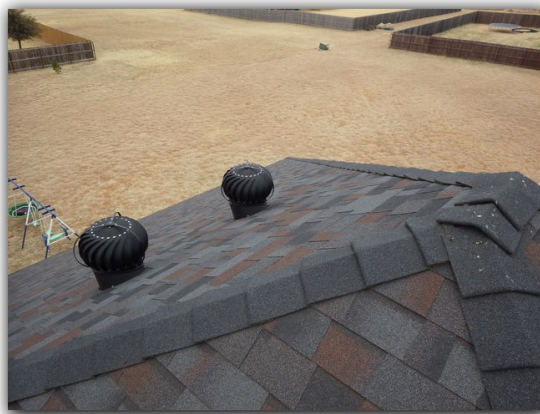
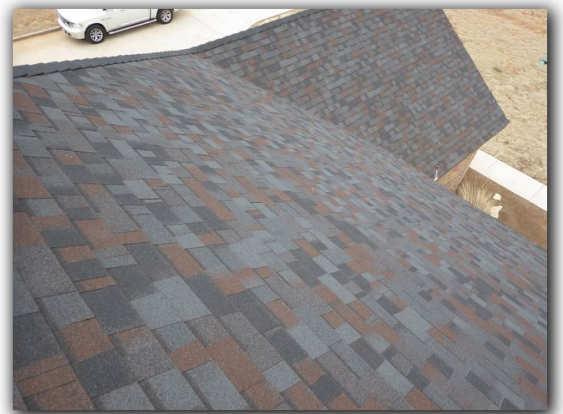
Turbine(s)

All components were found to be performing and in satisfactory condition on the day of the inspection.
