March 21, 2018

PROPERTY INSPECTION REPORT

Prepared For: Homeowner
(Name of Client)

Concerning: 2701 Button Willow Pkwy, Abilene, TX 79606
(Address or Other Identification of Inspected Property)

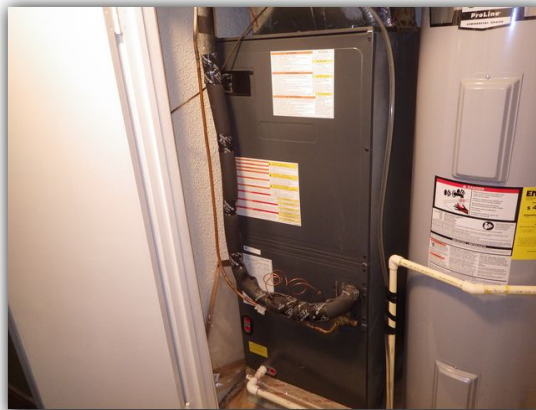
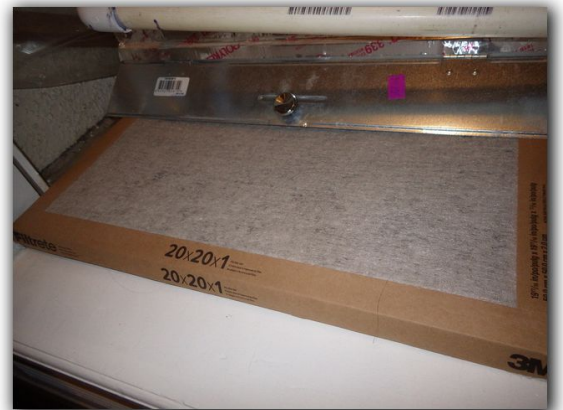
This component appears to be performing adequately at the time of this inspection. It is achieving an operation, function, or configuration consistent with accepted industry practices for its age.

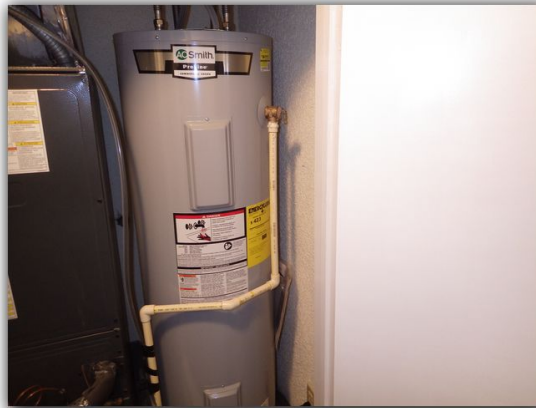
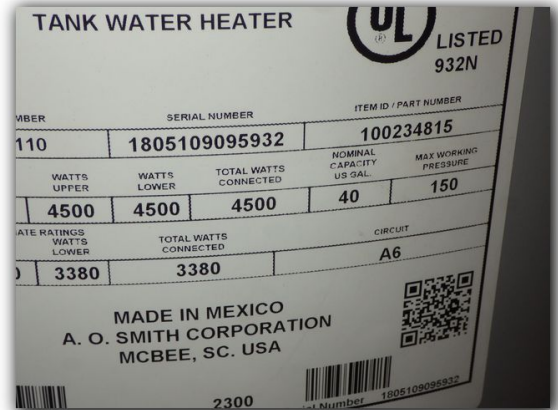
This component appears to be performing adequately at the time of this inspection. It is achieving an operation, function, or configuration consistent with accepted industry practices for its age.

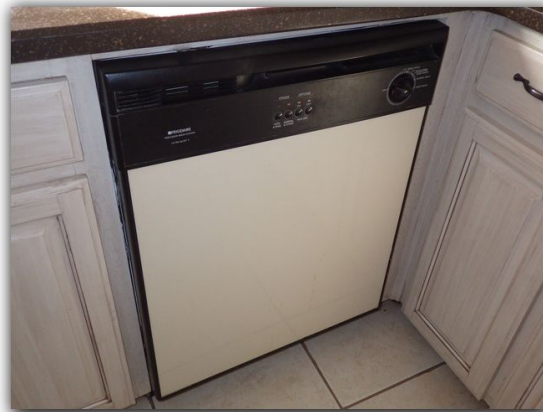
This component appears to be performing adequately at the time of this inspection.
