April 9, 2018

PROPERTY INSPECTION REPORT

Concerning: 781 Ballinger St, Abilene, TX 79605
(Address or Other Identification of Inspected Property)

By: David Renner, Lic #20502 / NAWT #12181ITC 04/09/2018
(Name and License Number of Inspector) (Date)

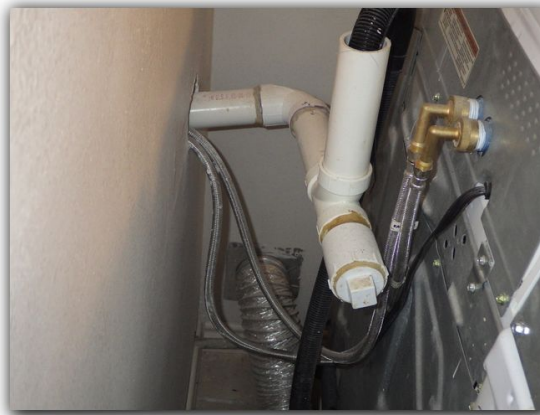
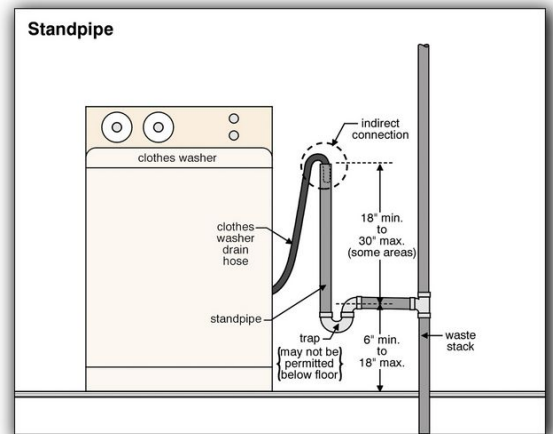
- **Note:** While water was run down the drains, this cannot simulate the waste flows characteristics of a fully occupied structure. Unless specified, fixtures and vessels were not filled to capacity for leak testing to prevent inadvertent water damage to the property. This means that some leaks may go undetected. Comprehensive water leak testing, including hydrostatic testing, may be available from qualified, licensed plumbers. You may also consider further testing and inspection of the sewer line(s) in older homes (40+ years), homes with previous foundation repair, and homes with evidence of poor foundation performance.
- The laundry standpipe does not appear to be installed correctly. Recommend further evaluation and repairs as needed.
