September 17, 2018

PROPERTY INSPECTION REPORT

Concerning: 2709 meadow lake, Abilene, TX 79606
(Address or Other Identification of Inspected Property)

By: River Dillard, Lic #22970 / NAWT #13972ITC 09/17/2018
(Name and License Number of Inspector) (Date)

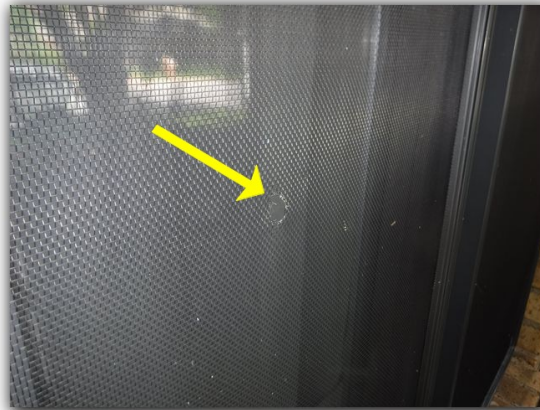
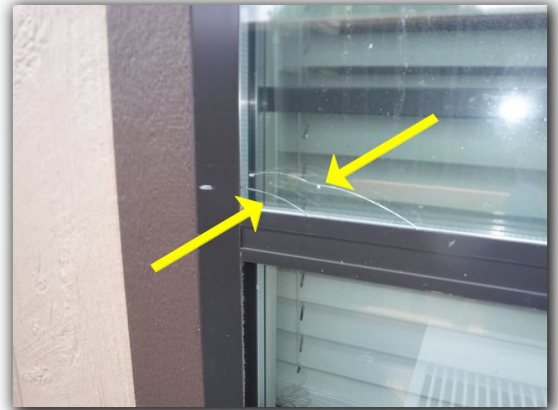
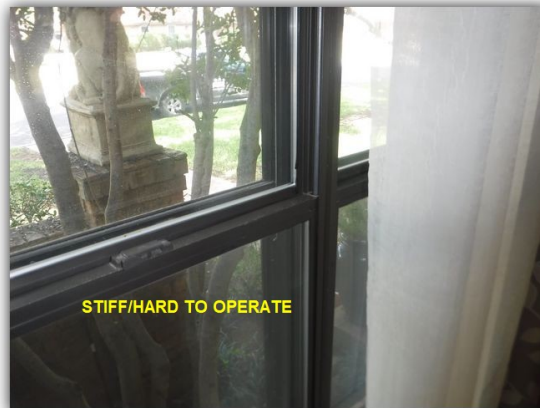
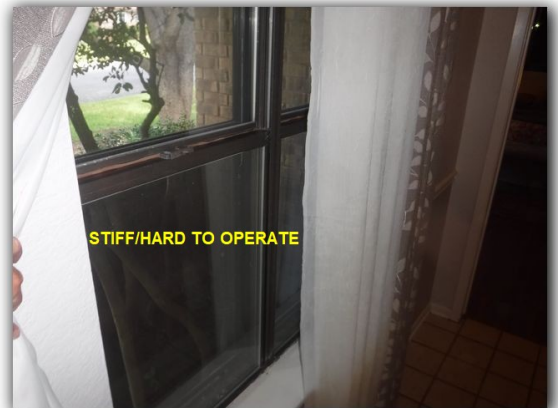
Windows

- **Note:** I was unable to inspect the operation of some of the windows due to window treatments, personal effects, large, heavy or fragile storage and/or furniture.
- One or more of the windows were observed to be stiff and hard to operate in the front entrance area.
- Cracked and/or broken window glass was observed in the garage.

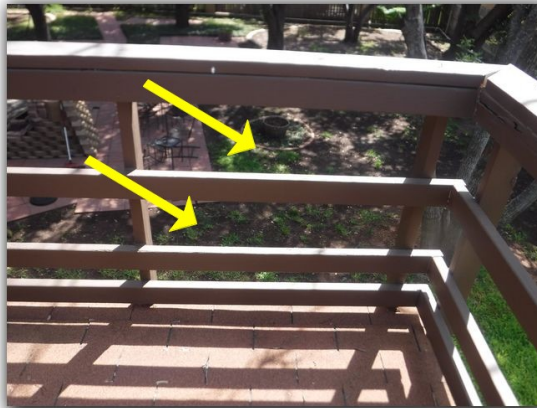
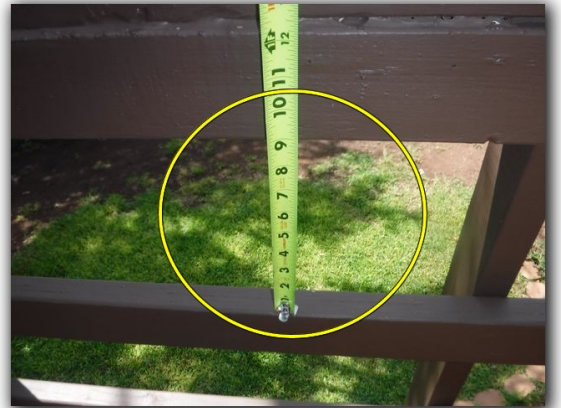
Balcony

- The guard railing balusters and/or spindles are installed too far apart under current building standards. This may be an "as-built" condition but Per TREC standards of practice we are required to report this condition as a deficiency. You may consider corrective measures for improved safety.

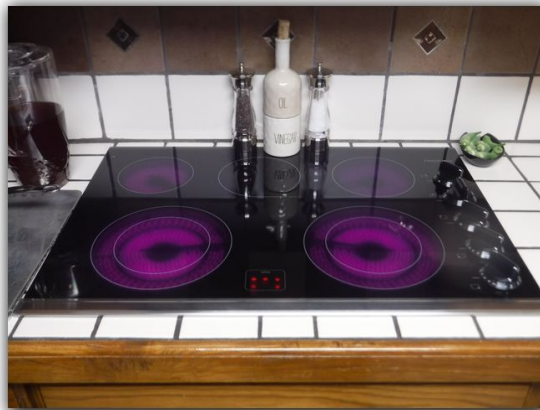
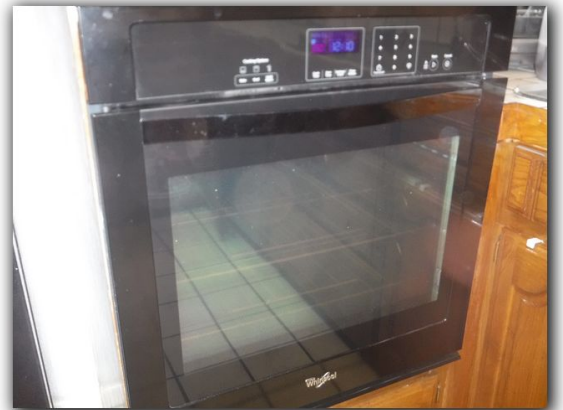
The oven was set to 350 degrees. When tested, at least 30 minutes later, the temperature rose to 350 degrees and held that temperature. A +/- of 25 degrees is considered acceptable.

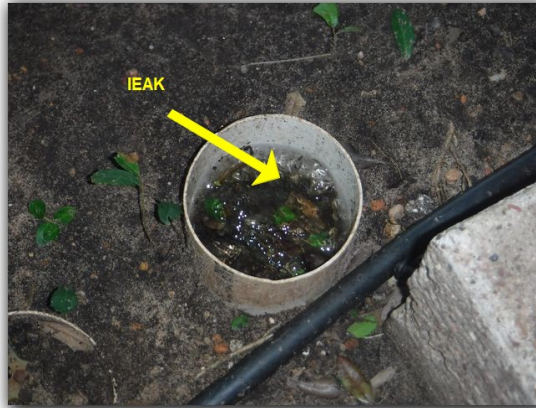
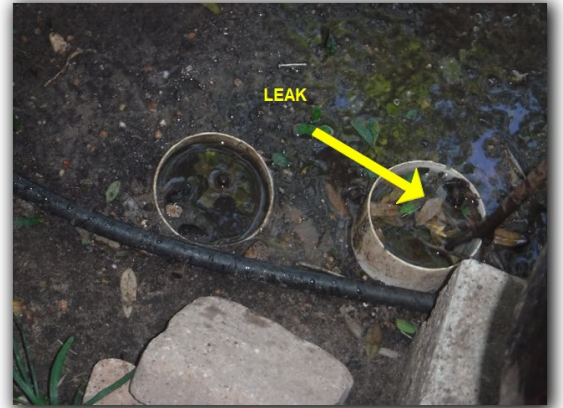
- I was unable to locate a moisture (rain / freeze) sensor device for the sprinkler system. This is an **“as-built” condition**, but Per TREC standards of practice we are required to report this condition as a deficiency.
- The sprinkler system control panel does not appear to be functioning properly. The cause and remedy should be further evaluated and corrected as necessary.
- One or more of the sprinkler heads need to be adjusted so not to spray water onto the exterior walls, surfaces or windows.
- One or more of the sprinkler heads were observed to be damaged and/or missings.
- The irrigation water supply valves leak at the handle when on.
- This is a manually operated system.
