July 19, 2019

PROPERTY INSPECTION REPORT

Concerning: 7901 Skyline Dr, Abilene, TX 79606
(Address or Other Identification of Inspected Property)

By: David Renner, Lic #20502 / NAWT #12181ITC 07/19/2019
(Name and License Number of Inspector) (Date)

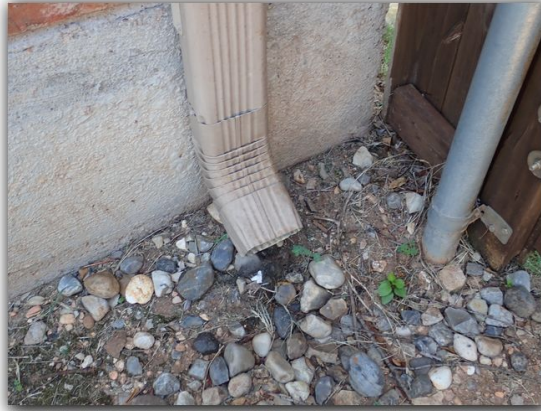
Gutter & Downspout System

- **Note:** The gutter downspouts should discharge water at least thirty-six inches (36") away from the foundation perimeter beam. Storm water should be encouraged to flow away from the structure at the points of discharge.

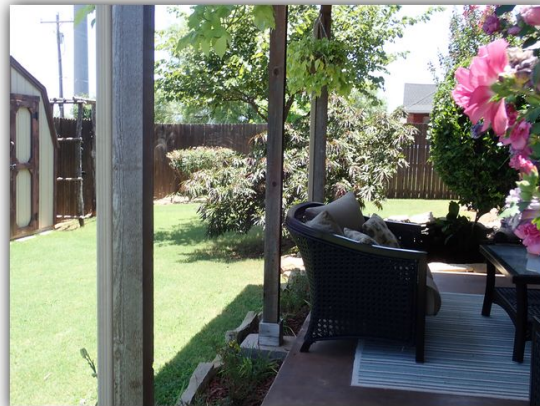
All components were found to be performing and in satisfactory condition on the day of the inspection.

- **Note:** It is recommended to maintain the exposed wood support posts by treating with a water repellent on a regular basis.
