August 12, 2019

PROPERTY INSPECTION REPORT

Concerning: 1 Mission Hills, Abilene, TX 79606
(Address or Other Identification of Inspected Property)

By: River Dillard, Lic #22970 / NAWT #13972ITC 08/12/2019
(Name and License Number of Inspector) (Date)

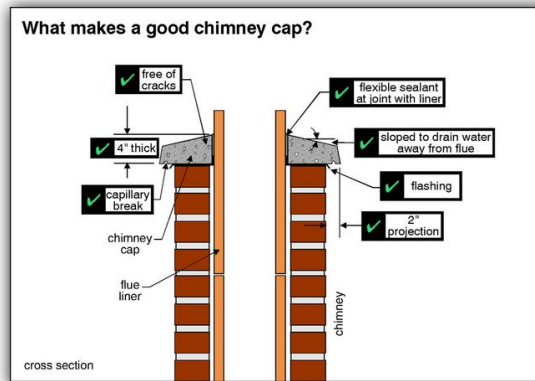
Master Bedroom Fireplace / Chimney

- When artificial gas logs are installed in a firebox with a damper; the damper should be permanently blocked open with a damper clamp to prevent accidental spillage of carbon monoxide into the living space.
- The roof level chimney mortar cap/crown is in need of improvement.

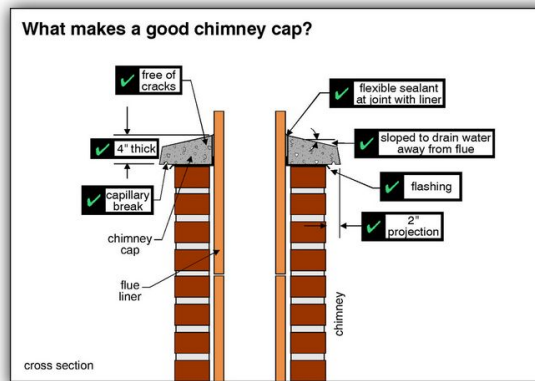
Living Area Fireplace / Chimney

- The firebox damper does not appear to be functioning properly.
- When artificial gas logs are installed in a firebox with a damper; the damper should be permanently blocked open with a damper clamp to prevent accidental spillage of carbon monoxide into the living space.
- The roof level chimney mortar cap/crown is in need of improvement.

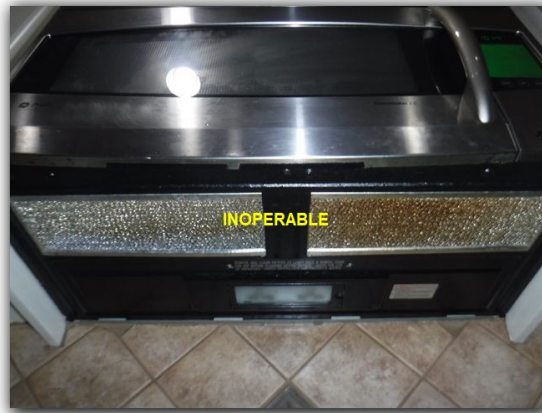
- The range exhaust vent fan motor does not function properly.
- The light at the range hood is inoperative.

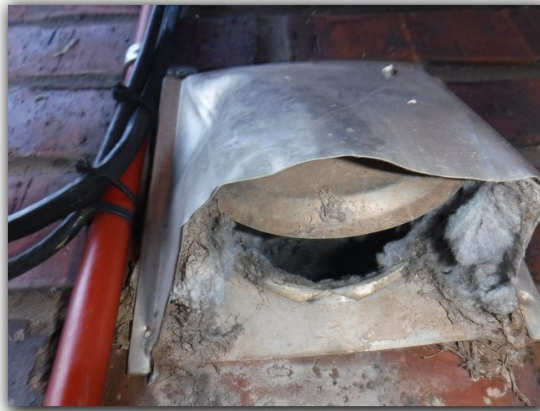
- The dryer exhaust duct (vent pipe) is dirty and needs to be cleaned.
