**5101 Bridle Path Ln  
Abilene, TX 79606**

**September 12, 2022**

# PROPERTY INSPECTION REPORT FORM

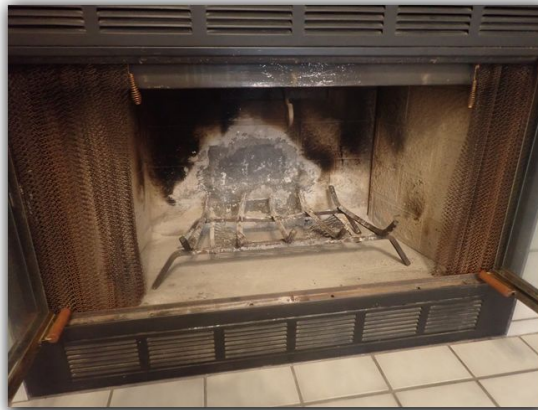
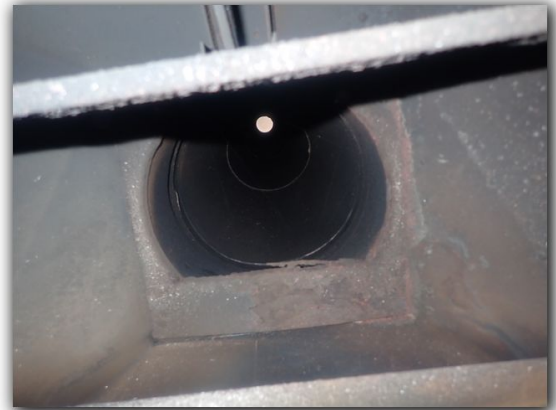
All components were found to be performing and in satisfactory condition on the day of the inspection.

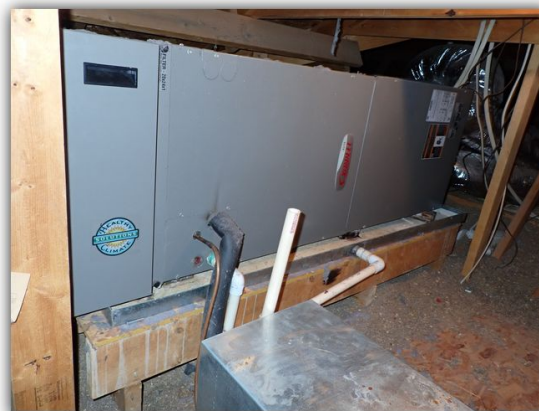
This component appears to be performing adequately at the time of this inspection. It is achieving an operation, function, or configuration consistent with accepted industry practices for its age.

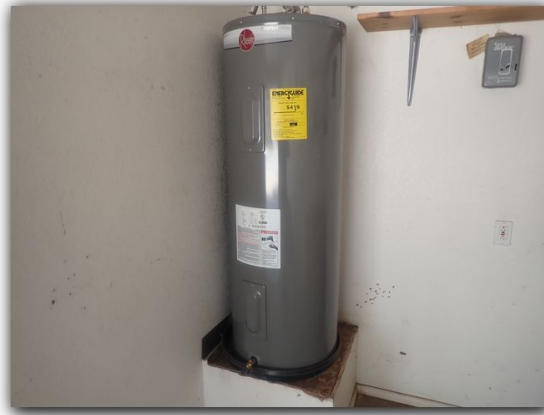
This component appears to be performing adequately at the time of this inspection. It is achieving an operation, function, or configuration consistent with accepted industry practices for its age.

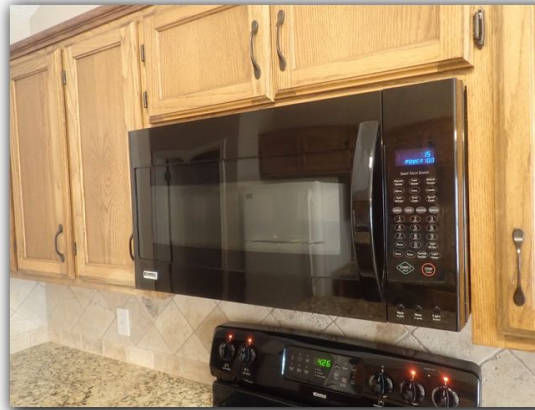
**E. Microwave Ovens**

**Brand Name:** Kenmore

This component appears to be performing adequately at the time of this inspection.

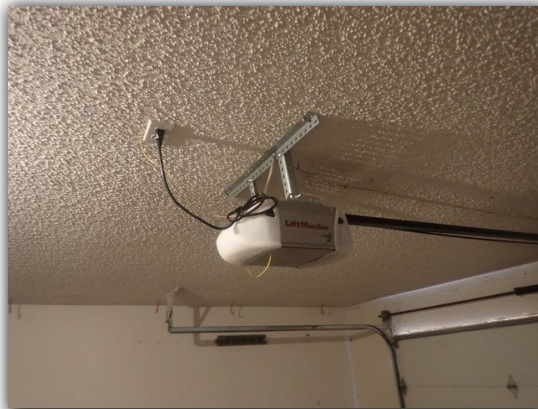
This component appears to be performing adequately at the time of this inspection.
