**Derrick & Akiko Beale
3417 Chimney Rock Rd
Abilene, TX 79606**

October 18, 2018

PROPERTY INSPECTION REPORT

By: Felipe Cruz, Lic #22478 / NAWT #13743ITC 10/18/2018
(Name and License Number of Inspector) (Date)

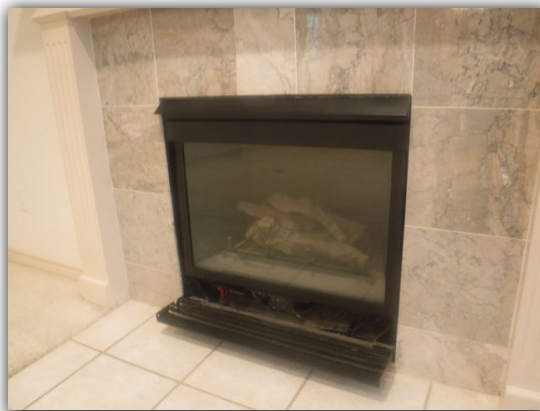
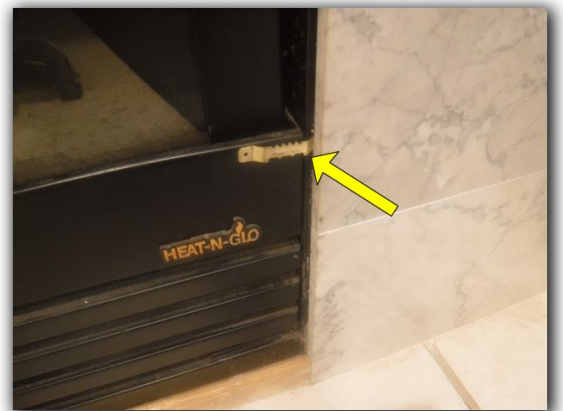
- **Note:** I was unable to light up the gas fireplace at the time of the inspection. The homeowner should be consulted about the conditions of the gas fireplace.
- **Note:** A bracket is being used to hold the gas fireplace bottom cover.
