PROPERTY INSPECTION REPORT

Concerning: 816 E 6th St, Baird, TX 79504
(Address or Other Identification of Inspected Property)

By: River Dillard, Lic #22970 02/26/2018
(Name and License Number of Inspector) (Date)

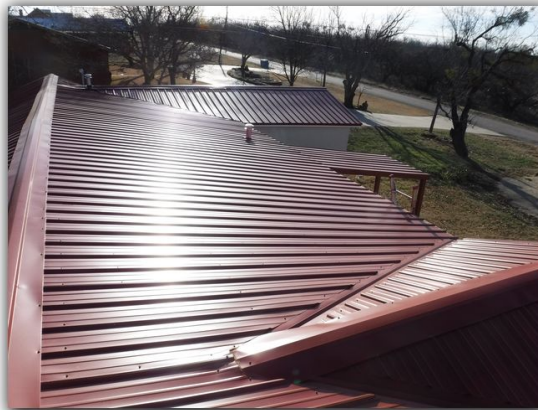
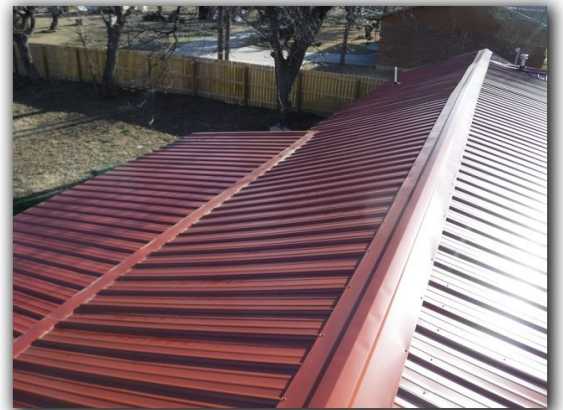
Flashing Details

All components were found to be performing and in satisfactory condition on the day of the inspection.

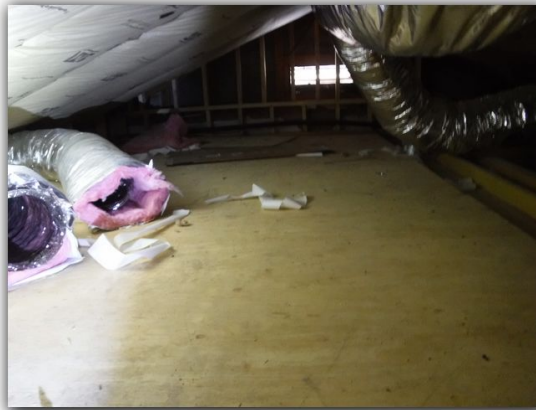
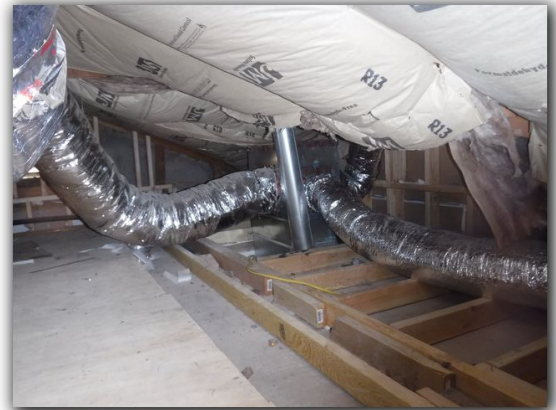
Attic Insulation

All components were found to be performing and in satisfactory condition on the day of the inspection.

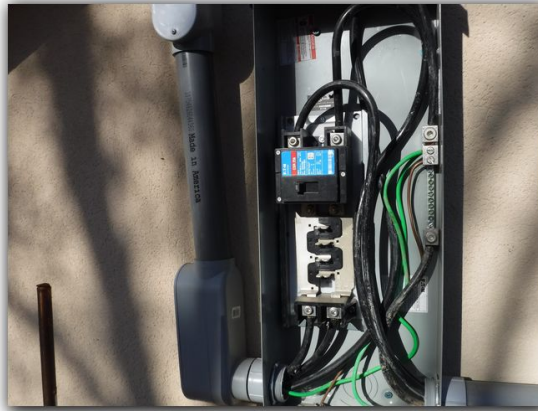
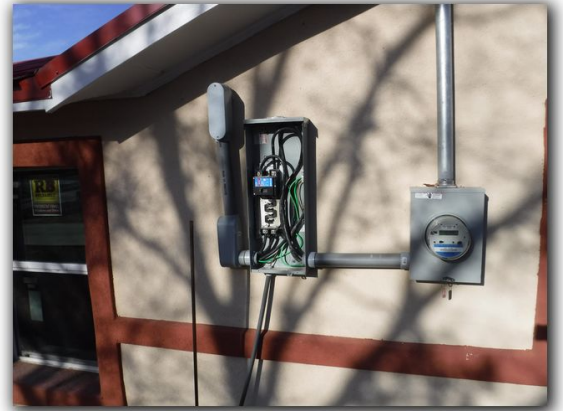
All components were found to be performing and in satisfactory condition on the day of the inspection.

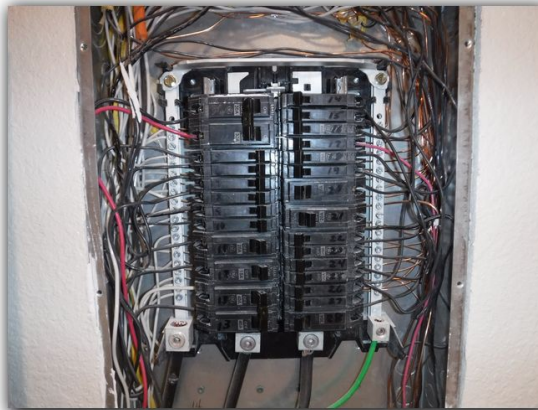
Sub Panel

All components were found to be performing and in satisfactory condition on the day of the inspection.
