PROPERTY INSPECTION REPORT

Concerning: 13 Mission Hills, Abilene, TX 79606
(Address or Other Identification of Inspected Property)

By: Felipe Cruz, Lic #22478 / NAWT #13743ITC 03/12/2018
(Name and License Number of Inspector) (Date)

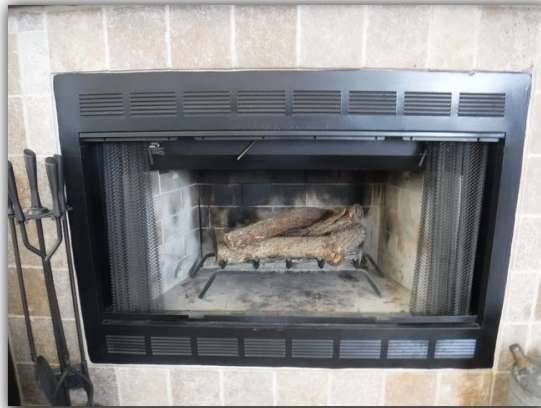
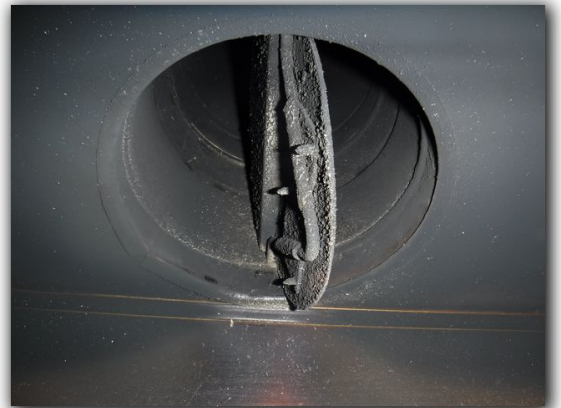
- The chimney flue needs to be cleaned by a Qualified Chimney Sweep. A creosote / soot build-up was observed in the visible flue area.

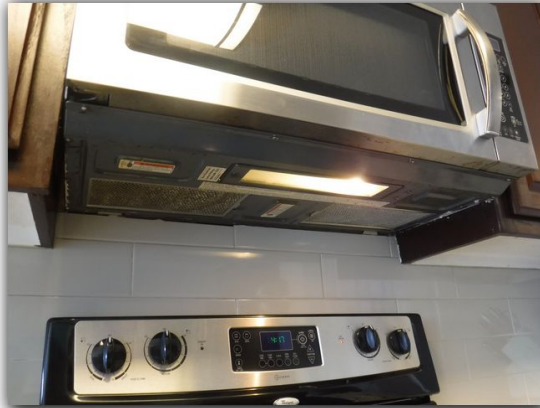
D. Ranges, Cooktops, and Ovens

The oven was set to 350 degrees. When tested, at least 30 minutes later, the temperature rose to 345 degrees and held that temperature. A +/- of 25 degrees is considered acceptable.
